## **Investigation of Painted Steel Piles at a Marine Commerce Terminal in Coastal New England**

George T. Bayer, Mehrooz Zamanzadeh, Anil Kumar Chikkam, and Aaron Ulmer  
Matergenics Inc.  
100 Business Center Drive  
Pittsburgh, PA 15205  
United States

### **ABSTRACT**

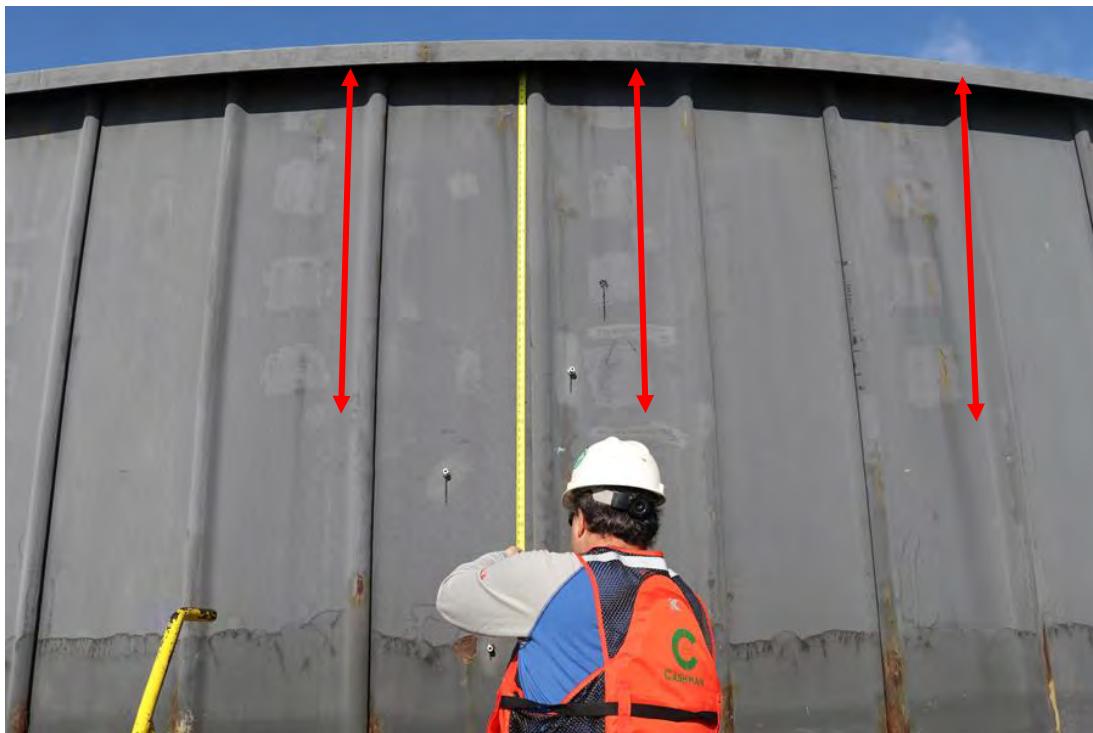
Figure 1 is a photograph of Pile 13 showing that mill coating was damaged and recoating was applied on-site at the damaged areas. The mechanical damage noticed on alternate plates is of similar pattern and present at similar position. Figure 2 is a photograph of Pile 13 showing mechanical damage areas in the splash zone, epoxy putty repairs at some of the corroded areas in the high tidal zone and barnacles in the low tidal zone.

**Figure 1: Photograph of Pile 13 showing that mill coating was damaged and recoating was applied on-site at the damaged areas. The mechanical damage noticed on alternate plates is of similar pattern and present at similar position.**

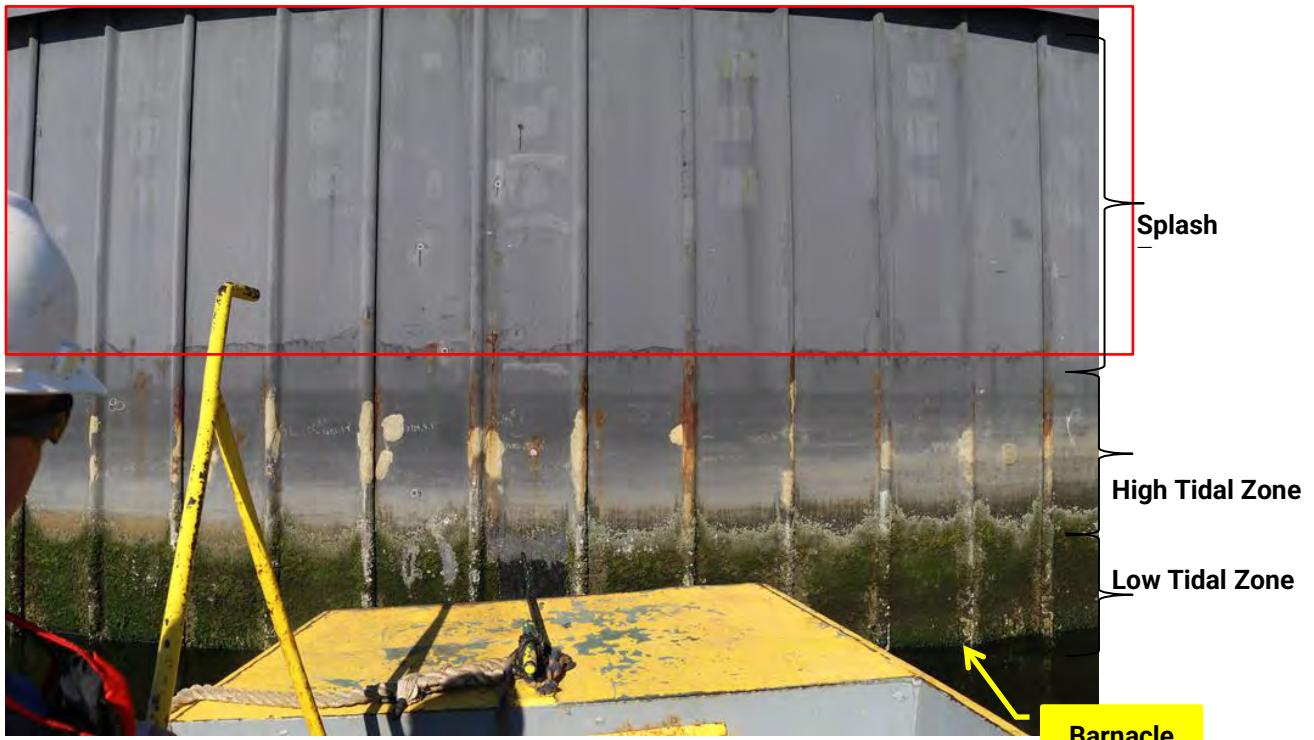
**Figure 2: Photograph of Pile 13 showing mechanical damage areas in the splash zone, epoxy putty repairs at some of the corroded areas in the high tidal zone and barnacles in the low tidal zone.**

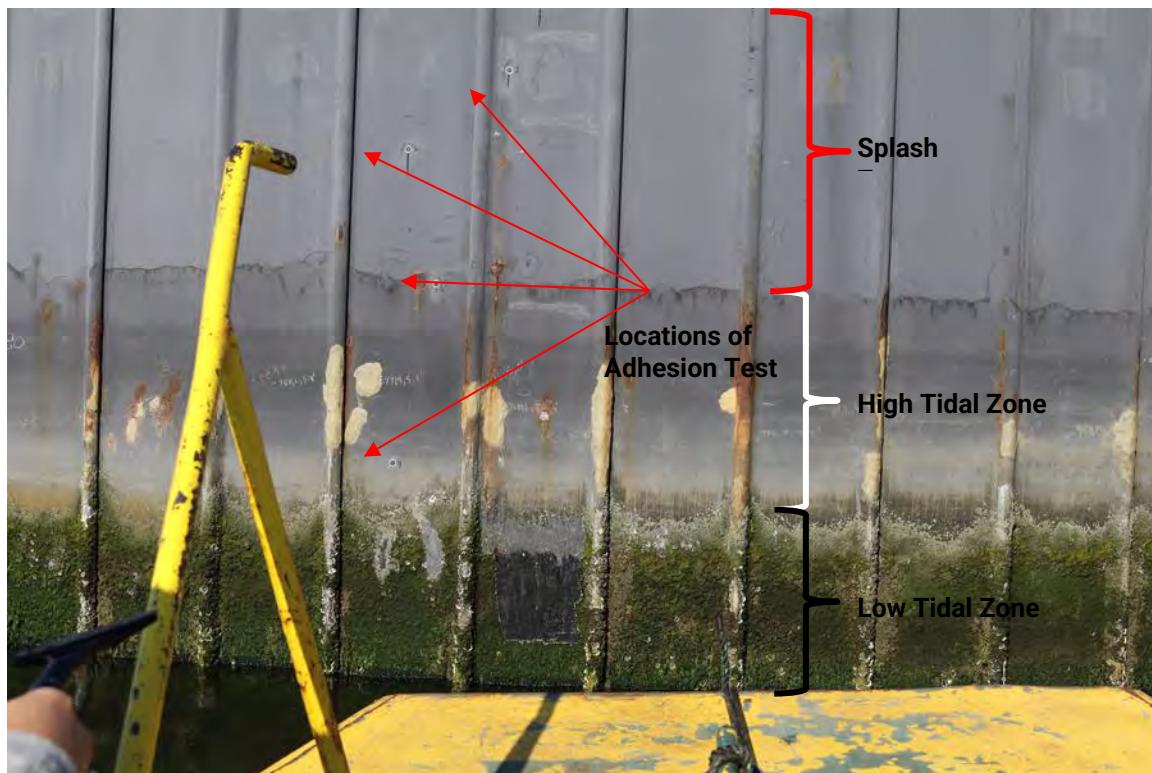
**Figure 3: Photograph of Pile 13 showing the locations of adhesion test.**

Tensile adhesion testing on four separate locations in the high tidal zone of Pile 13. The tensile adhesion test results for dollies one through four were as follows: 2600 psi, 2600 psi, 1500 psi, 1300 psi. The residual coating attached to the dollies after adhesion testing were returned to the laboratory for SEM/EDS analysis.

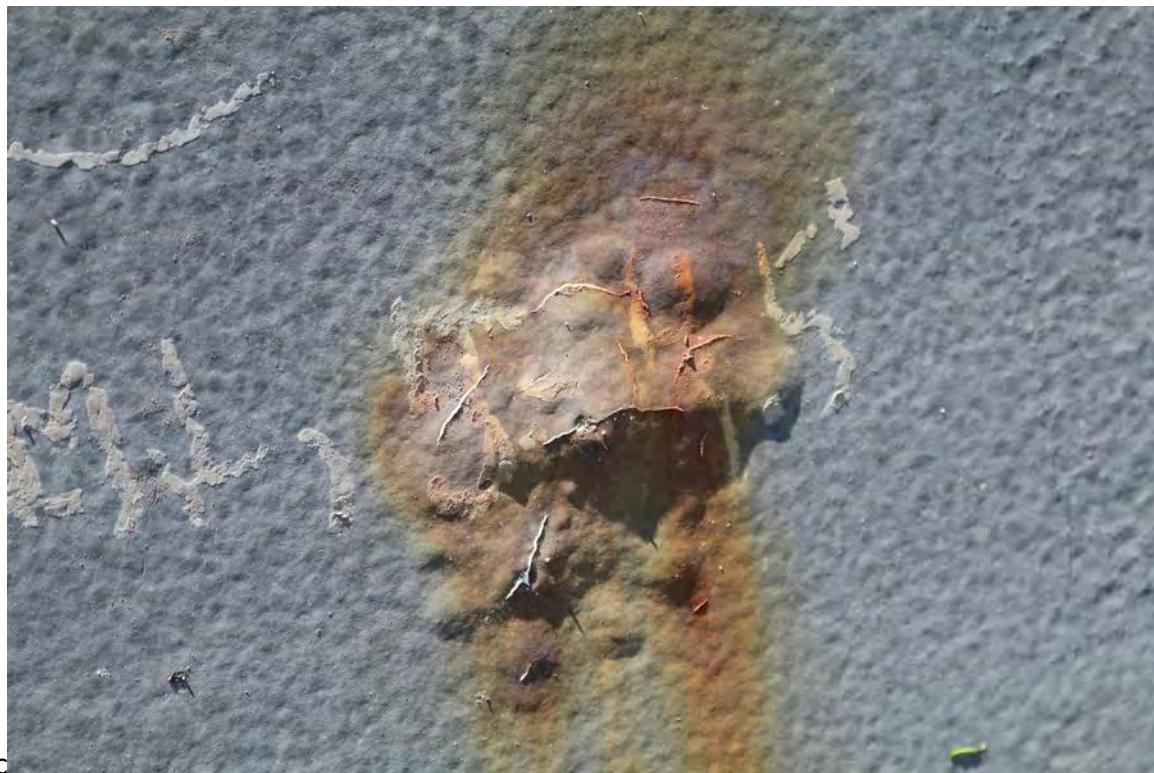
Figure 3 is a photograph of Pile 13 showing the locations of adhesion test. Figure 4 is a photograph of Pile 13 showing cracks in the coating and corrosion deposits underneath the coating. Figure 5 shows a closer view of Figure 16 after removing the coating and corrosion deposits.

**Figure 4: Photograph of Pile 13 showing cracks in the coating and corrosion deposits underneath the coating.**

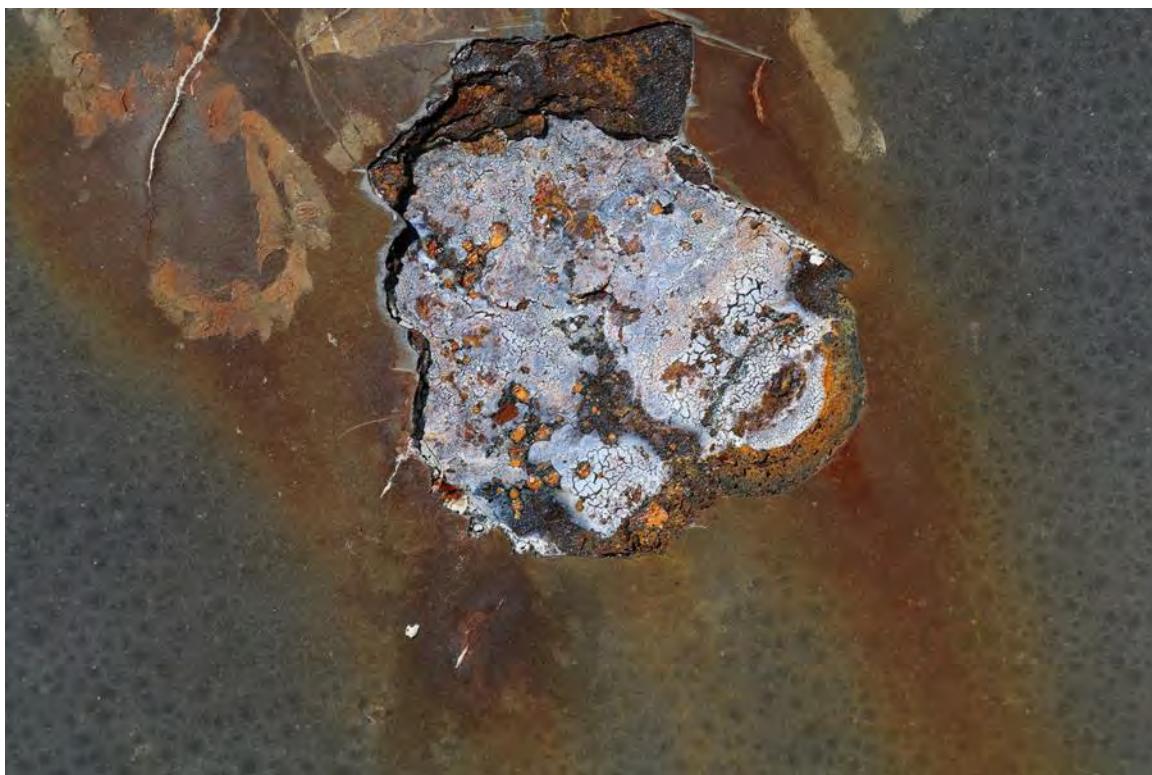
**Figure 5: Closer view of Figure 4 after removing the coating and corrosion deposits.**

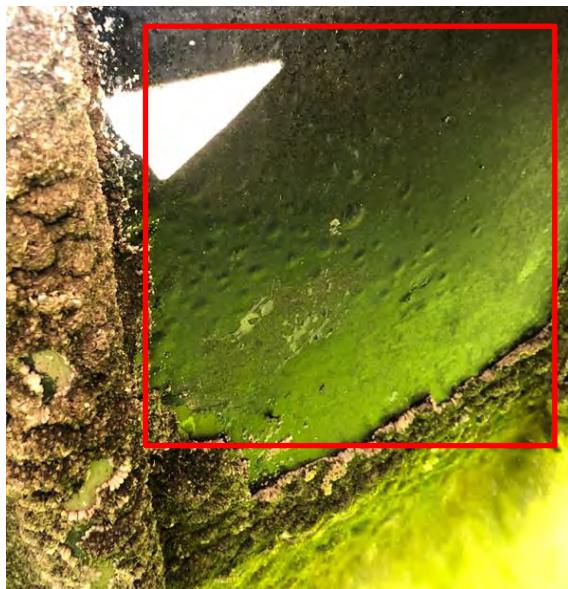
Coating blistering under scraped barnacles was examined closely and extensively documented by photographs. Figures 6 and 7 present photographs showing blisters in the coating after the barnacles in the low tidal zone are removed by scraping. Blisters in the coating are restricted only to low tidal zone and below under the barnacles which suggests existence of fouling activity.

**Figure 6: Photograph showing blisters in the coating after the Barnacles in the low tidal zone are removed by scraping. No evidence of blisters in the coating in the high tidal zone which is free from barnacles.**

- Painted surfaces exhibit blistering mostly under barnacles. Most of the blisters are observed in the barnacles indicating the primary reason for blistering is barnacle penetration and diffusion of chlorides and sulfur due to barnacle penetration. In the long term, a buildup of barnacles will act as a barrier to corrosion and reduce cathodic protection current demand.

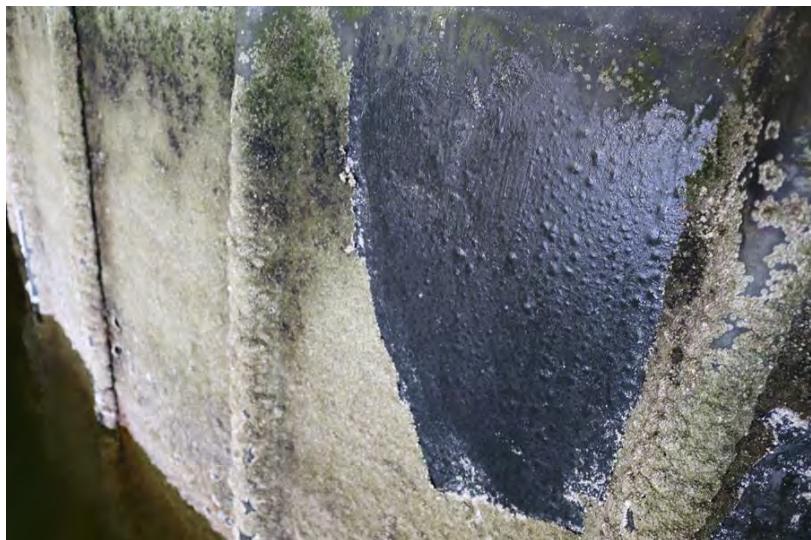
**Figure 7: Photograph showing blisters in the coating after the barnacles in the low tidal zone are removed by scraping. No evidence of blisters in the coating in the high tidal zone which is free from barnacles.**

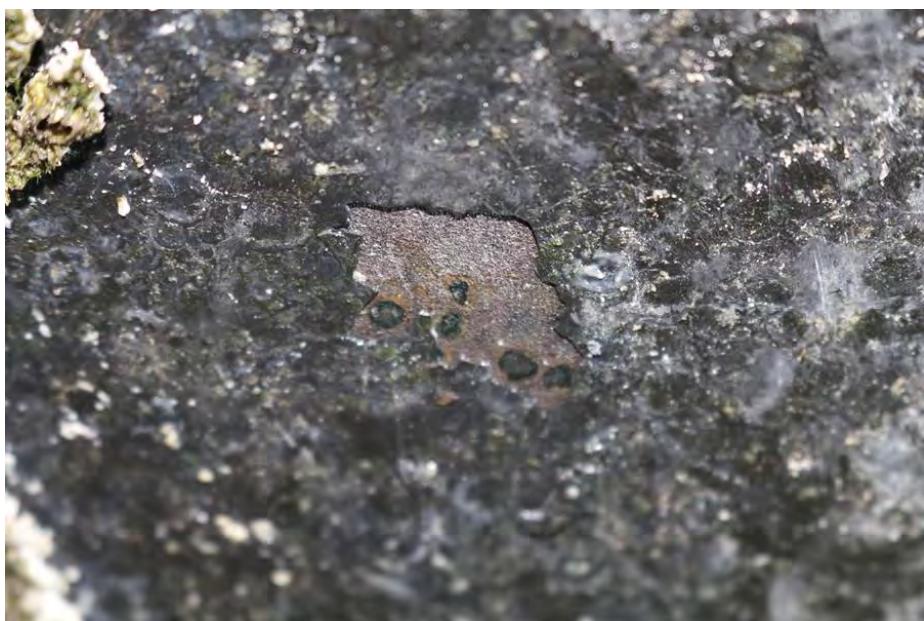
Figure 8 is a photograph showing that the steel surface under the coating blisters is free from accelerated corrosion. Magnetite (black spots) can be clearly seen. Magnetite is a protective form of iron oxide ( $Fe_3O_4$ ) and serves as a passivating film on the steel surface.

**Figure 8: Photograph showing that the steel surface under the coating blisters is free from accelerated corrosion. Magnetite (black spots) can be clearly seen.**

- No accelerated corrosion was observed inside blisters, only a passivating film on the steel surface. There are many coated pipelines in service with blisters without any evidence of corrosion of the substrate even after 30-40 years.

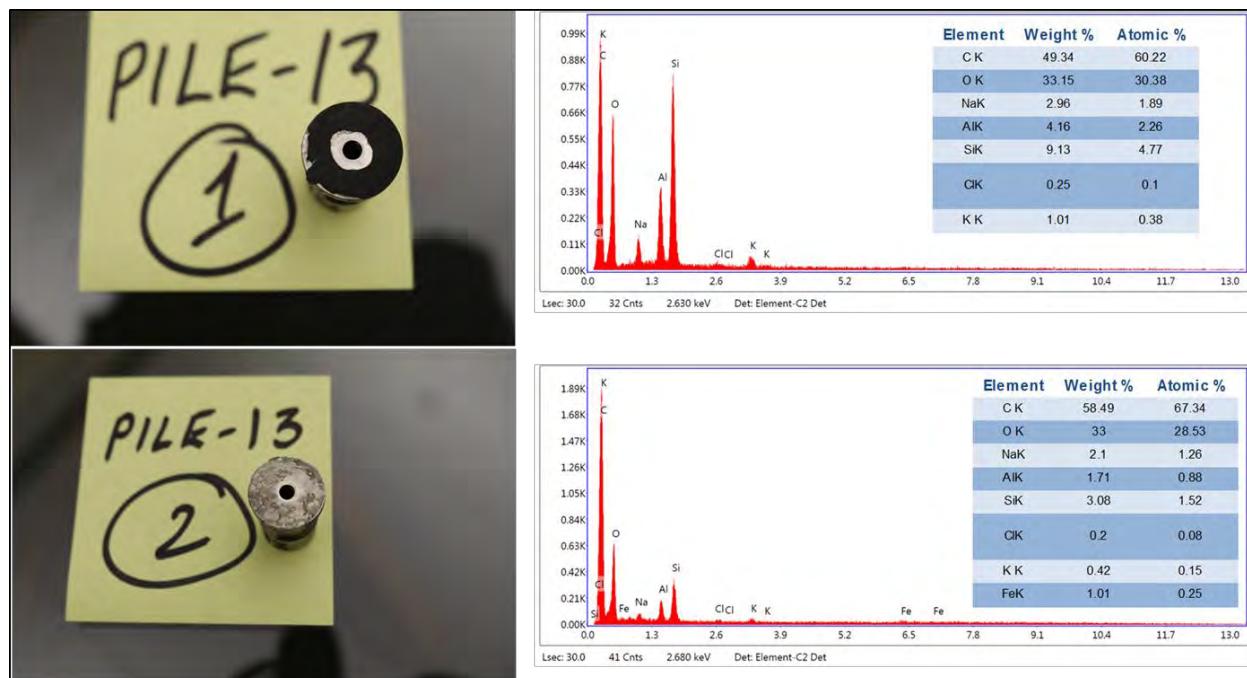
Figures 9 and 10 present the EDS data collected from the back side of the coating from adhesion test dollies on Pile 13. The primary elements found in the analysis were carbon (C) and oxygen (O), at 33 weight percent or greater. Secondary elements found in all samples between 1 and 10 weight percent included sodium (Na), aluminum (Al), and silicon (Si). Elements found in amount of 1 weight percent or less include magnesium (Mg), chlorine (Cl), potassium (K), and iron (Fe). This elemental chemistry is consistent with exposure to salt water from the ocean.

Figure 9: EDS data collected from the back side of the coating of the test dollies 1 and 2.

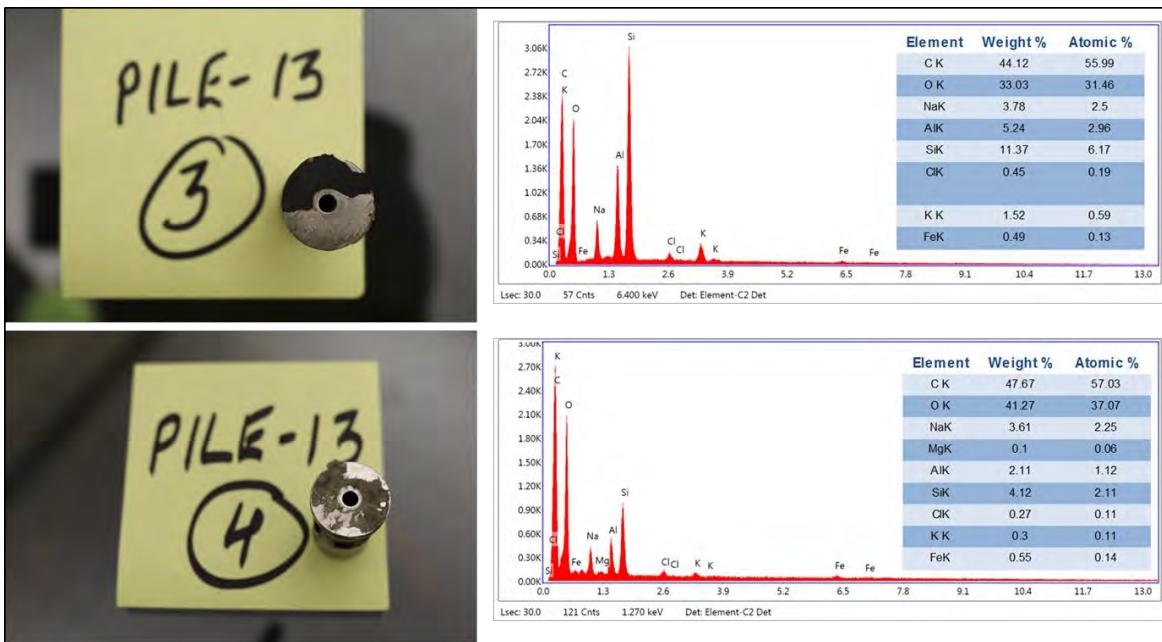
**Figure 10: EDS data collected from the back side of the coating of the test dollies 3 and 4.**

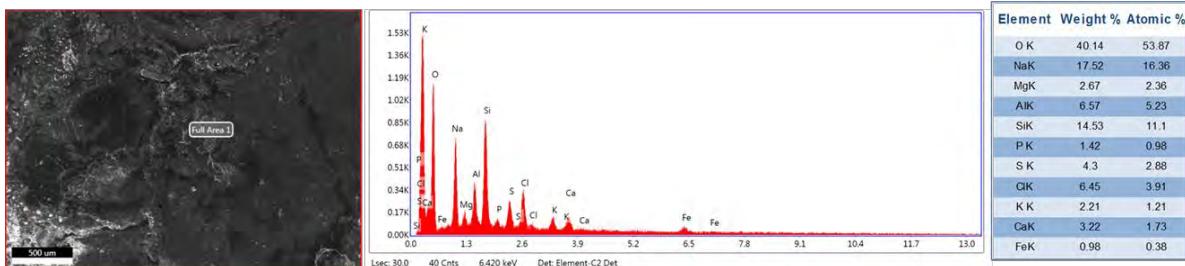
Figure 11 presents EDS data collected from the front side of the coating sample extracted from plate 77 of Pile 7. Elements identified above one weight percent (in descending order) include oxygen, sodium, silicon, aluminum, chlorine, sulfur (S), calcium (Ca), magnesium, potassium, and phosphorus (P).

**Figure 11: EDS data collected from the front side of the coating sample extracted from plate 77 of Pile 7.**

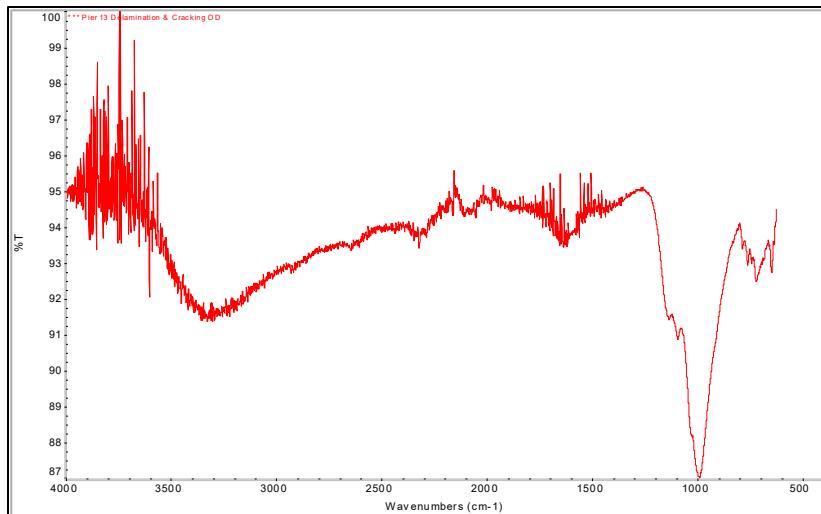
For all four spectra, a definitive coating chemistry could not be confirmed due to degraded coating resin. As the coating was known to be an epoxy, exposure to the ultraviolet rays found in sunlight are likely responsible in large part for this degradation.

**Figure 12: FTIR spectrum of coating chip “Pile 13 Coating Delamination & Cracking” front side (degraded coating resin).**

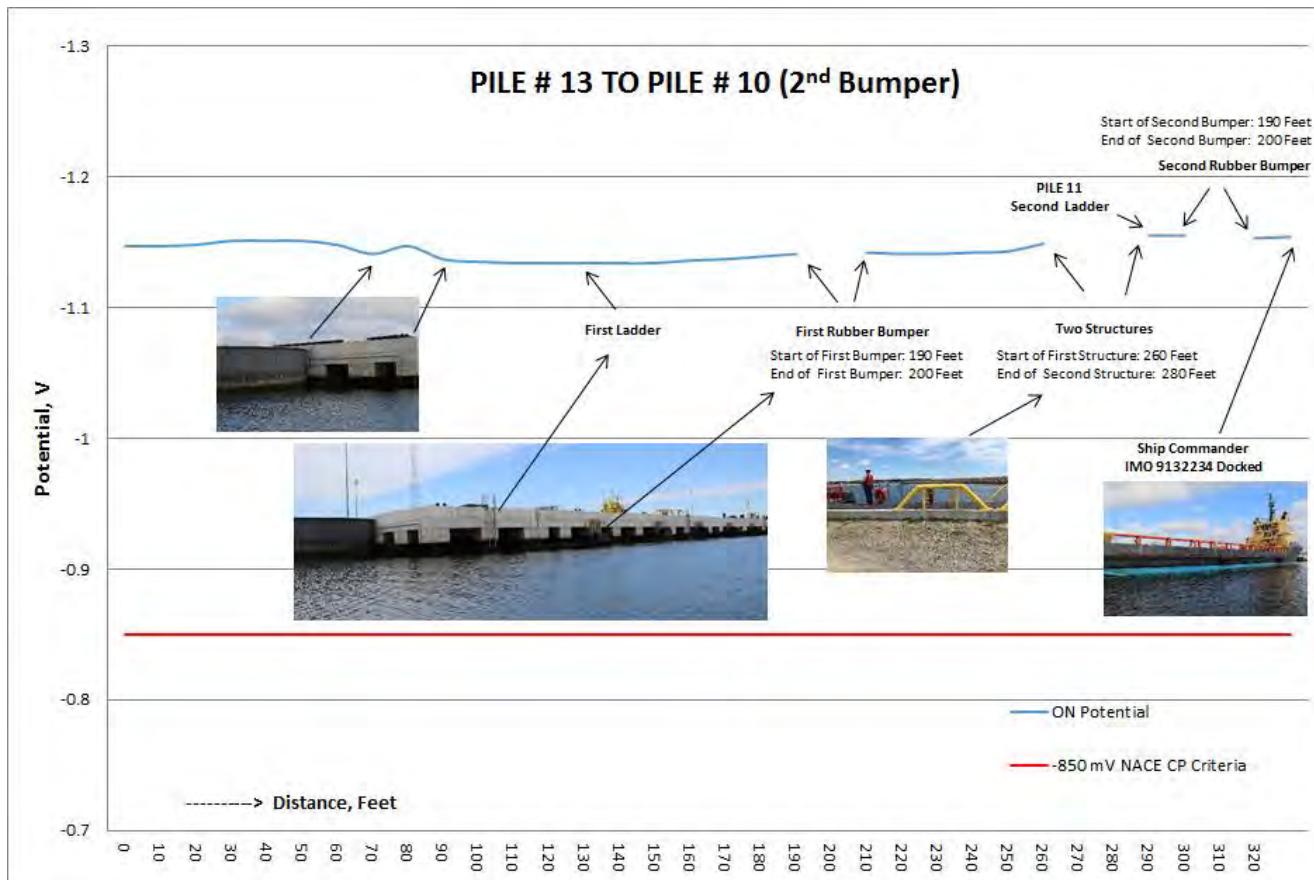
The potential data collected during the on-site investigation was plotted to determine the effectiveness of cathodic protection at the site. The AMPP criteria for cathodic protection is a maximum of -850 millivolts or -0.85 volts (v) vs Cu/CuSO<sub>4</sub>). Figure 14 presents a plot showing potential survey data collected from

Pile 13 to Pile 10 (2<sup>nd</sup> Bumper). Potential readings here ranged between -1.1 and -1.2 v and reveal that the piles are receiving adequate cathodic protection.

**Figure 14: Plot showing potential survey data collected from Pile 13 to Pile 10 (2<sup>nd</sup> Bumper). Potential readings reveal that the piles are receiving adequate cathodic protection.**

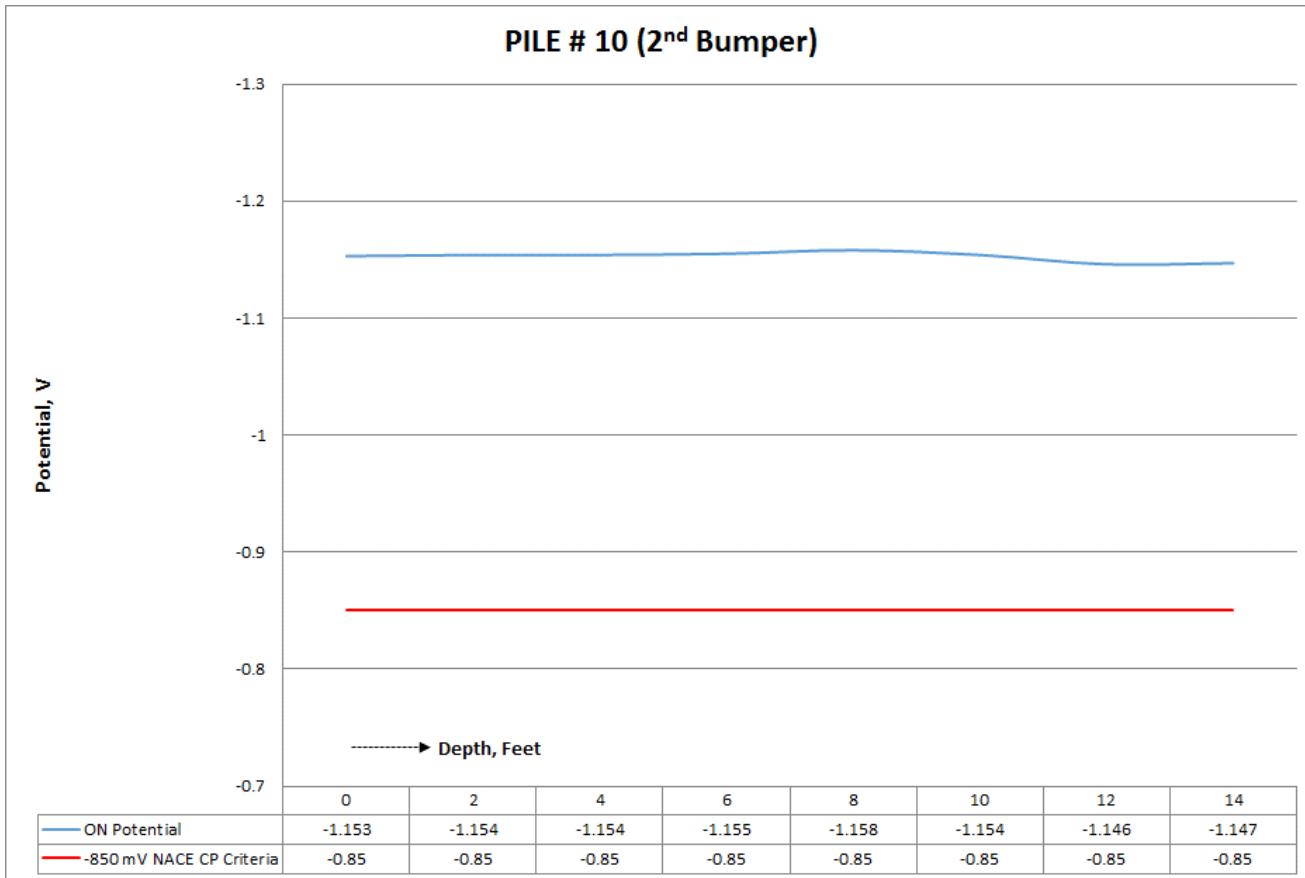
Figure 15 presents a plot showing potential survey data collected at Pile 10 (2<sup>nd</sup> Bumper) from water surface to a depth of 14 feet in the water. Potential readings here range from -1.146 to -1.158 v and reveal that the Pile 11 is receiving adequate cathodic protection. However, the potentials are on the negative side and promote disbondment and further blistering. The potentials should be brought down to more positive numbers than -0.90 v range.

**Figure 15: Plot showing potential survey data collected at Pile 10 (2<sup>nd</sup> Bumper) from water surface to a depth of 14 feet in the water. Potential readings reveal that the pile11 is receiving adequate cathodic protection.**
