Watermain Breaks - Materials Does Matter

Edward Larkin
Matergenics Inc
100 Business Center Dr
Pittsburgh, PA 15205
USA

CASE HISTORY 1: GRAPHITIZATION² OF DUCTILE IRON WATERMAIN

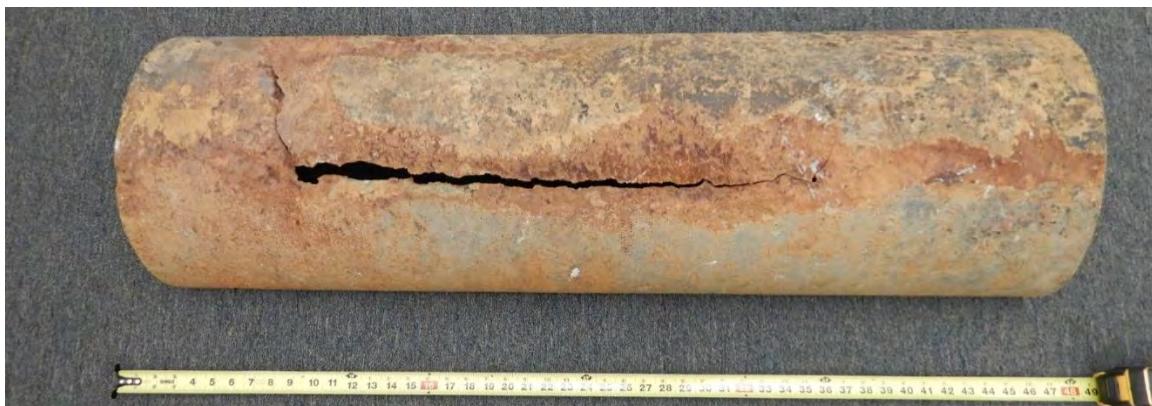
The failed DI pipe section is shown in Figures 2 and 3. The pipe exhibited three perforations, and a large crack connecting the perforations. Figures 4 - 5 show closer view of the perforations. Figure 6 shows wall thickness loss due to corrosion.

Figure 2: Photographs showing the failed watermain pipe section.

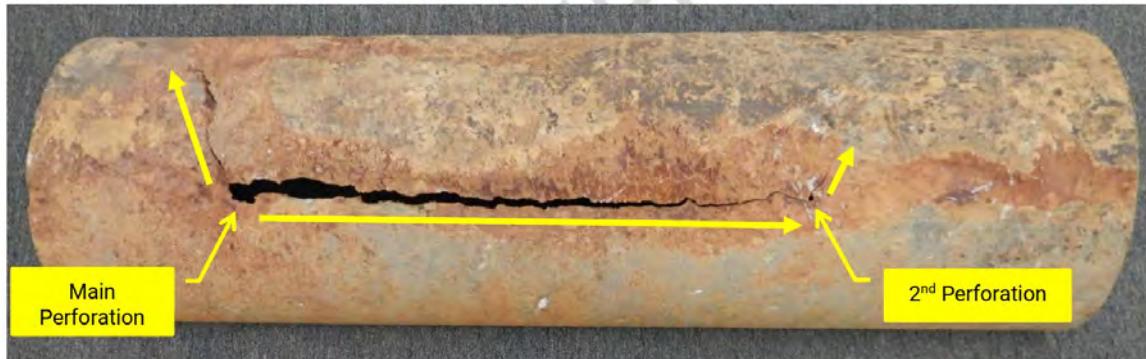
Figure 3: Figure 2 is retouched for better understanding to show the crack propagation. Main perforation and 2nd perforation can be seen in the photograph.

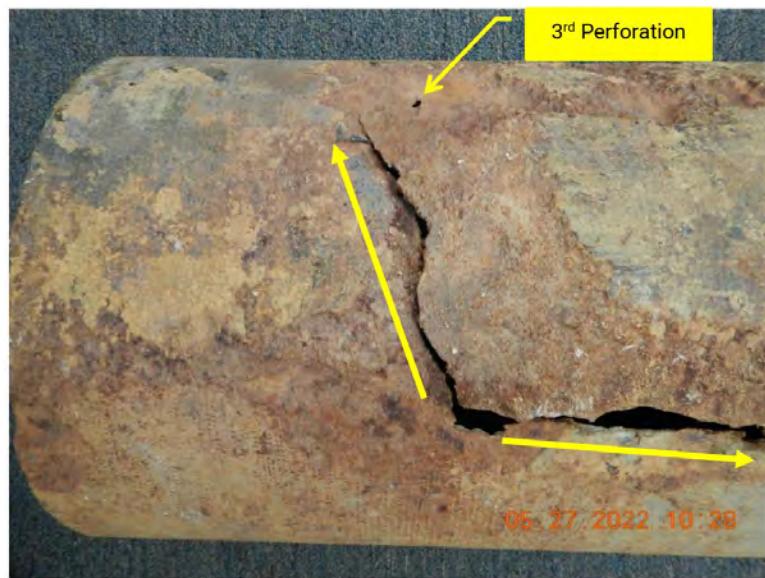
Figure 4: Closer view of main perforation. 3rd perforation can also be seen.

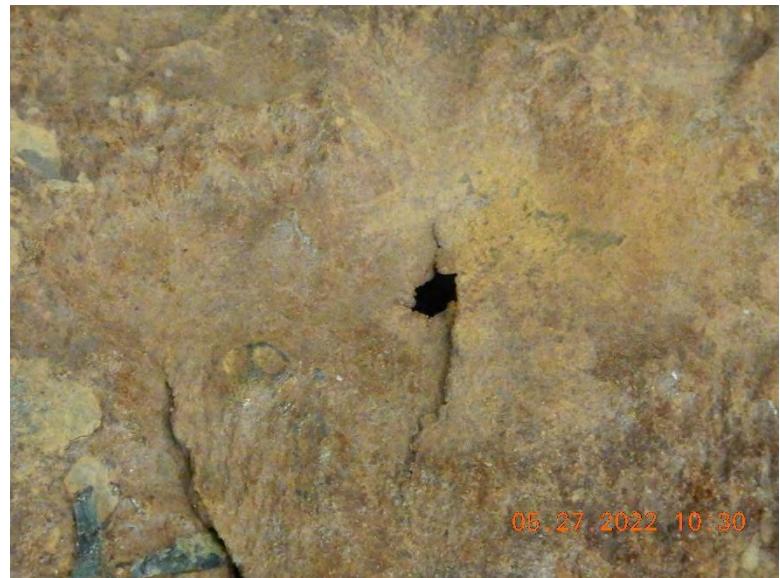
Figure 5: Closer view of 3rd perforation.

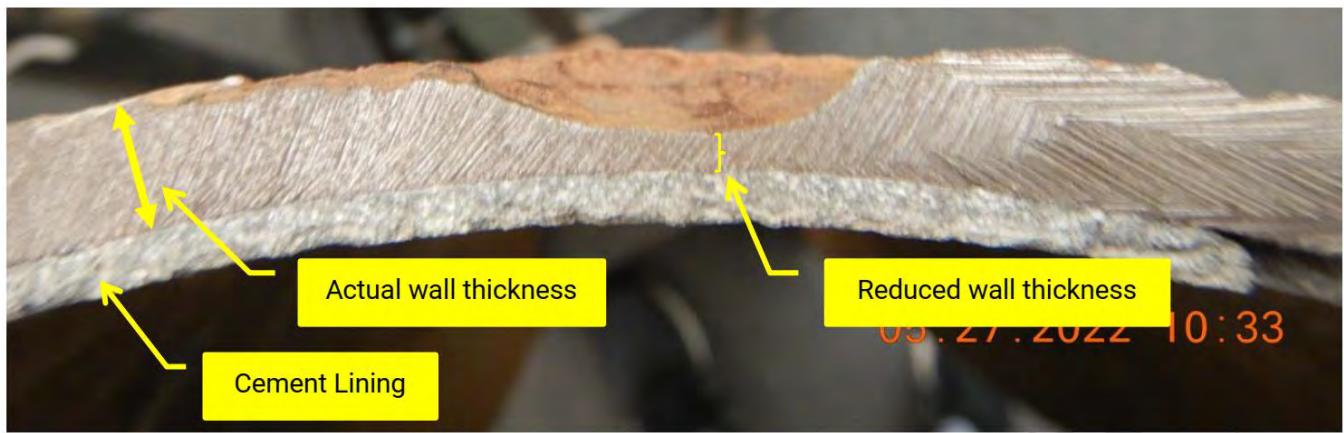
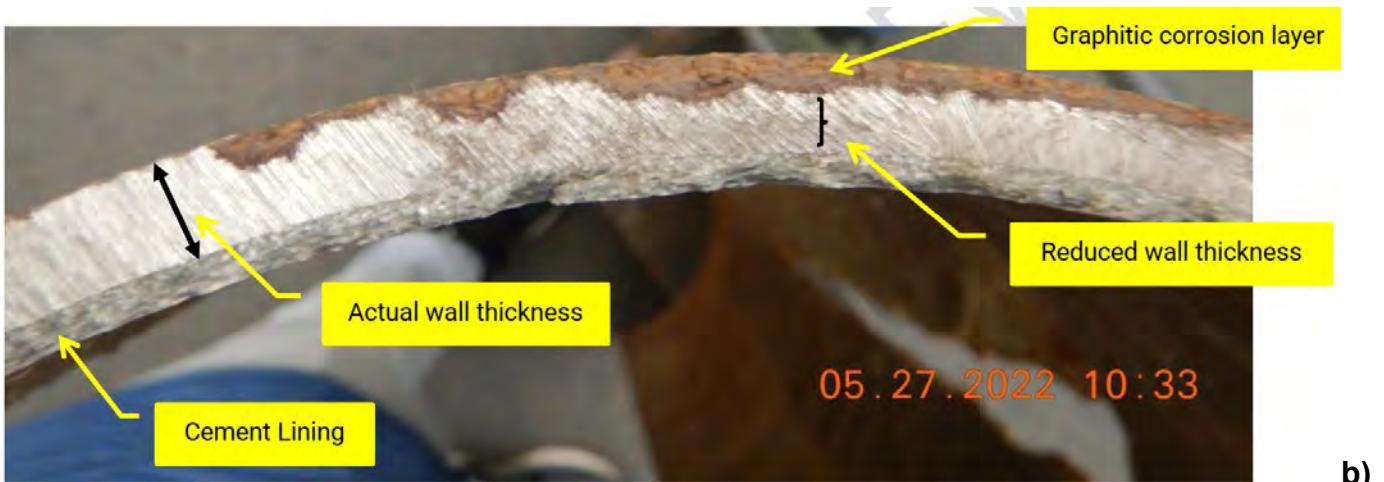
Primary Cause – The 12-inch (30.48 cm) diameter DI watermain failed as a direct result of graphitic corrosion of the outside diameter bottom surface due to the corrosivity of the soil and microbiologically-

induced corrosion (MIC). The DI pipe wall at the perforation exhibited significant loss of sound metal thickness due to complete through-wall graphitization corrosion.

Root Cause – The soil chemistry in contact with the pipe was very corrosive in the area of the failure. This promotes graphitic corrosion and loss of wall thickness in service.

Figure 6: Photographs showing the thickness loss due to the corrosion.

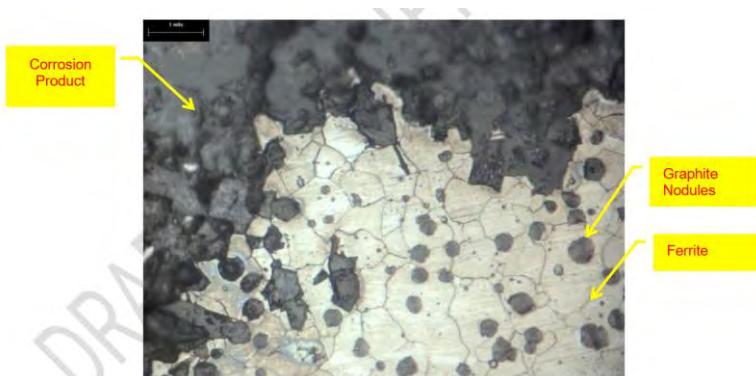
For microexamination, a cross-sectional sample was extracted from the perforation. The cross section was metallographically prepared by grinding and polishing to 1- μ m (1 micron) surface finish, etched with 2% Nital and examined under an optical light microscope. The overall microstructure of the steel both at the corroded region and the unaffected region consists of nodules of graphite, pearlite and ferrite which is typical of ductile iron (Figure 7). Similar microstructure at both corroded and non-corroded locations of the pipe indicates that the ductile iron microstructure has not contributory influence on the initiation of the corrosion noticed in the pipe.

Figure 7: Photomicrograph taken at the perforation shows nodules of graphite, pearlite (dark islands) and ferrite (light background) which indicates that the material of the water pipe is ductile iron. Mag: 400X. Etched with 2% Nital.

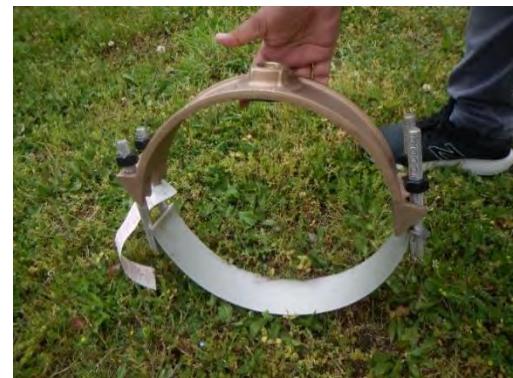
Other – There was no cathodic protection found, and no polyethylene wrap was present on the failed watermain. Potential measurements at the site revealed that there was no indication of DC stray currents. It was observed that metallic strap containing several metal types (brass, stainless steel, carbon steel bolts and nuts) was used around the DI watermain for tap hole to connect the service line (Figure 8). It can be clearly seen that galvanic corrosion failure could occur at these locations in future.

Figure 8: Photograph showing the metallic strap used around the DI watermain for tap hole to connect the service line.

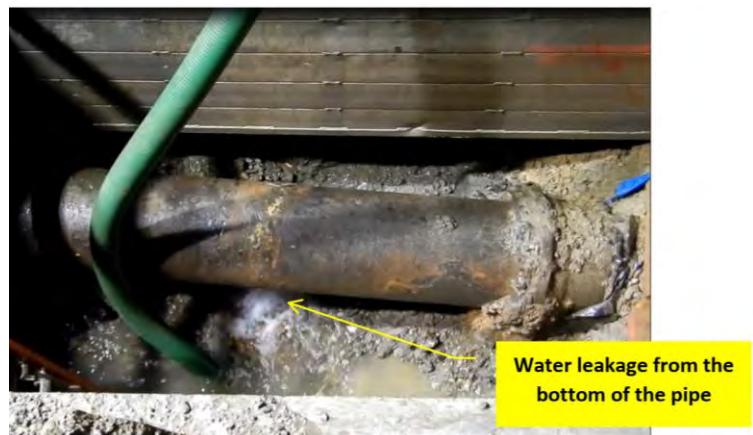
Visual examination of the failed 16-inch diameter water pipe indicated that the failure of the pipe occurred as a result of a hole in the bottom side of the pipe. Water was still leaking from the pipe and collecting at the bottom of the trench (Figures 9 - 11). After visual examination of the new pipe sections and the old pipe remnant, soil samples were collected near the pipe for laboratory analysis. Testing was also performed to look for the presence of stray currents.

Figure 10: Photograph showing the water leakage from the bottom of the 16-inch diameter failed water pipe.

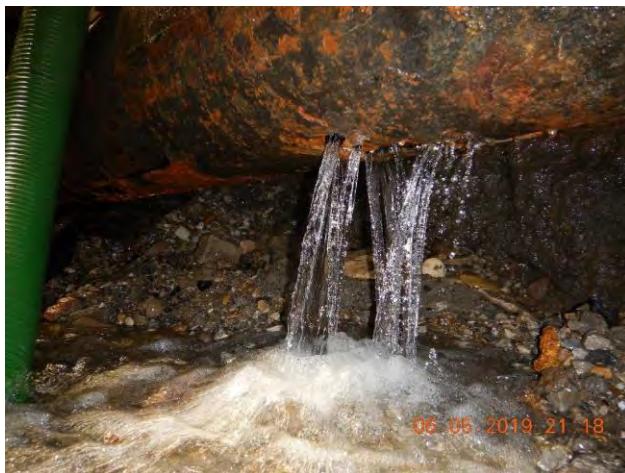
Figure 11: Photograph showing the water leakage from the bottom of the 16-inch diameter failed water pipe.

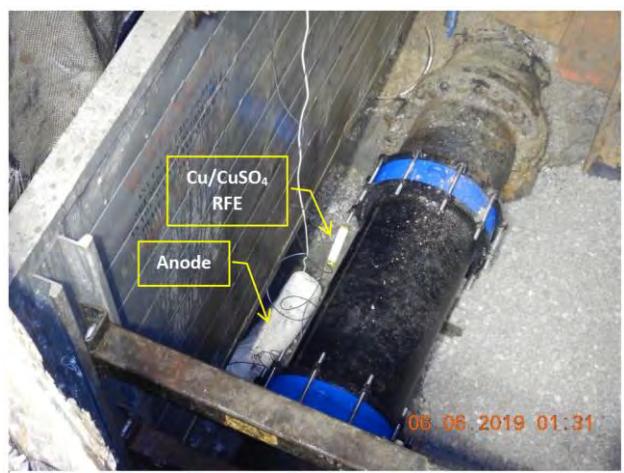
Figure 12: Photograph showing installation of anode and reference electrode.

As PE wrap is not present, cathodic protection (CP) is the only standalone corrosion control to prevent corrosion of the new 16-inch watermain pipe section. Sacrificial high potential magnesium anodes were used (Figure 12) as a part of cathodic protection of the watermain pipe and these anodes become the new path of least resistance and degrades much faster than the watermain pipe. Henceforth, instead of having to repair major damage of the watermain pipe, only the sacrificial anodes can be replaced periodically.

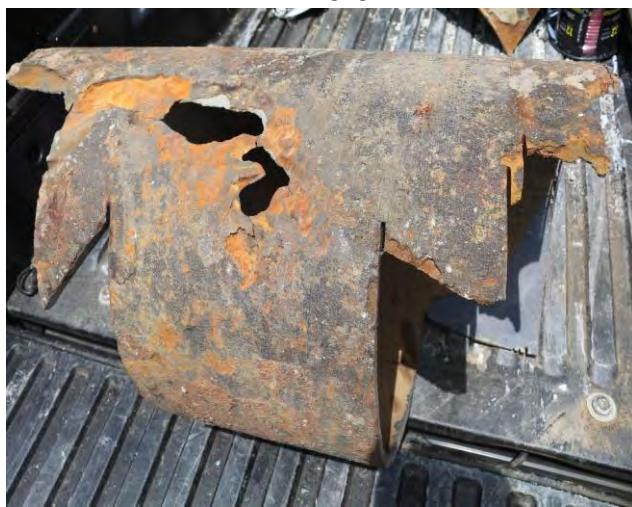
The failed pipe section with two adjacent holes in the bottom of the pipe is shown in Figure 13. As shown in Figure 14 many of the corrosion products had spalled away from the bottom pipe surface to reveal a very irregular remaining metal surface profile. The saw cut surfaces through the failed pipe revealed the presence of dark localized graphitic corrosion (Figure 15). Corrosion had penetrated completely through the metallic wall thickness of the pipe leaving only the cement lining intact at the location of the leak. The dark corrosion products were intact at most locations which is characteristic of graphitic corrosion. The pipe wall thickness in a relatively non-corroded area was measured to be 3/8 inch (0.95 cm).

Primary Cause – The 16-inch diameter ductile iron watermain failed as a result of graphitic corrosion of the outside diameter. The ductile iron pipe at the point of failure exhibited a significant loss in wall thickness of metal due to complete through wall graphitization corrosion in several locations.

Root Cause – As per 10-point system described in Appendix A of ANSI/AWWA C105/A21.5, the sum of total points is 16.5 which indicates that soil is very corrosive to ductile iron pipe. Pipe-to-Soil potentials revealed that the potentials at the bottom portion of the pipe are electropositive compared to the potentials at a distance of 2 feet away from the pipe owing to stray current effects.

Figure 13: Photograph showing the holes in the bottom side of the 16-inch diameter pipe.

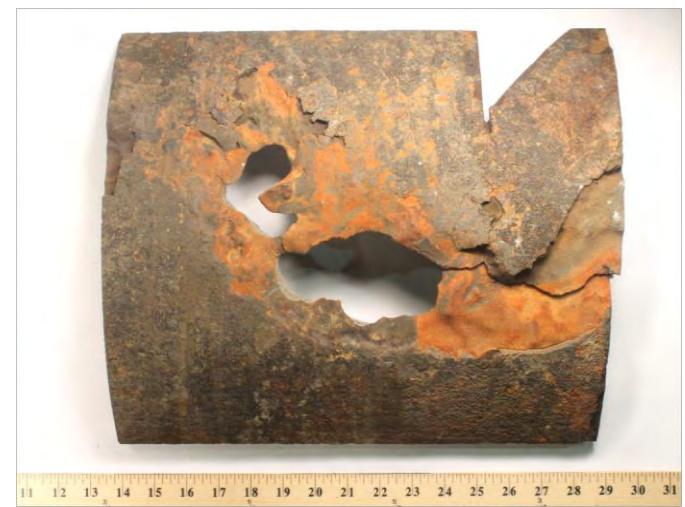
Figure 14: Photograph showing the holes and other areas of corrosion in the bottom side of the 16-inch diameter pipe.

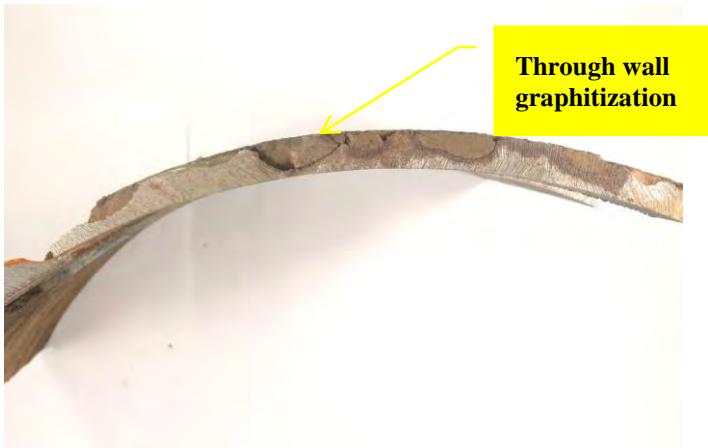
Figure 15: Photograph showing dark areas of graphitic corrosion in the bottom side of the 16-inch diameter pipe. Holes in pipe at left.

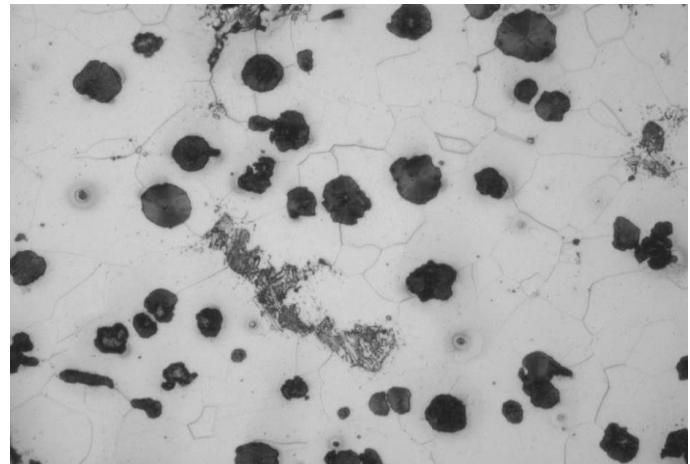
Transverse cross section through the 16-inch diameter pipe was prepared for subsequent metallographic examination. In the as polished condition small graphite nodules were observed throughout the pipe wall thickness which is characteristic of a ductile cast iron. Etching with a 2% Nital solution revealed the microstructure of the ductile iron pipe which was found to consist primarily of white etching ferrite plus some dark etching pearlite as shown in Figure 16.

Figure 16: Photograph at 400x showing the microstructure of the 16-inch diameter ductile iron pipe. 2% Nital

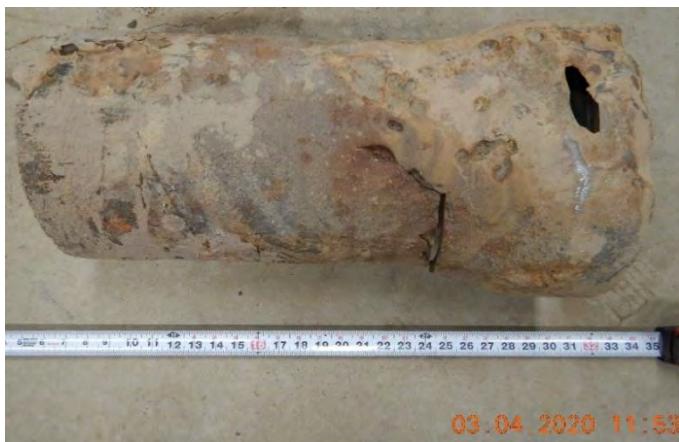
The failed pipe section is shown in the Figure 17. The pipe exhibited one large perforation on the bell at 6 O'clock position. Careful examination of the as-received pipe section showed deep pits around the perforation (Figure 18).

Primary Cause – The 8-inch diameter ductile cast iron watermain failed because of stray current corrosion. Ductile iron pipes near a foreign structure with cathodic protection (CP) is at high risk of corrosion leading to failure due to stray current corrosion. PE wrap and or CP is highly recommended.

Figure 17: Photograph showing the perforation and some deep pits around the perforation in the as-received pipe section.

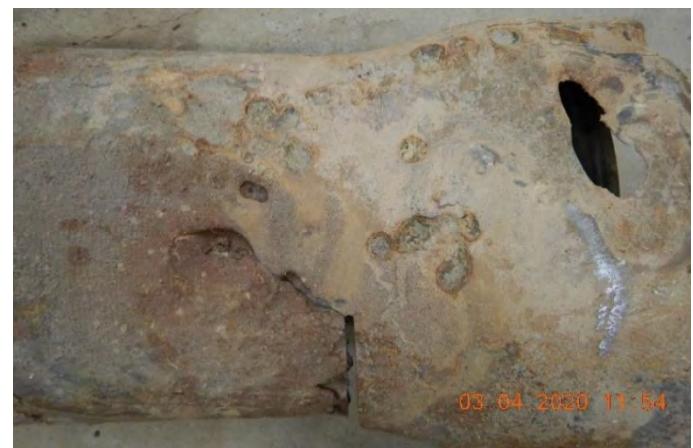
Figure 18: Photograph showing the perforation and some deep pits around the perforation in the as-received pipe section.

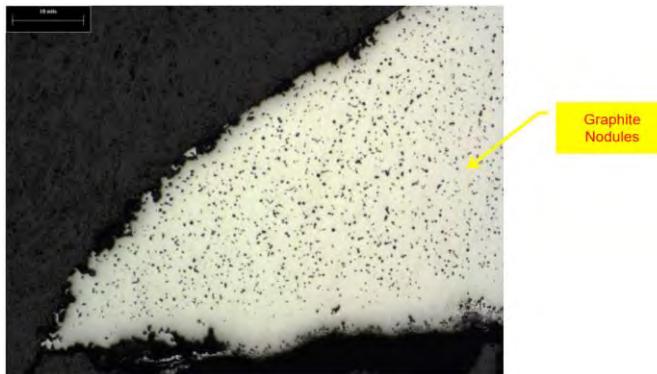
A longitudinal cross-sectional specimen was sectioned through the perforation. The cross section was metallographically prepared by grinding and polishing to 1μ (1 micron) surface finish and examined under microscope. The nodules of graphite were clearly visible in the as polished condition which indicates that the material of the pipe is Ductile Iron (Figure 19). Then, metalographic specimen was etched with 2% Nital and examined under a Nikon optical light microscope. The overall microstructure of the steel both at the corroded region and the unaffected region consists of nodules of graphite and ferrite which is typical of ductile iron (Figure 20). The microstructure in both corroded and the unaffected locations in the pipe indicates that the ductile iron microstructure was not responsible for the corrosion.

Figure 19: Photomicrograph taken at the perforation shows nodules of graphite in the steel substrate which indicates that the material of the water pipe is ductile iron. Mag: 100X. As Polished condition.

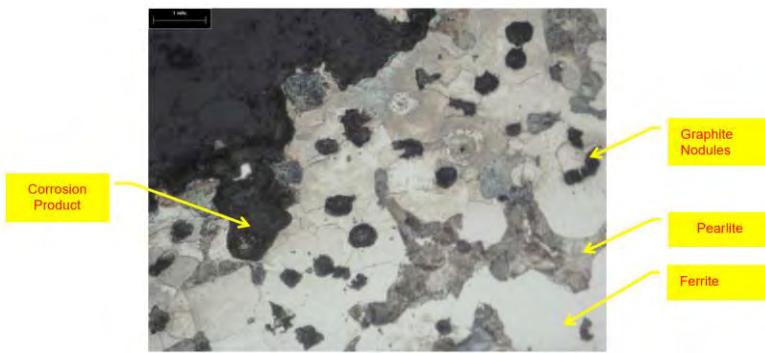
Figure 20: Photomicrograph taken at the perforation shows nodules of graphite, pearlite and ferrite (light background) which indicates that the material of the water pipe is ductile iron. Mag: 400X. Etched with 2% Nital.

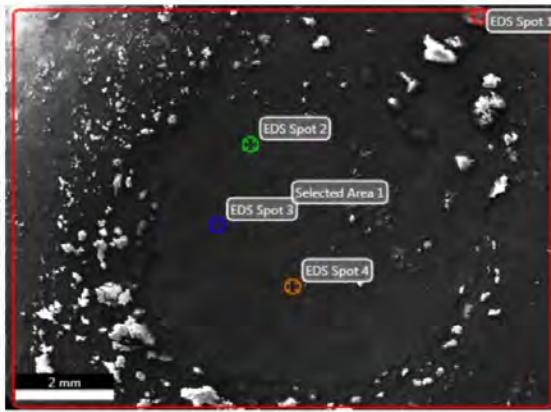
the stray current leaves the watermain will cause that location to be anodic and will corrode at an accelerated rate. Cl⁻ ions has migrated to anodic area.

Figure 21: EDS data (spot 2) shows that the deposits in the pit are rich in Chlorine (Cl). The other elements such as Oxygen (O), Aluminum (Al), Silicon (Si), Phosphorous (P), Calcium (Ca), Iron (Fe) and Copper (Cu) were also detected.

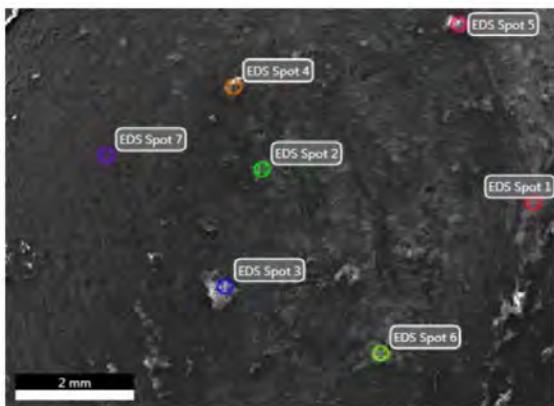
Figure 22: EDS data (spot 1) shows that the deposits away from pit are rich in Sodium (Na), Magnesium (Mg), Potassium (K), Calcium (Ca) and Chlorine (Cl). The other elements such as Oxygen (O), Aluminum (Al), Titanium (Ti) and Iron (Fe) were also detected.

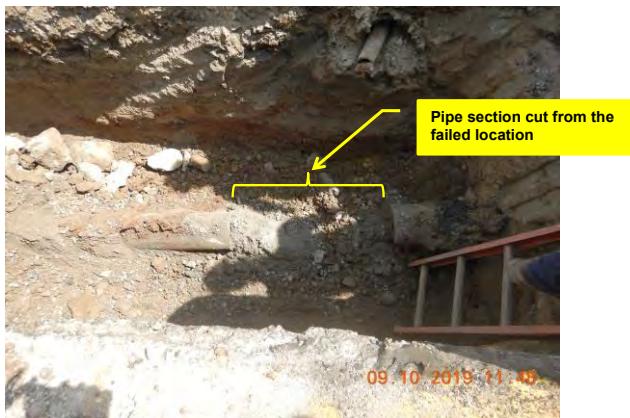
Figure 23 shows the location from which the failed pipe section was cut from the watermain. The failure of the pipe occurred directly as a result of a hole on the side of the pipe (i.e., the 9 o'clock position). Visual examination of the remaining pipe section in the trench has revealed a longitudinal crack that was present along the entire length of the pipe section. Further examination has revealed presence of tubercles at the internal surface of the failed water pipe (Figure 24). Careful examination revealed that cement lining was not present in the failed pipe section. PE sheet was not wrapped around the pipe. This important finding indicates that no basic corrosion control measures were in place at this location.

Figure 23: Photograph showing the location where pipe section was cut from the failed location.

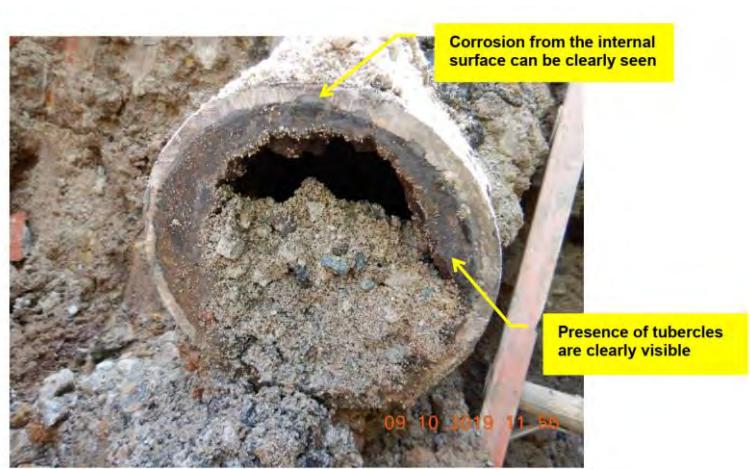
Figure 24: Photograph showing tubercles at the internal surface of the water pipe.

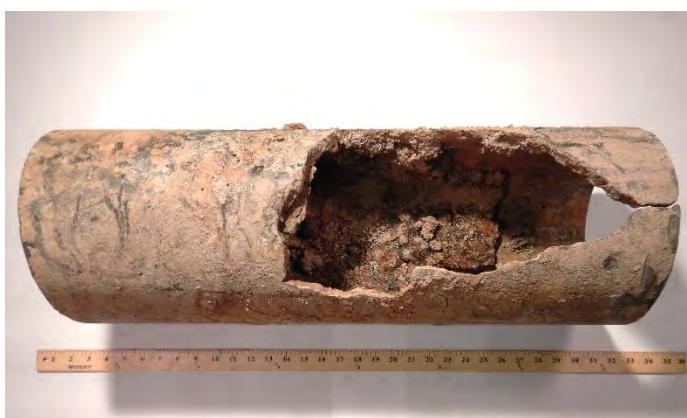
The pipe exhibited one large perforation as shown in Figure 25. Closer examination has revealed presence of tubercles at the internal surface of the failed water pipe (Figure 26) which indicates that the grey cast iron has experienced internal corrosion and developed tubercular scales. Further examination

Primary Cause – The 8-inch diameter cast iron water pipe failed as a result of graphitic corrosion of both external surface and internal surface. The graphitic corrosion of external surface is primarily due to corrosivity of the soil and the graphitic corrosion of internal surface is due to water corrosion and Microbiological Induced Corrosion (MIC), wherein iron from the unlined water pipe reacts with the corrosive ions and iron corrosion products within the water to form tubercles. To conclude, the 8-inch cast iron water pipe failed due to combined effects of both external and internal corrosion.

Figure 25: Photograph showing the pipe section cut from the failed location of the 8-inch diameter failed water pipe. Tubercles at the internal surface of the water pipe are clearly visible.

Cast iron pipes in corrosive soils are at high risk of graphitic corrosion leading to failure. Cathodic protection is recommended at such sites. Unlined cast iron pipes are at high risk of internal corrosion. Cement lining at the internal surface is always recommended to avoid scaling or tuberculation.

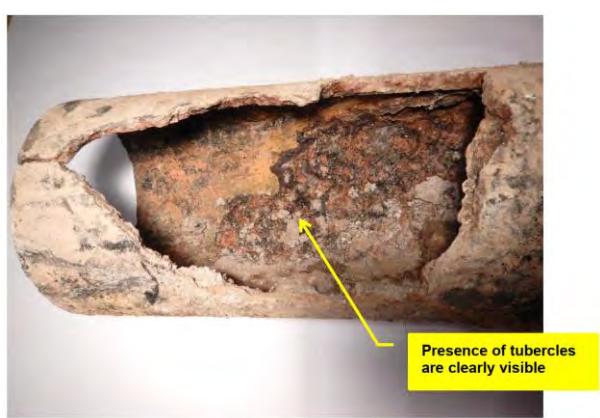
has revealed that this pipe section does not have cement lining. Scaling is most commonly found in unlined cast iron pipes. Ultimately, scaling reduces the diameter of the pipe and restricts water flow.

Figure 26: Photograph showing the failed location of the 8-inch diameter failed water pipe. Tubercles at the internal surface are clearly visible.

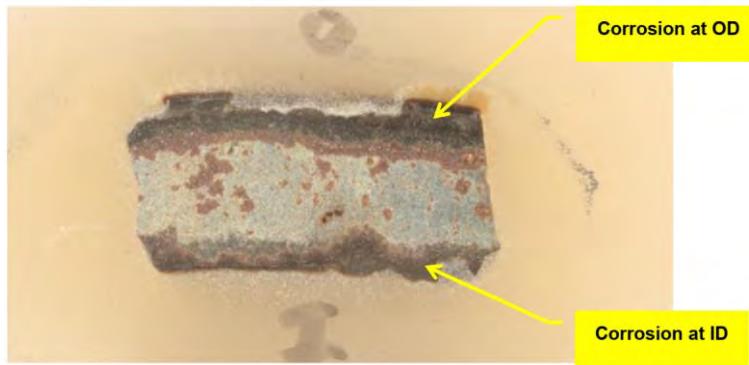
A transverse cross-sectional specimen was sectioned from the location adjacent to the perforation. The cross section was metallographically prepared by grinding and polishing to 1- μ m (1 micron) surface finish, etched with 2% Nital and examined under a stereo microscope. As seen in Figures 27 and 28, graphitic corrosion was observed at both external surface and internal surface. Indications of corrosion attack was also observed throughout the wall thickness. This particular finding suggests that at the failed location the graphitic corrosion fronts from both external surface and internal surface might have merged and finally resulted in failure due to the water pressure at the reduced thickness of the pipe.

27: Photograph showing transverse cross-section specimen extracted from the pipe section cut from the failed location of the 8-inch diameter failed water pipe. Corrosion at both OD and ID is clearly visible.

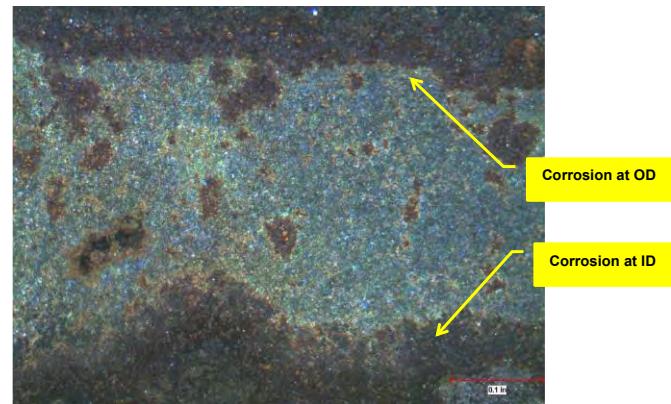
28: Stereoscope image showing corrosion at both OD and ID. Indications of corrosion through wall thickness is also visible. Mag. 7X.

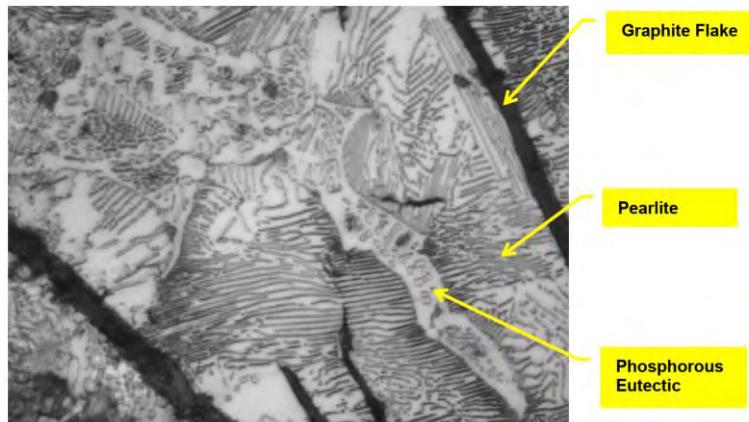
After stereoscopic examination, the metallographic specimen was examined under an optical light microscope. Etching with a 2% Nital solution revealed the microstructure of the iron matrix which was found to consist of darker etching pearlite plus numerous, sometimes large, islands of phosphorous eutectic as shown in Figure 29. The microstructure of gray cast iron is typically made up of graphite flakes, which are embedded in a matrix of ferrite and pearlite. If a high level of phosphorus is present in the gray cast iron, it can form a eutectic microstructure. The eutectic microstructure is made up of a mixture of ferrite and iron phosphide (Fe_3P). The presence of iron phosphide in the microstructure can increase the brittleness and decrease the toughness of the gray cast iron. Additionally, the high level of phosphorus can also have a negative impact on the corrosion resistance of gray cast iron. The iron phosphide can act as a cathode, promoting corrosion and reducing the overall service life of the cast iron. Therefore, the amount of phosphorus in gray cast iron is typically kept low to prevent the formation of the eutectic microstructure and to improve the cast iron's mechanical properties and corrosion resistance.

Figure 29: Photograph at 1000x showing the large phosphorous eutectics within the microstructure of the pipe. Etched with 2% Nital.

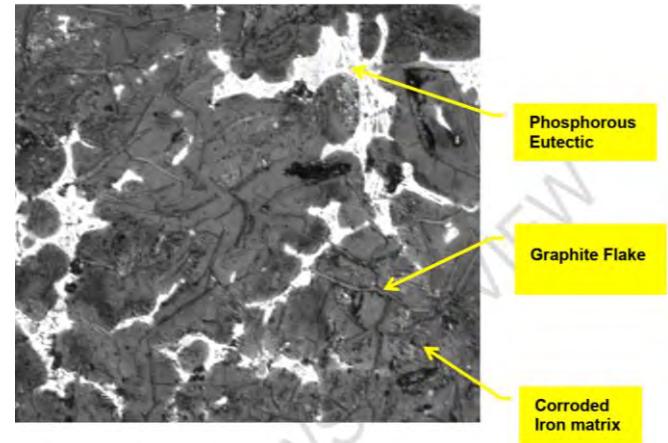
Graphitic corrosion was observed at both the outside diameter surface of the pipe and at the inside diameter surface of the pipe. The depth of graphitic corrosion was observed to be greater at the outside diameter surface. In graphitic corrosion localized galvanic corrosion cells form between the graphite flakes and the iron matrix causing corrosion of the iron matrix. The graphite flake network keeps the iron corrosion products in place so pitting and metal wastage is rarely visible from the exterior surface. The graphitic corrosion of the inside diameter surface is the result of the absence of a cement lining on the inside diameter surface of the pipe. Within the areas of graphitic corrosion both graphite flakes and phosphorous eutectics are still visible while the iron matrix has turned into dark iron oxidation products (Figure 30).

Figure 30: Photograph at 200x showing the graphitic corrosion products and non-corroded phosphorous eutectics. Etched with 2% Nital.
