**Condition Assessment, Corrosion Risk Assessment, FEA Analysis Of Pack-out For
Weathering Steel Transmission Structures**

M. Zamanzadeh, PhD
Fellow of NACE, Fellow of ASM
Matergenics, Pittsburgh, Pennsylvania

Ben Jessup
Transmission and Civil Infrastructure Project Development
PEPCO Holdings

Behzad Kasraie, PhD., P.E., Peyman Taheri, PhD, P Eng.
Matergenics

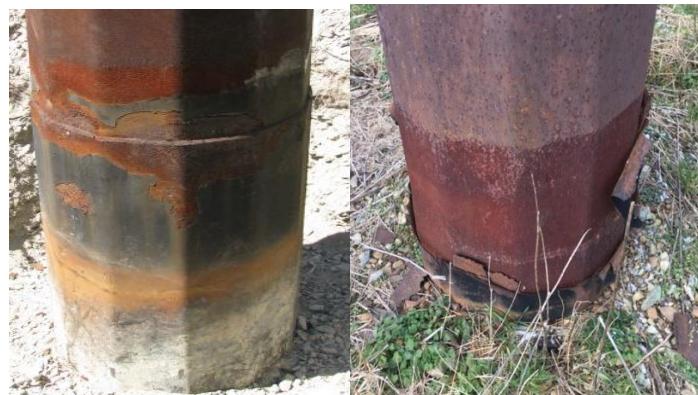
First generation, direct embedded weathering steel (ASTM A-871) transmission poles have become a focus of ground line inspections and repair in the past several years (Figure 1). Weathering steel monopoles for direct embedded applications are typically sleeved and coated with a marine grade polyurethane, from 2 feet above grade to pole bottom. The first and second generation of these coatings perform excellent below grade but have typically performed poorly above grade (Figures 2). Coating failure and accelerated corrosion have occurred above the ground-line, causing primary wall thickness loss. It is suspected that coating specification, coating application, and local environment are the primary contributors to the coating failure and accelerated corrosion.

Figure 1 – Embedded first generation weathering steel poles in service for 25 years (Source: Author(s)).

Ground-line inspection for embedded weathering steel monopoles should include visual inspection and excavation as needed. Wall thickness measurements will also be needed if accelerated corrosion is evident. For poles with severe corrosion, additional measurements should be taken for welded sleeve design.

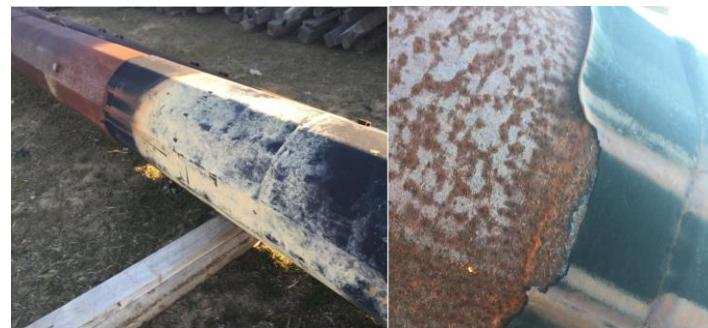
Figure 2 – Embedded 2nd generation weathering steel pole removed from service after 16 years. The coating is in excellent condition above and below grade, with less than an inch of adhesion loss at the coating interface. (Source: Author(s))

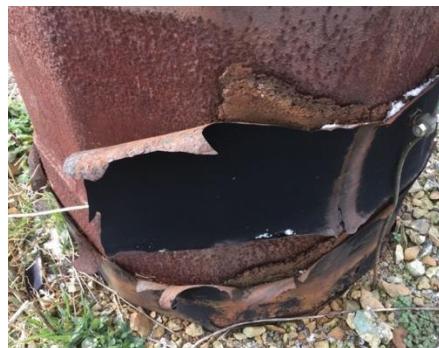
Coating application errors can include rough edges and poor surface preparation. When combined with higher DFT, these errors contribute to large scale adhesive failure of the coating. For weathering steel, dis-bonded coatings are especially problematic, due to the aggressive crevice corrosion that occurs. In some cases, circumferential sections of coating that are a height of 6-10 inches, can lose adhesion but do not immediately crack or flake. Under the expansive forces of the corrosion, the crevice tends to increase in size while still holding standing water. This is sometimes called the “tulip effect”. Eventually, expansive corrosion products put enough internal surface pressure on the protective coating to delaminate and crack it (See Figure 3).

Figure 3 – Example of dis-bonded coating and expansive corrosion products in the crevice formed between polyurethane coating and weathering steel substrate (Source: Author(s))

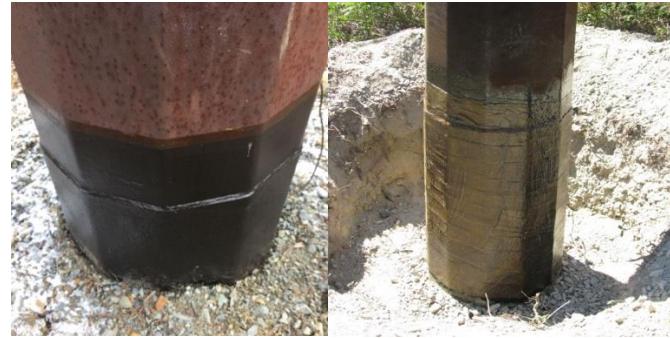
Figure 4 – Example of embedded weathering steel monopoles with field applied coating and petrodatum tape (Source: Author(s))

Repair of the ground-line coating for embedded weathering steel monopoles is similar to the repair of painted or galvanized monopoles. During inspection, disbonded coating should be removed. The primary repair method is excavation, surface preparation, and coating application. Other coating repair methods from the underground piping industries, such as petrolatum tapes are also available (See Figure 4).

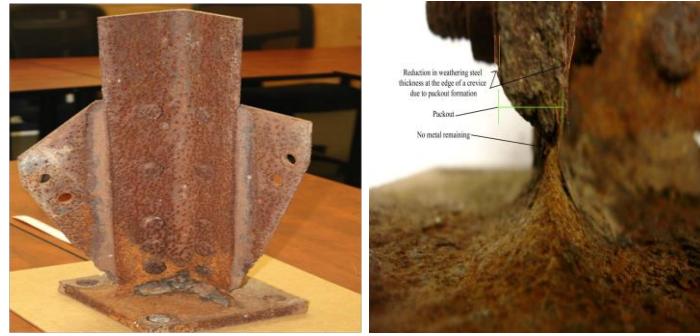
The corrosion rate of weathering steel towers was monitored on several transmission towers over an extended period of time prior to 1980, and in 1982 it was found that severe rust growth had continued, as well as corrosion product buildup in excess of 1/8 inch thick (3.18 mm) in some cases. In 1998 another on-site and laboratory investigation was performed which indicated further growth is taking place in joints containing pack-out (>1/2 inch (>12.7 mm)) (See Figures 5, 6 and 7).

Figure 5 - Photographs exhibiting buildup of Pak-out and loss in thickness of load bearing member (photo on-right hand side)

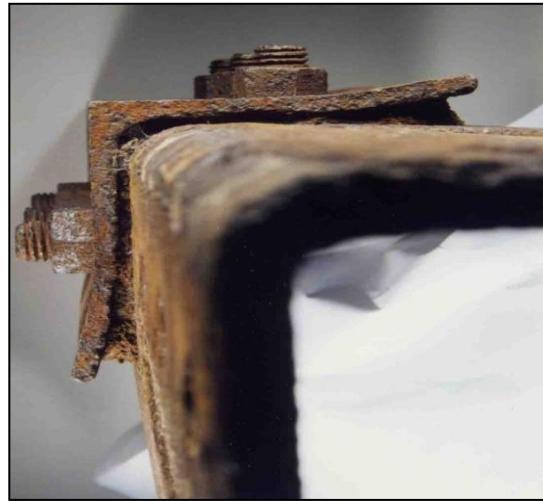
Figure 6 - Pack-out formation on bolted joints

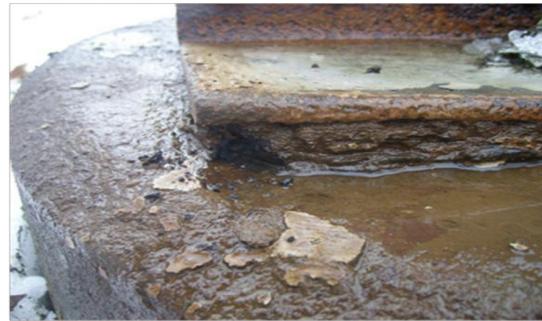
Figure 7 - Formation of pack-out between concrete foundation and base plate of WS tower.

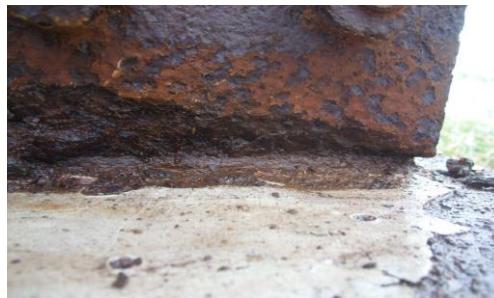
Figure 8 - Accelerated corrosion and extensive thinning of the tower leg .Was hidden under dirt/leaves

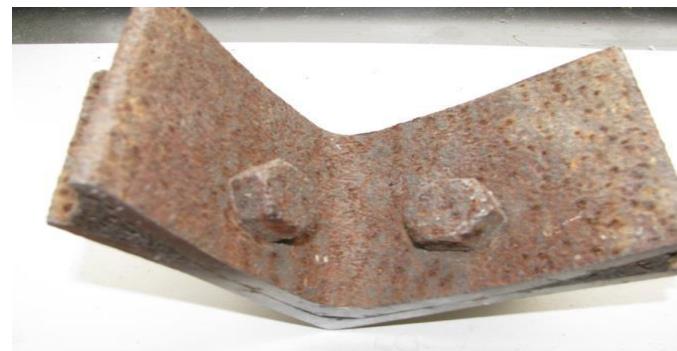
Finite element modeling and analysis is used to determine the displacements and stress levels developed in a typical joint exposed to pack-out corrosion. Photographs of this joint are reproduced in Figures 9 and 10. As seen in these photographs, pack-out corrosion has developed between the straps (added possibly for reinforcement) to an existing base with two $5/8$ inch (16 mm) bolts.

Figure 9 - Pack out Piece that was used for FEA Analysis

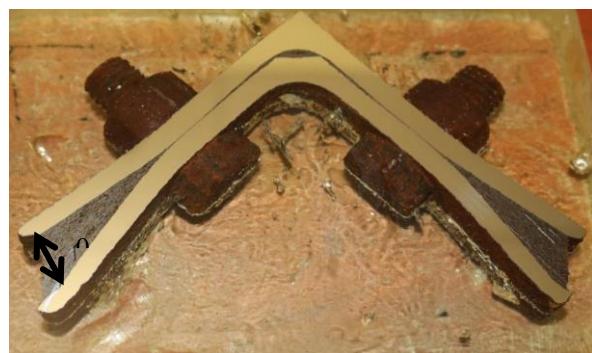
The overall FEA model of the connection is reproduced in Figure 11. The initial thickness of the base metal and straps was 0.25 inch (6.35 mm) before being reduced during the corrosion process to as thin as 0.18 inch (4.6 mm) in some locations. The expansion of the pack-out corrosion separated the strap from the base by about 0.6 inch (15.2 mm), as shown in Figure 10 and in the FEA results in Figure 12.

Figure 10 - Joint Cross Section showing porosity in pack-out.

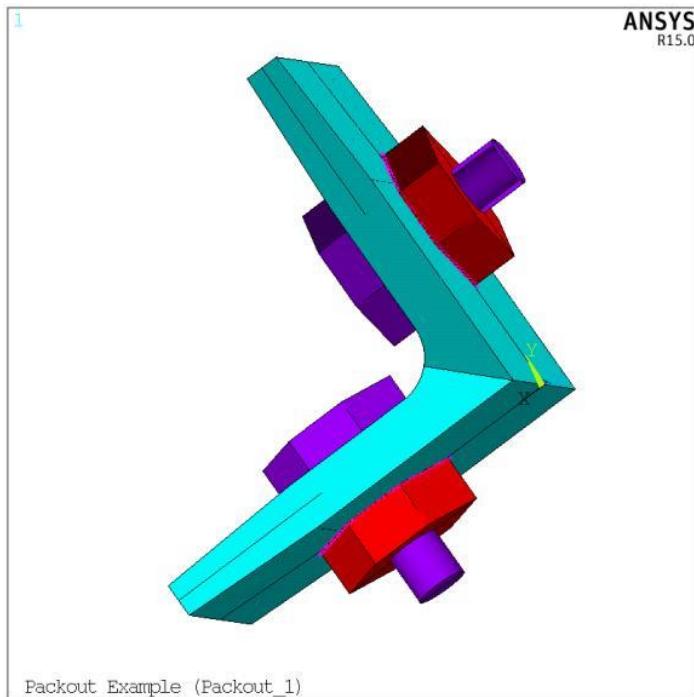
Figure 11 - Overall FEA Model

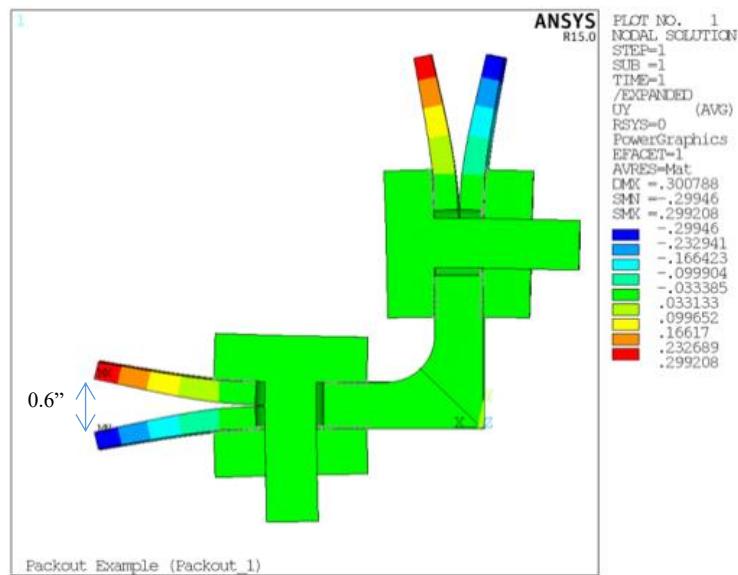
Two opposite forces of 33,200 lbs. each had to be applied to the plates to open the gap by 0.6 inch (15.2 mm) as was measured in the actual sample. Large axial stresses (much greater than

Figure 12 - FEA Results Showing 0.6 inch (15.2 mm) Metal Separation Caused by Pak-out

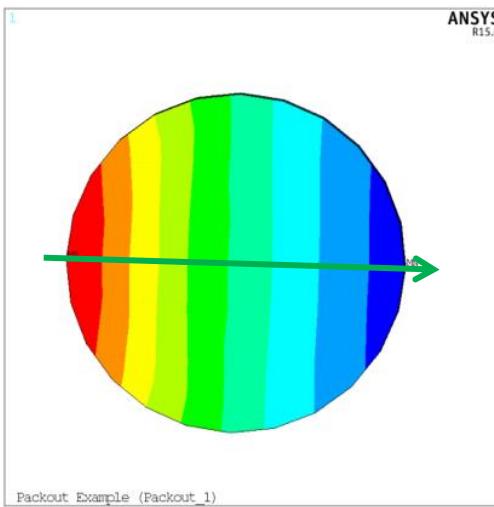
yield), caused by pack-out corrosion, in the bolt's shank cross-section are shown in Figure 13. Figure 14 shows the same stresses but in the bolts cross-section along its length. Linearized membrane, membrane plus bending, and total stresses across the bolt's shank centerline (shown in Figure 13) are presented in Figure 15. No bolt preload was included in the analysis. In addition to bolt overload issues, the reduction in the thickness of the plates reduces the load-carrying capacity of the joint.

Figure 13 - Axial Stresses in Bolt Shank Center

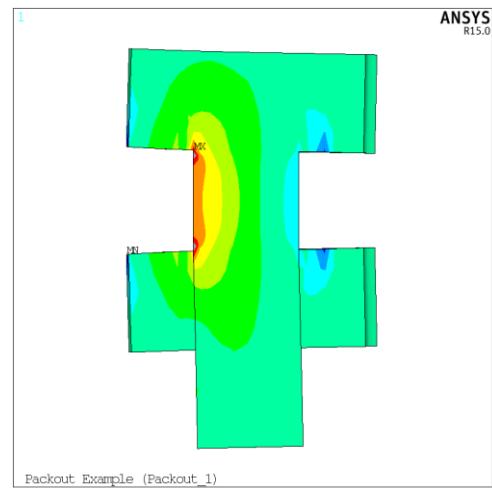
Figure 14 - Axial Stresses in Bolt Cross-Section

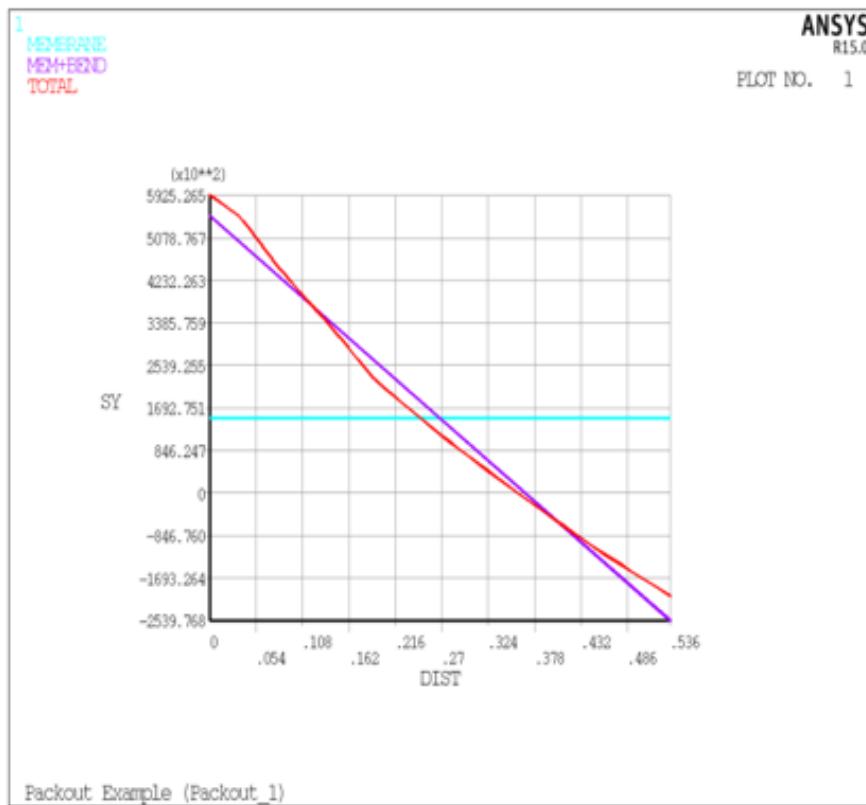
Figure 15- Membrane and Membrane +Bend along the Arrow Sown in Figure 13
