**Preventing Emergency Landings:
Addressing Jet Fuel Filter Clogging and Microbial Contamination**

Anil Kumar Chikkam, Aaron Ulmer, Nathan Pace, Edward Larkin, Mehrooz Zamanzadeh,
Farzan Zolfaghari, and James Datesh
Matergenics Inc
100 Business Center Dr
Pittsburgh, PA, 15205
USA

CASE HISTORY 1: CLOGGING OF FUEL FILTER DUE TO MICROBES

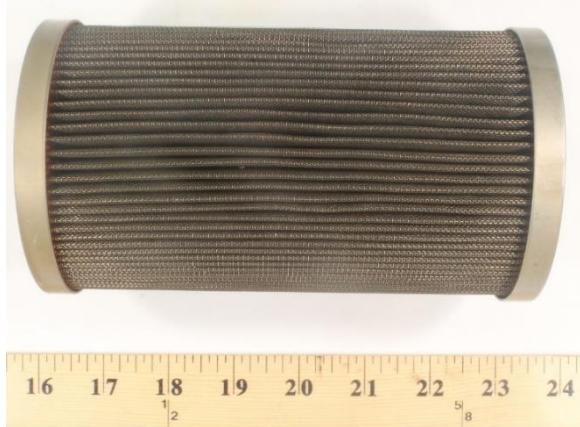
Figures 1, and 2 show as-received fuel filters. Small samples were extracted from each fuel filter for subsequent examination. The clogged fuel filter sample is covered with black deposits. However, the unclogged fuel filter sample did not show any deposits to the naked eye. A ray of light was incident on one side of clogged fuel filter and no light was transmitted through fuel filter. This confirms that the submitted filter section has been fully clogged. When a ray of light was incident on one side of unclogged fuel filter, light transmitted through fuel filter which suggests that the filter is not clogged.

Figure 1: Photograph of the fuel filter that is clogged.

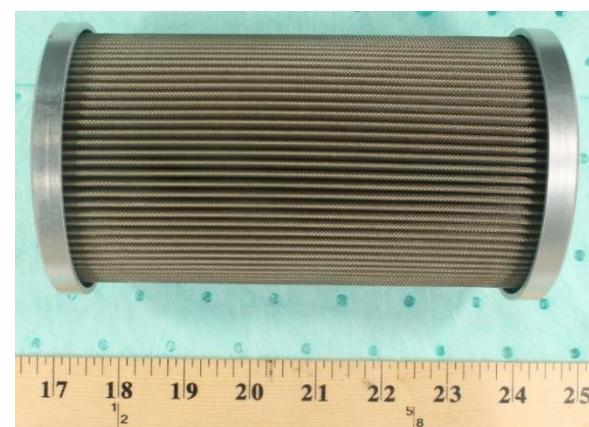
Figure 2: Photograph of the fuel filter from the same aircraft that is not clogged

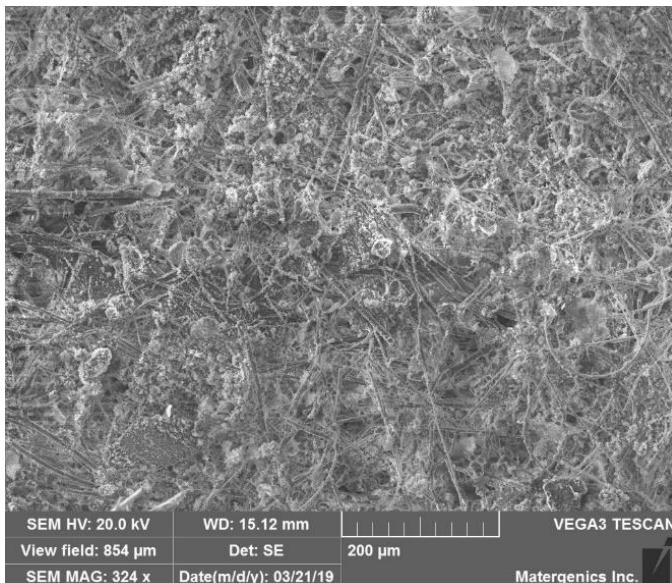
Figure 3 shows SEM images taken on the sample from the clogged fuel filter clearly shows that the filter is clogged. EDS data (Table 1) shows that the deposits are rich in sulfur (S). EDS analysis of the deposits also revealed presence of other elements such as carbon (C), oxygen (O), silicon (Si), phosphorus (P), nitrogen (N), sodium (Na), iron (Fe), calcium (Ca), aluminum (Al), lead (Pb), copper (Cu), and magnesium (Mg) containing materials. Figure 4 from unclogged filter shows that the fuel filter is not clogged. EDS analysis of the fuel filter sample showed no presence of sulfur. EDS data (Table 2) shows that the fibers consist of elements such as carbon (C), oxygen (O), and silicon (Si). SEM examination revealed that the fibrous strands are round and not flat.

Figure 3 a): Clogging of filter can be clearly seen.

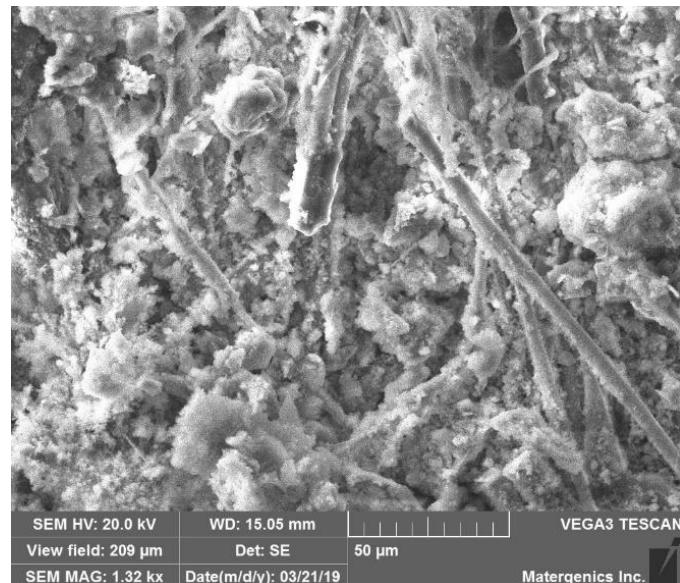
Figure 3 b): Closer view of Figure 3a) showing clogging of the filter.

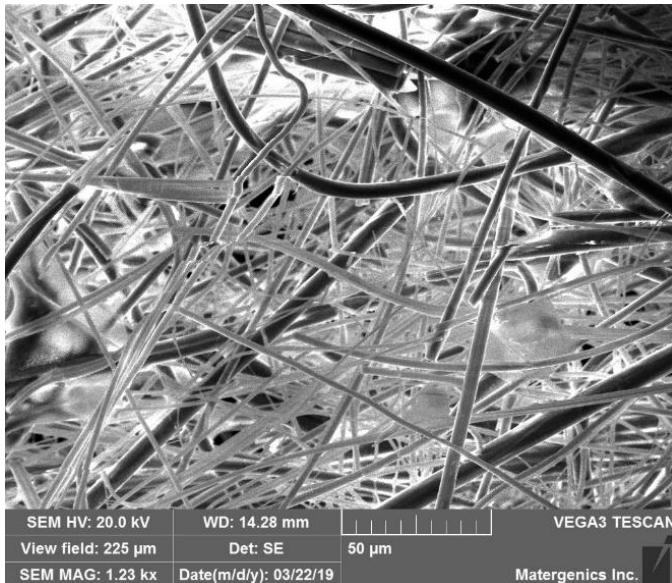
Figure 4 a): The filter is not clogged.

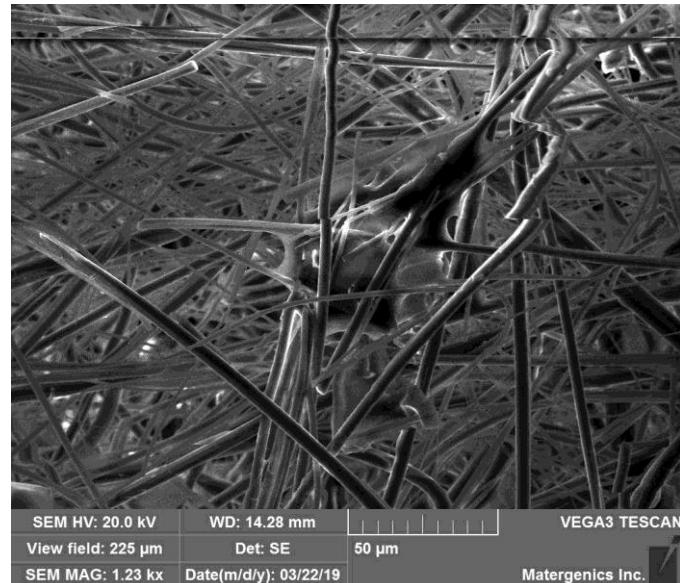
Figure 4 b): Fibrous strands can be clearly seen.

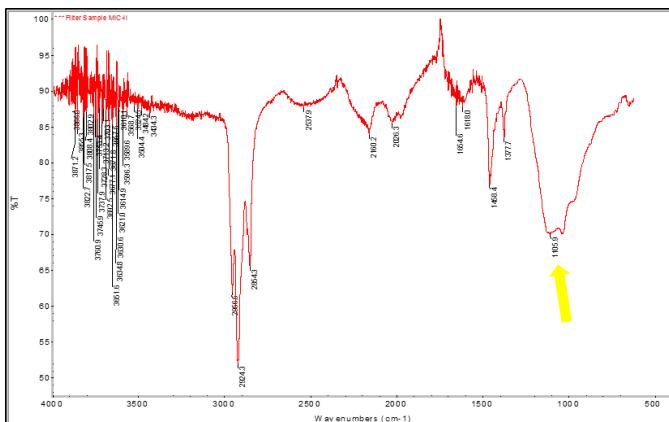
FTIR spectral analysis of clogged fuel filter (Figure 5) manifest the IR absorption bands for sulfate/ammonium sulfate (particularly strong around 1100 cm^{-1}). FTIR analysis of the unclogged fuel filter did not show any irregularity (Figure 6).

Figure 5: FTIR spectrum of the clogged filter manifest the IR absorption bands for sulfate/ammonium sulfate (pointed by yellow arrow).

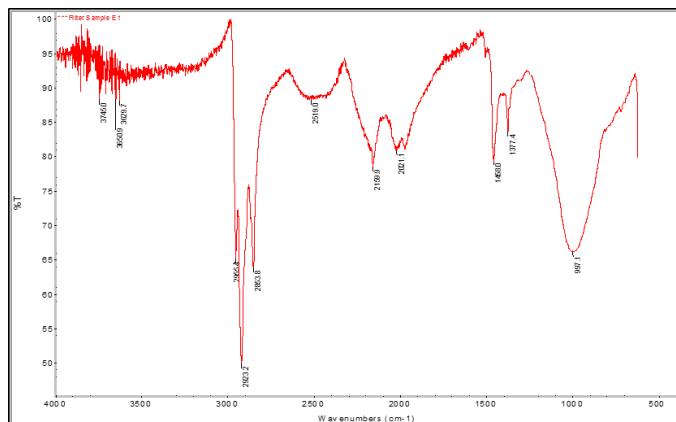
Figure 6: FTIR spectral analysis of unclogged fuel filter. No evidence of sulfate peaks.

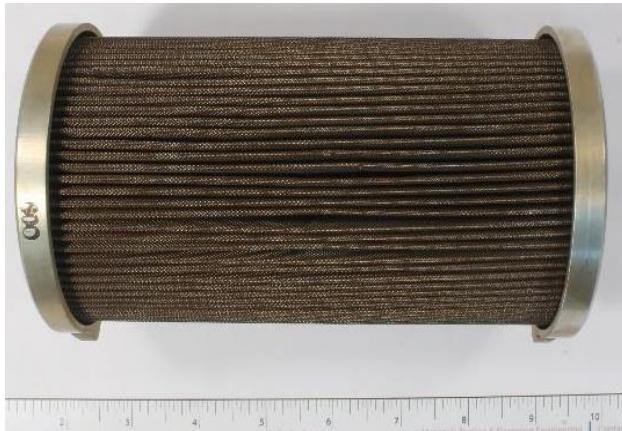
Figure 7 shows image of the as received fuel filter. Normally, fuel filters for analysis will be bright. This is the first time we have noticed that the fuel filter is brownish gold in color to the naked eye. Filter samples were extracted from the fuel filter for the subsequent testing. The extracted filter sample revealed that the fuel filter is murkier. A ray of light was incident on one side of the filter, and it was observed that the light did not transmit entirely through the fuel filter (Figure 8). This finding confirms that the fuel filter is partially clogged.

Figure 7: Photograph of the fuel filter that is clogged.

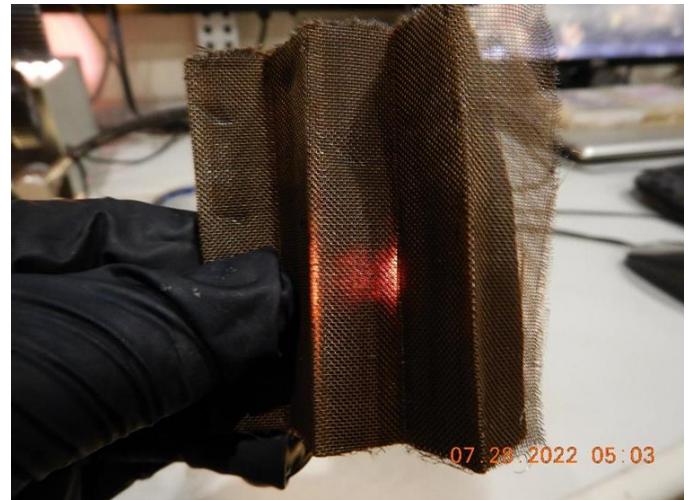
Figure 8: Photograph showing that when a ray of light was incident on one side of filter, the light did not transmit through fuel filter entirely.

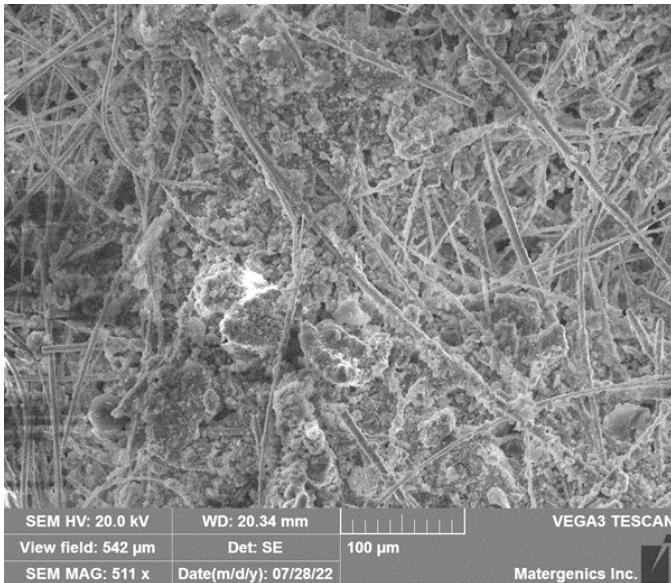
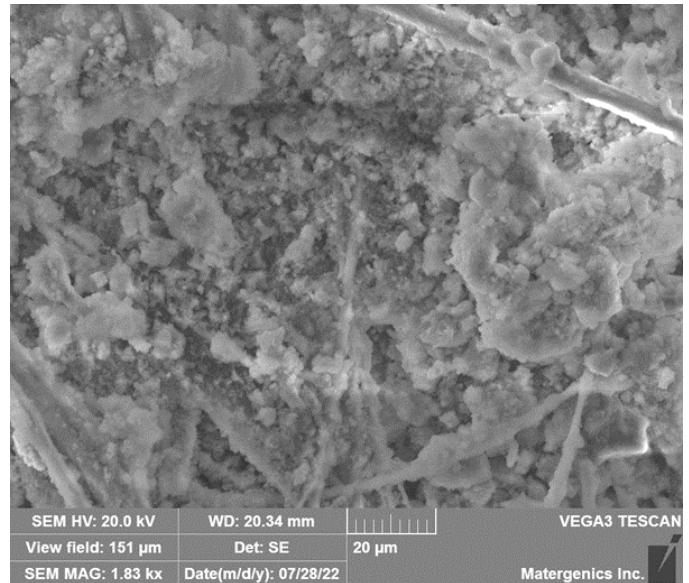
SEM images (Figure 9) taken on the fuel filter sample shows that the filter is clogged due to deposits. SEM examination revealed that the fibrous strands are round and not flat. EDS analysis (Table 4) of the deposits noticed in the fuel filter sample revealed that the deposits are rich in Sulfur. EDS analysis of the deposits also revealed the presence of other elements such as copper (Cu), carbon (C), oxygen (O) silicon (Si), phosphorus (P), nitrogen (N), sodium (Na), iron (Fe), calcium (Ca), aluminum (Al), and magnesium (Mg).

Figure 9: SEM images of the clogged fuel filter.

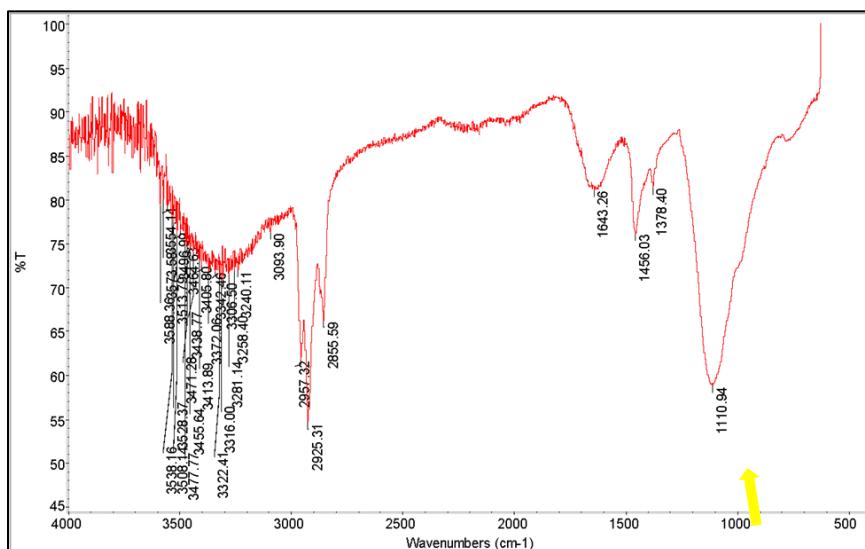
FTIR absorption bands (Figure 10) at 2957, 2925, 2856, and 1456 cm^{-1} are characteristic of hydrocarbons, a primary component of jet fuel. Sulfur was confirmed in the EDS analysis and has sulfate bands in the FTIR spectrum at 1378 and 1111 cm^{-1} . The presence of nitrogen is noted in bands in the FTIR spectrum at 3332 and 1643 cm^{-1} . The filter contains a nitrogen/sulfur compound like ammonium sulfate. Nitrogen may also be present in proteins associated with biological material such as microorganisms.

Figure 10: FTIR spectrum of the clogged filter sample. The yellow arrow shows sulfate/ammonium sulfate.

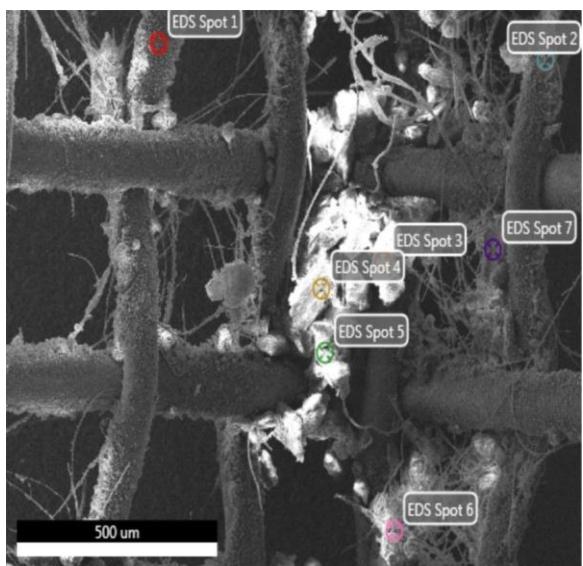
Spot 4: Deposit rich in Copper (Cu)

Spot 7: Deposit rich in Tin (Sn)

Figure 11: Semi-quantitative analyses of deposits observed at the outer stainless steel mesh.

- Corrosion deposits might have a secondary influence in clogging, but it is not the primary cause. The primary cause for filter clogging is due to microbial mass.
- No solid metal/bronze particles were observed.

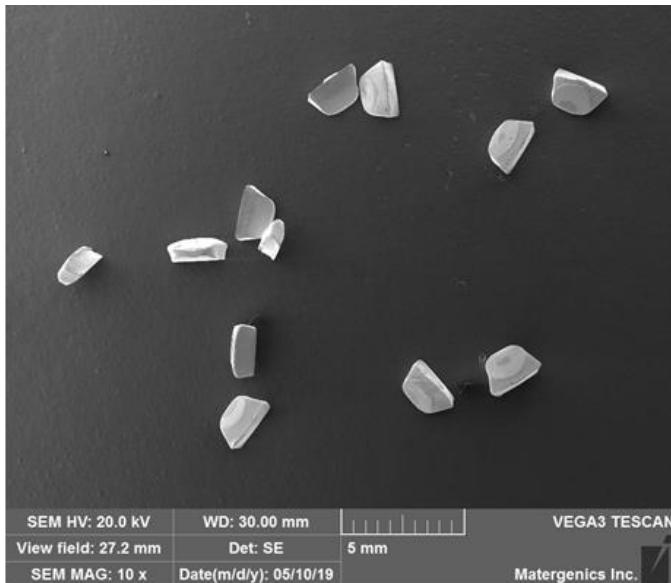
When a magnet was brought close to the debris/chips, they were attracted to the magnet which indicates that the chips are magnetic in nature. Figure 12 shows the SEM image of metal chips extracted from the

fuel filter. Similar macroscopic features were observed on the unaffected surface of all the chips. Moreover, the appearance of fracture surface of all chips is similar. Ratchet marks indicative of multiple crack origin sites were noticed on the fracture surface (Figure 13). Moreover, beach marks were also noticed on the fracture surface. The presence of ratchet marks and beach marks indicate that the metal flakes have chipped off from the actual material due to fatigue mechanism. Tables 7 and 8 show the EDS data taken on the metal chip sample. EDS analysis on the fracture surface of the metal chip sample suggested that the material of the metal chip is alloy steel. EDS analysis on the unaffected surface of the metal chip revealed predominantly Silver (Ag).

Figure 12: SEM image of the metal chips collected from fuel filter

1. The metal chips are magnetic in nature.
2. EDS data suggests that the actual material of the metal chips is silver plated alloy steel.
3. The metal chips are most likely from the bearing component. Silver plating bearings can provide an anti-galling surface and reduce friction. It can also offer an added level of protection from wear.

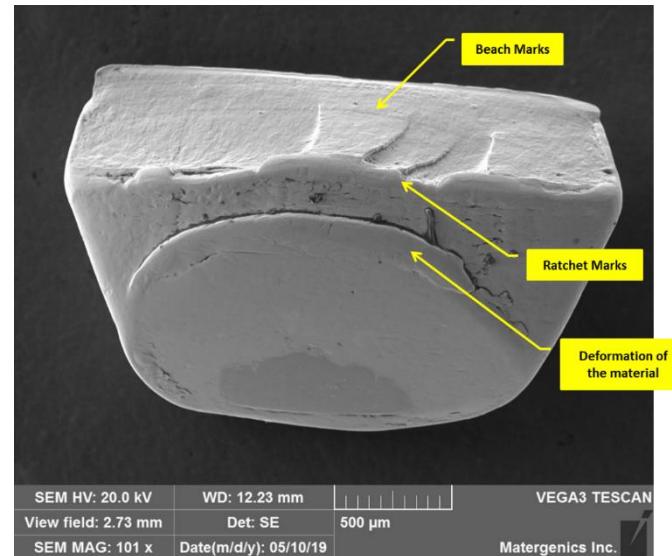
Figure 13: SEM image of metal chip sample showing ratchet marks and beach marks.

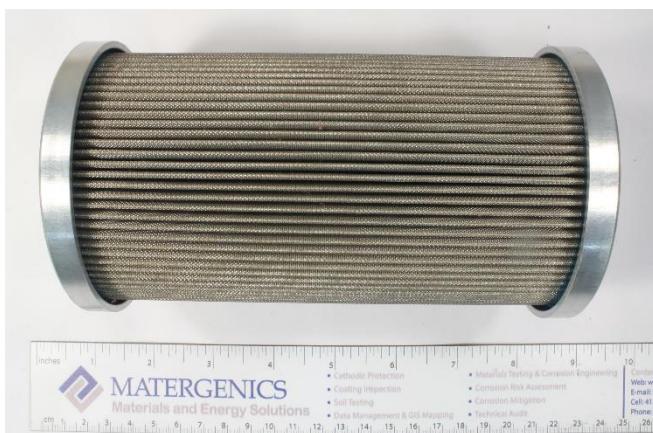
Figure 14 shows the received fuel filter. From visual examination, the filter looked clean, undamaged and no indications of discoloration. However, the filter had lint on the stainless steel (SS) mesh (Figure 15). Stereoscopic examination revealed that the lint is in fiber form. Convolutions and color contrast of the fibers were clearly seen.

Figure 14: Photograph of the fuel filter that is clogged.

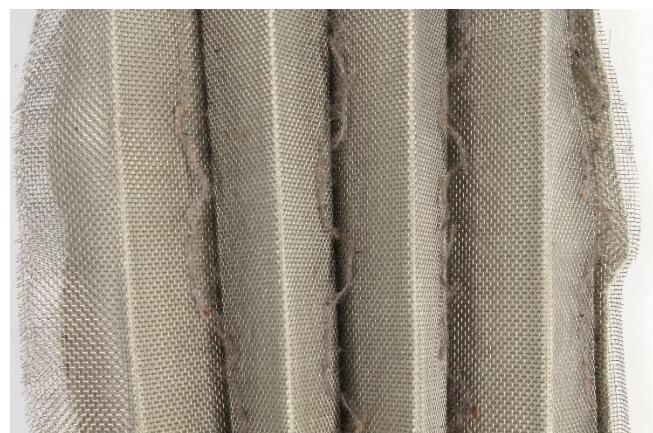
Figure 15: Presence of lint can be clearly seen at the stainless steel mesh.

- No evidence of metal contaminants in the filter.
- Lint fibers were noticed in both filters. It can be speculated that at some point, cotton rags might have been used to clean the filter, engine components, or could be carried over of minerals/dust by water in the fuel.

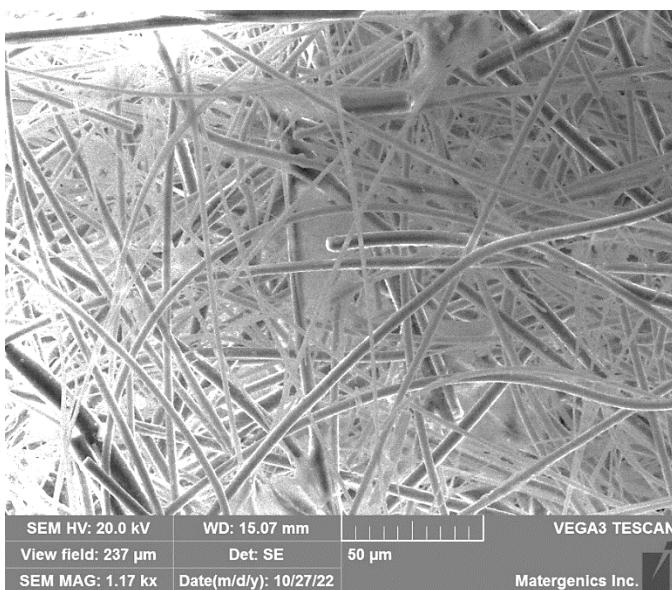
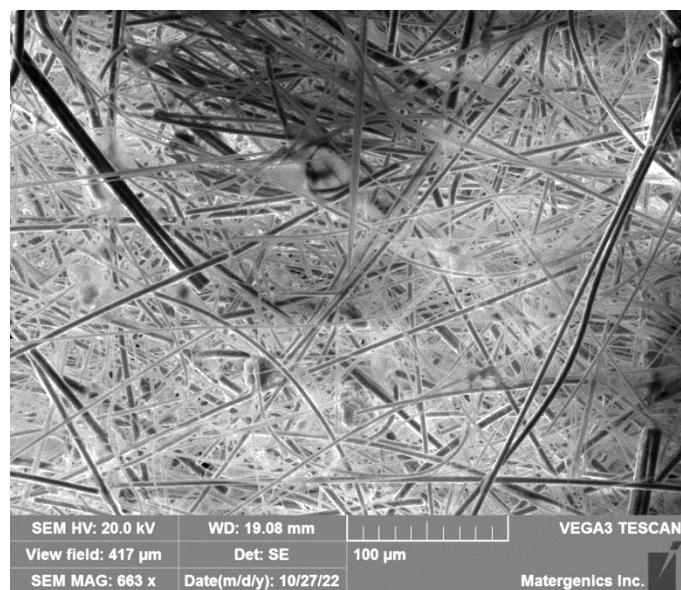
Figure 16: SEM images showing that the filter is not clogged.

SEM images taken on the filter sample shows that the filter is not clogged due to deposits (Figure 16). SEM examination revealed that the fibrous strands are round and not flat. The morphology of lint fibers revealed by SEM imaging was typical for cotton fiber (Figure 17). The fibers were smoother and warped (cursive) in nature. EDS analysis revealed presence of carbon and oxygen suggesting that the observed lint fibers could be cotton fibers (Table 9).

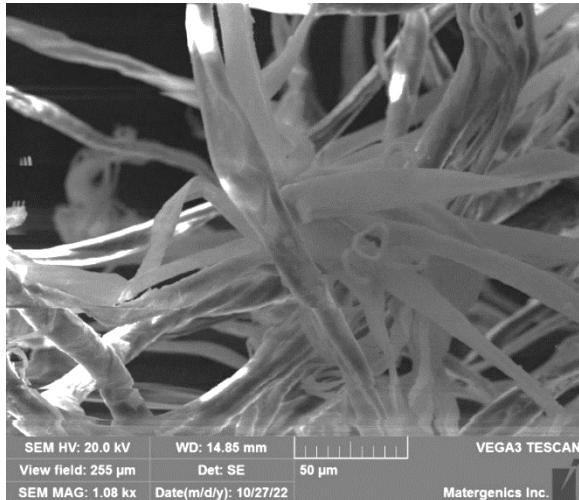
Figure 17: SEM image of the lint fibers.
