Condition Assessment of 66 kV Underground Transmission Lines in Concrete Vaults

Anil Kumar Chikkam, Aaron Ulmer, Nathan Pace, and Mehrooz Zamanzadeh
Matergenics Inc
100 Business Center Dr
Pittsburgh, PA, 15205
USA

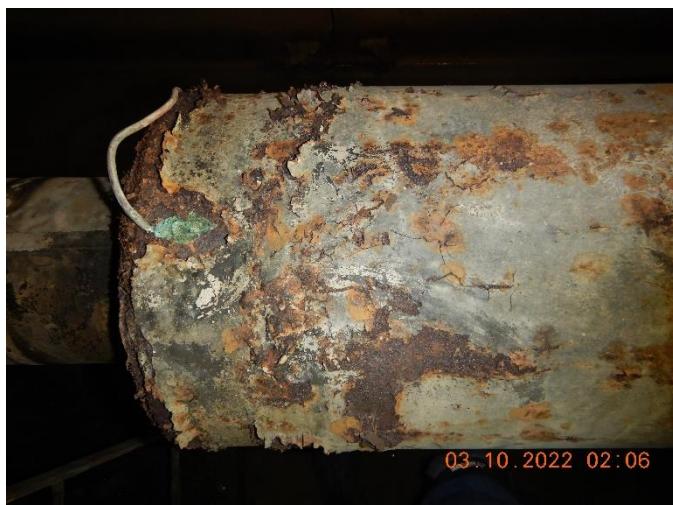
As a part of initial assessment, the condition of the coating on the below ground piping in the vaults was assessed. A visual assessment of the coated surfaces of pipe type cable, and steel pipe casing were conducted to determine the extent, location, and any noticeable patterns of coating deterioration and/or corrosion. Findings of the visual examination are as follows: The coating on the steel pipe casings across all six vaults is in suboptimal condition. Notable defects observed, which are commonly attributed to the aging of the coating, include flaking, delamination, blisters, and cracking. These defects can be seen in the sample images provided in Figures 5 and 6.

Figure 5: Photograph showing coating deterioration and corrosion of the underlying steel pipe casing.

2. The nominal thickness of the polypropylene coating on the carrier pipe is \approx 60 mils (1.52 mm).
3. The condition of the mastic coating on the 14 inch (35.56 cm) diameter steel pipe casing is poor and should be recoated immediately.

- o It is recommended that the existing coating on the steel pipe casing should be removed using chemical strippers or blasting systems.
 - o Then, apply new coatings with a brush and roller, or a conventional spray system.

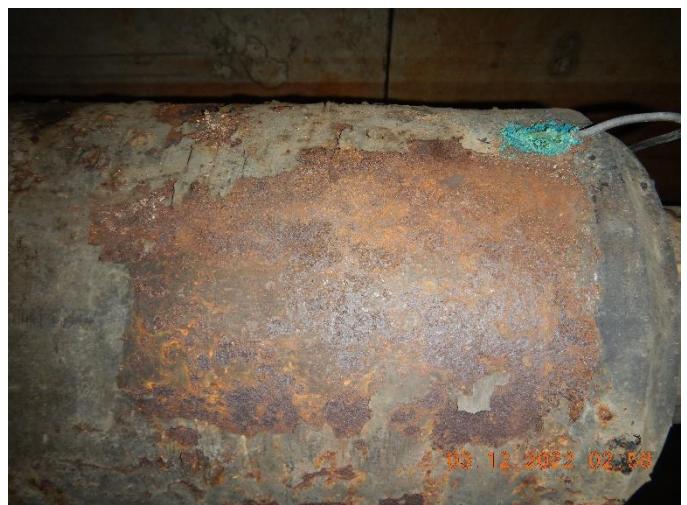
Figure 6: Photograph showing coating deterioration and corrosion of another steel pipe casing.

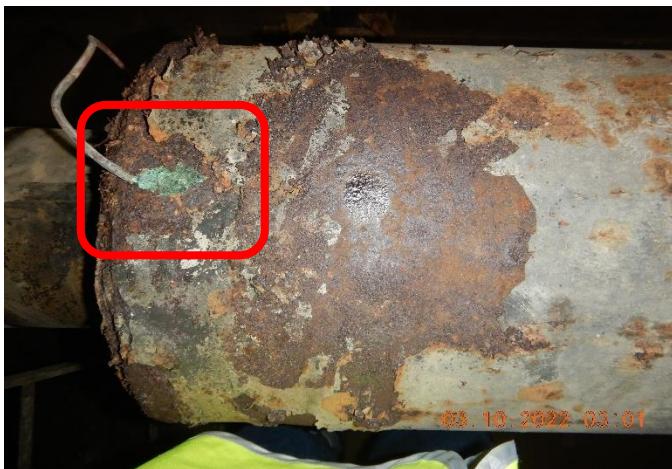
Furthermore, a significant majority of the Cad weld connections show signs of corrosion. The exposed steel surface surrounding these Cad weld connections presented signs of deterioration, captured in representative images of two separate pipe type cables are presented in Figures 7 and 8. The root cause for the corrosion of the cad weld connections is due to poor workmanship.

Figure 7: Photograph showing corrosion of the Cad weld connection.

5. All Cad weld (thermit weld) connections showed green deposits which is a corrosion product of the copper lead wire connected to the casing.
 - o The root cause for the corrosion of the cad weld connections is due to poor workmanship. After the cad welding, all cable attachments to structures should be coated. This coating should be compatible with the structure coating.

- o Before recoating on the steel pipe casing, client should ensure that all Cad weld connections of lead wires to the pipe casing are mechanically secure, then remove the green corrosion product on the cad weld connection, remove the existing coating on the steel pipe casing using chemical strippers or blasting systems, and then apply the recommended coating on the steel pipe casing and the cad weld connections.

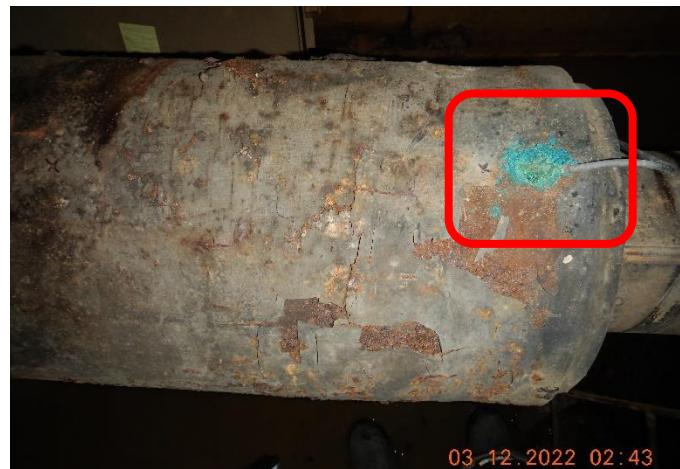
Figure 8: Photograph showing corrosion of the Cad weld connection.

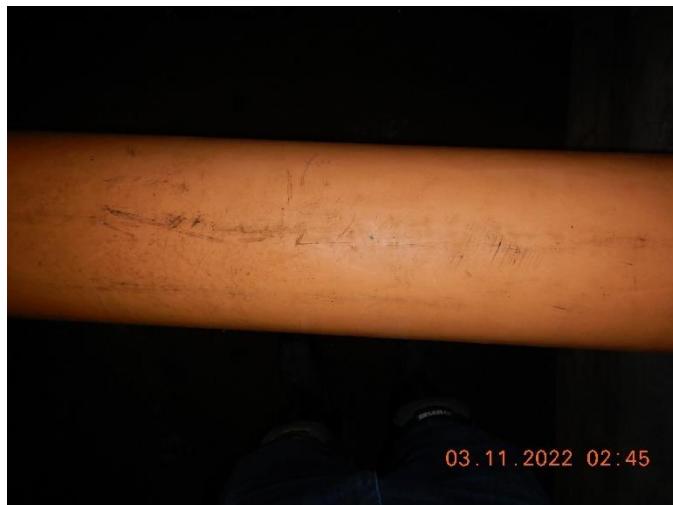
Examination of the coating on the carrier pipes revealed that the coating material is polypropylene. Further examination revealed that the condition of the coating on the 6-5/8 inches (16.8 cm) diameter carrier pipe is good. Sample images of two separate carrier pipes are provided in Figures 9 and 10. Polypropylene is one of the most suitable coatings when high mechanical properties (impact resistance, penetration resistance, etc.) and/or heat resistance are required. However, it should be noted that polypropylene coating when disbanded shields cathodic protection (CP), so condition of the coating must be checked every 3 years. CP shielding is defined as preventing or diverting the CP current from its intended path.² Electrochemical potential survey in the vault revealed that the carrier pipes and steel pipe casings are receiving adequate CP, more electronegative potential than -0.850 V_{CSE}, when they are submerged in water, when present in the vault.

Figure 9: Photograph showing the condition of the coating on the carrier pipe.

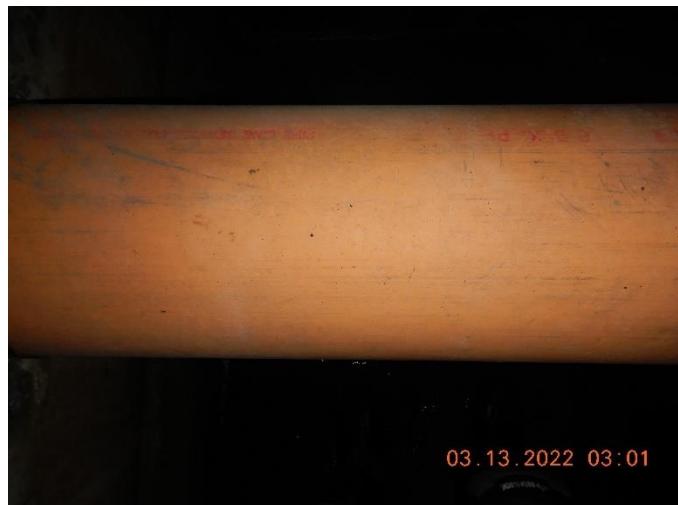
Figure 10: Photograph showing the condition of the coating on the carrier pipe.

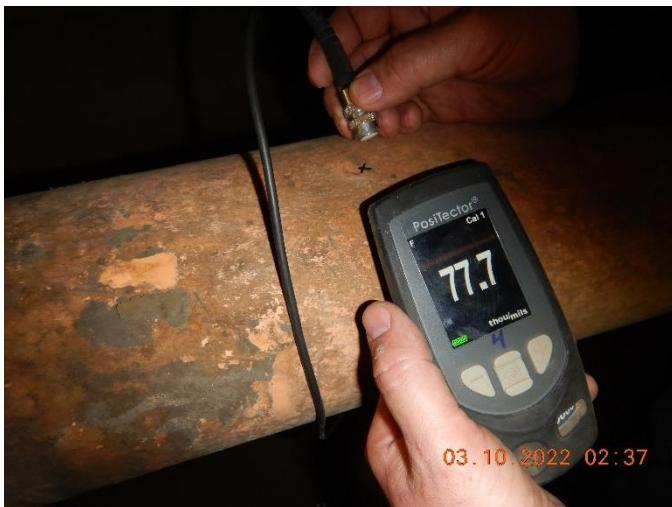
than the polypropylene coating present on the carrier pipe. Figure 11 is a sample picture showing the thickness of the coating (77.7 mils) present on the carrier pipe. Figure 12 is a sample picture showing the thickness of the coating (6.1 mils) present on the steel pipe casing.

Figure 11: Photograph showing the thickness of the coating present on the carrier pipe.

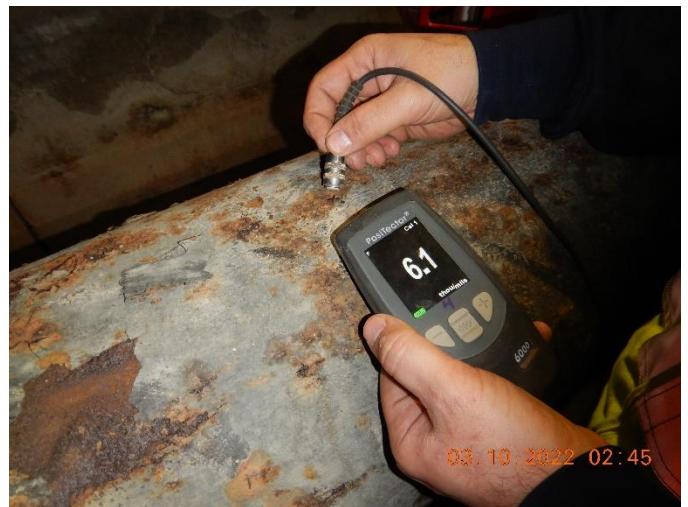
Figure 12: Photograph showing the thickness of the coating present on the steel pipe casing.

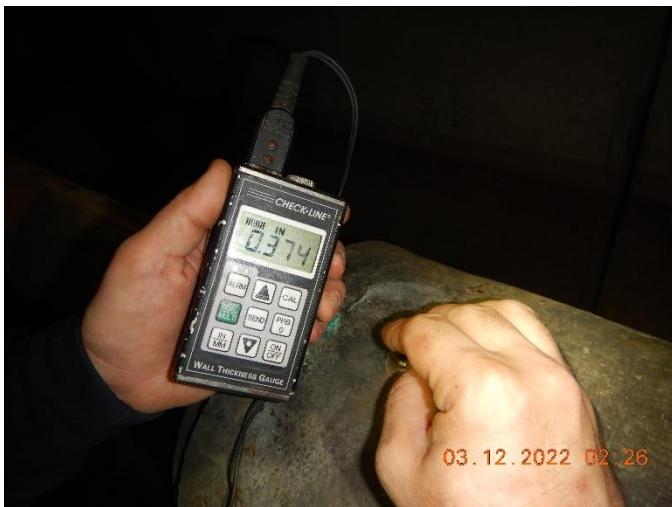
The wall thickness measurements are usually performed to prevent failures due to corrosion, and to guide decisions regarding component life span/replacement. The wall thickness of the carrier pipes and the steel pipe casings were measured using ultrasonic wall thickness gauge. However, wall thickness measurement was more focused on the steel pipe casing because the coating was deteriorated, and the corrosion of the underlying pipe steel casing was evident to the naked eye. The nominal wall thickness of the steel pipe casing is 0.375 inches (9.52 mm). Figure 13 shows the sample picture showing the wall thickness of the steel pipe casing. Considering the number of years, the steel pipe casing was in service and the measured wall thickness readings, there is no reduction in wall thickness and the observed corrosion on the exterior of the pipe has not decreased the overall wall thickness of the steel pipe casing, indicating that wall thinning is not a concern when addressing the integrity of the pipe. Figure 14 shows the wall thickness of the carrier pipe. The wall thickness readings indicate that there was no reduction in the wall thickness of the carrier pipe as well.

Figure 13: Photograph showing the wall thickness of the steel pipe casing.

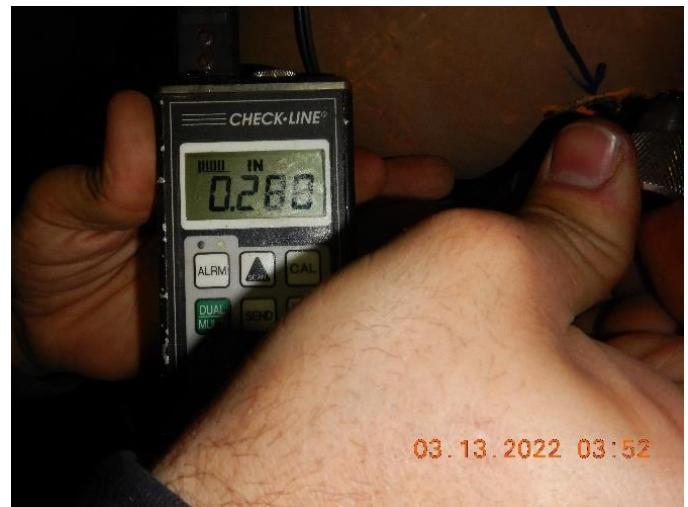
Figure 14: Photograph showing the wall thickness of the carrier pipe

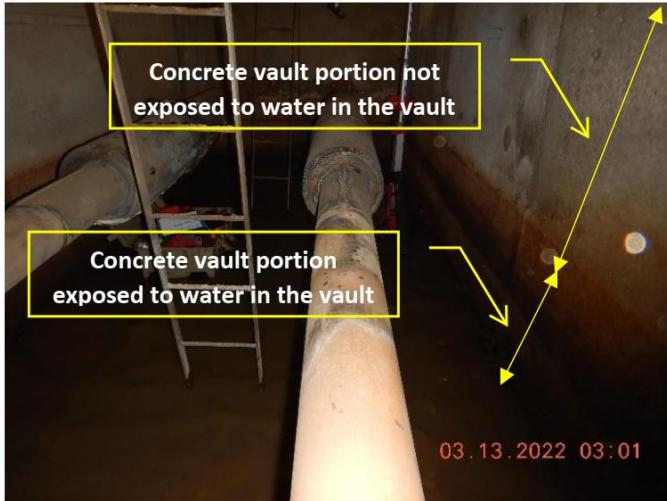
Condition assessment of the concrete in the inspected vaults also revealed discoloration of the lower portion of the concrete due to corrosion of the embedded rebar (Figures 15 and 16). For better understanding of the condition of the concrete in the vaults, pictures of two vaults are included. Moisture and de-icing salts can aggravate the corrosion reaction. Corrosion of the lower portion of the concrete suggests that the lower portion of the concrete vault was in contact with water at some point in service.

Figure 15: Photograph showing corrosion of the concrete vault.

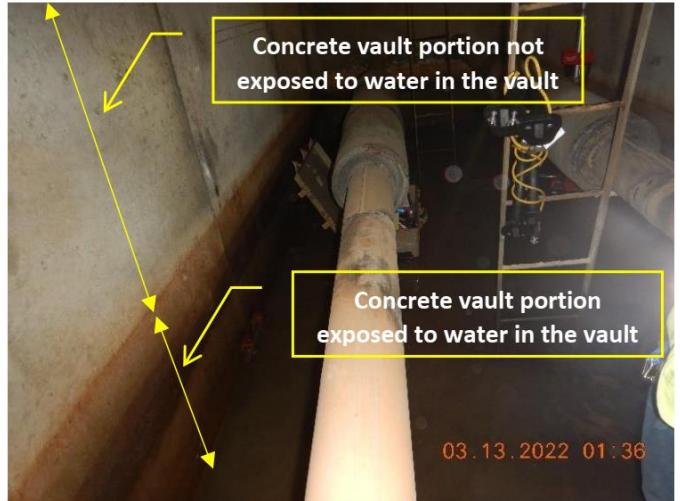
Figure 16: Photograph showing corrosion in another concrete vault.

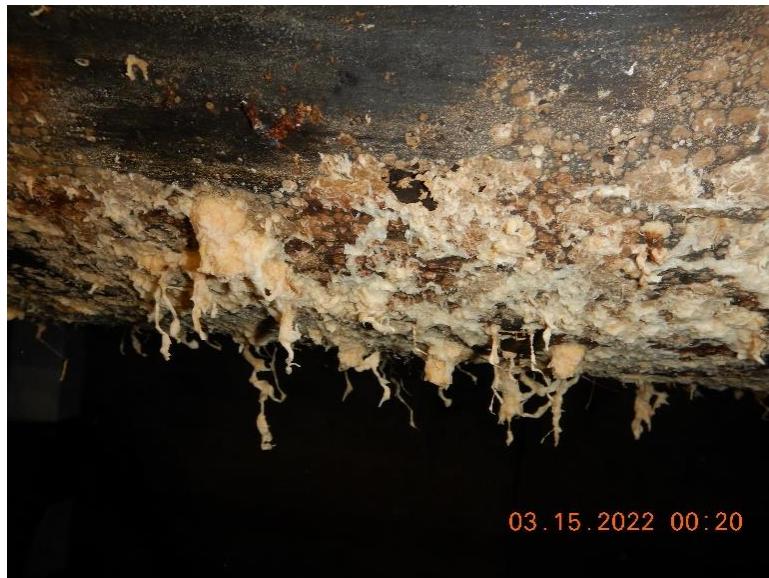
During condition assessment of the concrete, it was observed that white fuzzy build up was noticed predominantly on the bottom side of the pipes in the concrete vaults (Figure 17). The build-up could be efflorescence from the concrete. When the pipe comes in contact with water, the dissolved salts or minerals from the concrete might have settled on the pipe surface.

Figure 17: Photograph showing white deposit build-up on the pipe at the 6 O' clock position.

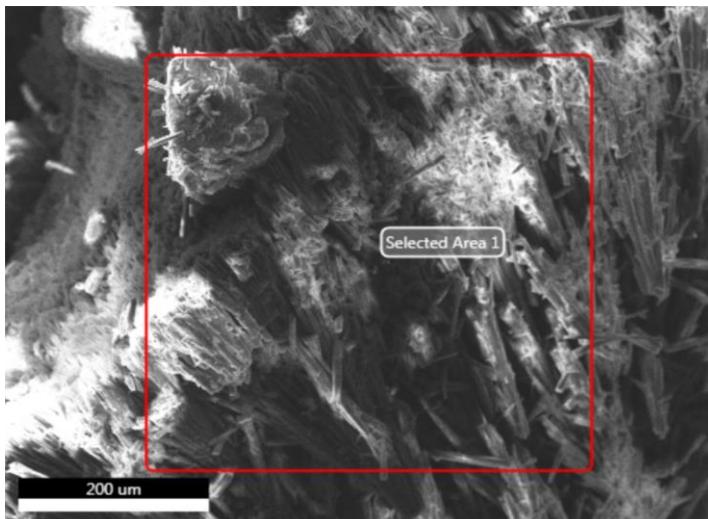
Corrosion product, and one of the white deposits collected from the carrier pipes in the vaults were analyzed in the lab using SEM/EDS analysis. The presence of elements such as calcium (Ca), oxygen (O), carbon (C), magnesium (Mg), and aluminum (Al) from the EDS analysis indicate that the white deposit is in fact the efflorescence product of the concrete (Figure 18). A typical efflorescence is formed by calcium carbonate (CaCO_3). Moreover, efflorescence could be sulfate and carbonate compounds of sodium (Na), potassium (K), calcium (Ca), magnesium (Mg), and aluminum (Al).

Figure 18: EDS data showing the elemental composition of white deposit.

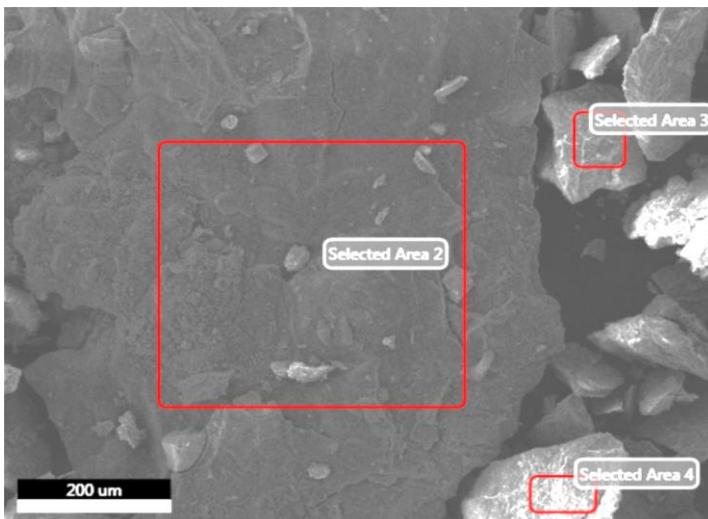
Elemental composition of the corrosion product revealed presence of elements such as iron (Fe), oxygen (O), carbon (C), silicon (Si), chlorine (Cl), and manganese (Mn). EDS data indicates that the corrosion product is predominantly iron oxide, and iron carbonate (Figure 19).

Figure 19: EDS data showing the elemental composition of the corrosion product collected from the surface of the steel pipe casing.
