Effects of Corrosion and Wildfires on Galvanized Steel Towers: A Case Study with Wildfire and Corrosion Sensors

Mehrooz Zamanzadeh, Anil Kumar Chikkam, George T. Bayer, Clinton Char, Carolyn Tome, Farzan Zolfaghari, and Nathan Pace

Matergenics Inc.
100 Business Center Drive
Pittsburgh, PA 15210

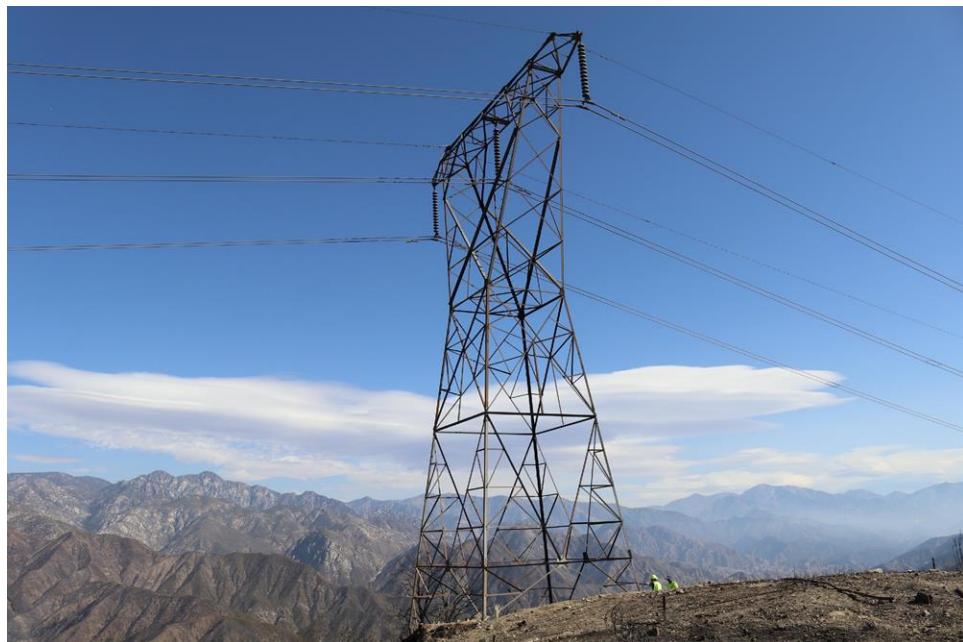
- Increased Temperature: The high temperatures associated with wildfires can compromise the integrity of the galvanized coating, making the underlying metal more susceptible to corrosion. Figure 1 shows the wildfire exposed tower under study and Figures 2 and 3 exhibit the effect of wildfires on galvanized layer the first defense against corrosion in transmission towers¹,

Figure 1: Tower exposed to wildfire under study.

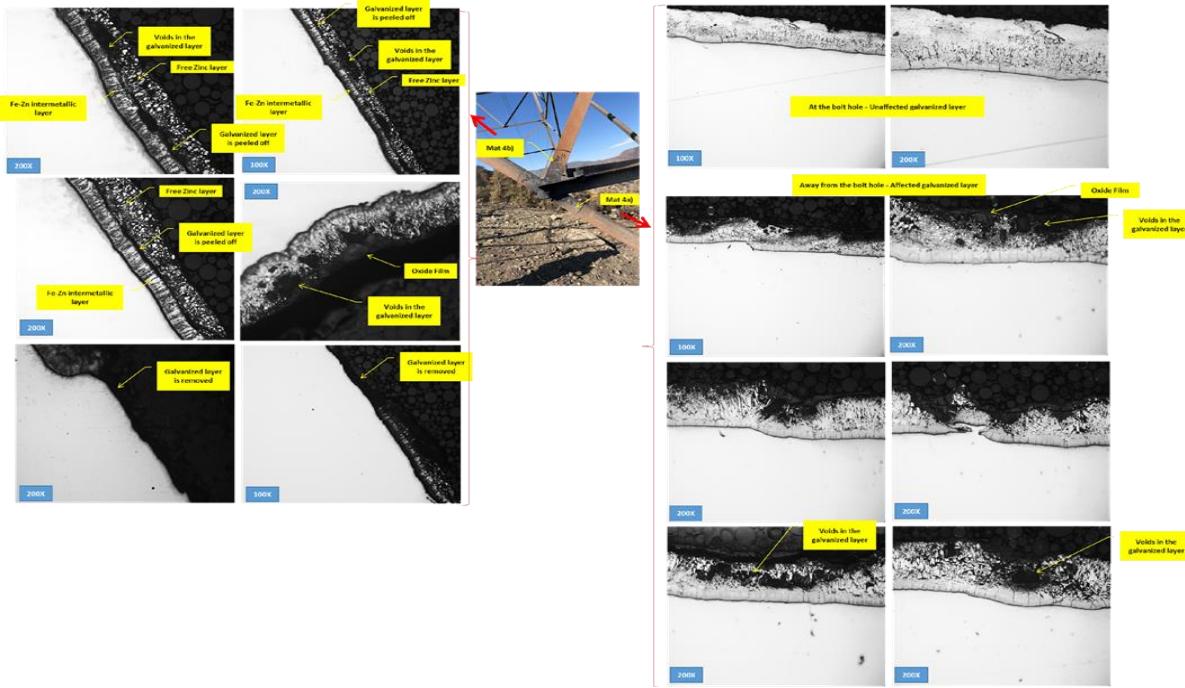
Figure 2: Cross sections of galvanized members exposed to wildfire and the damage observed indicating oxidation and delamination of galvanized layer due to temperature raise above 350F (177°C)¹.

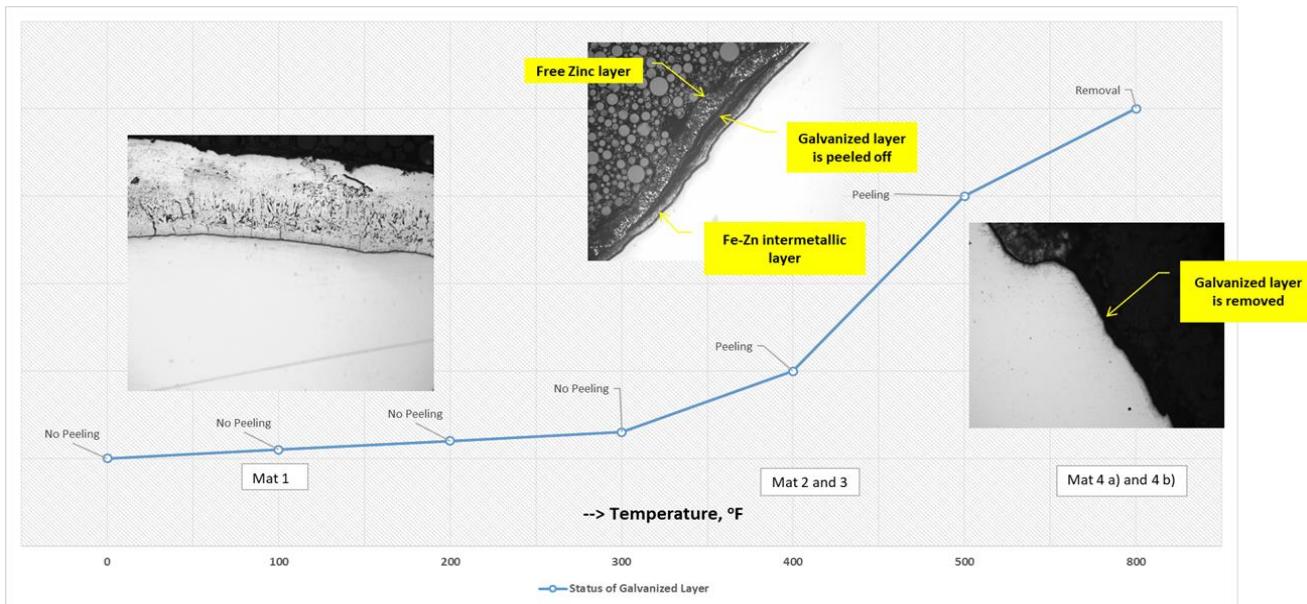
Figure 3: Temperature versus galvanized layer peeling indicating temperature raise above 300 F (149°C) results in delamination and depletion of galvanized layer¹.

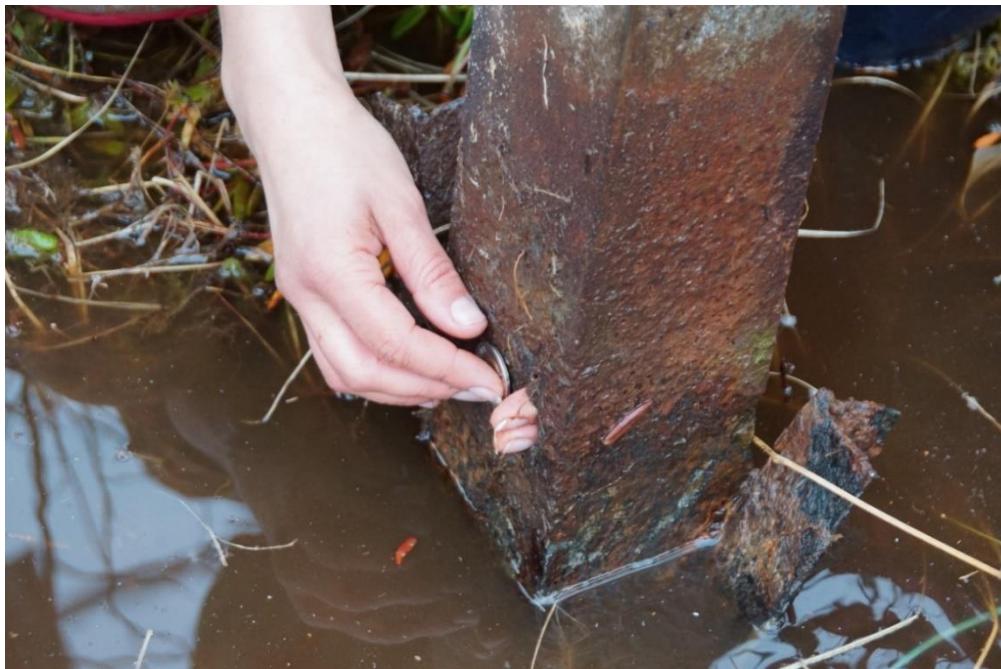
Figure 5 a): Corrosion Perforation in Corrosive Water

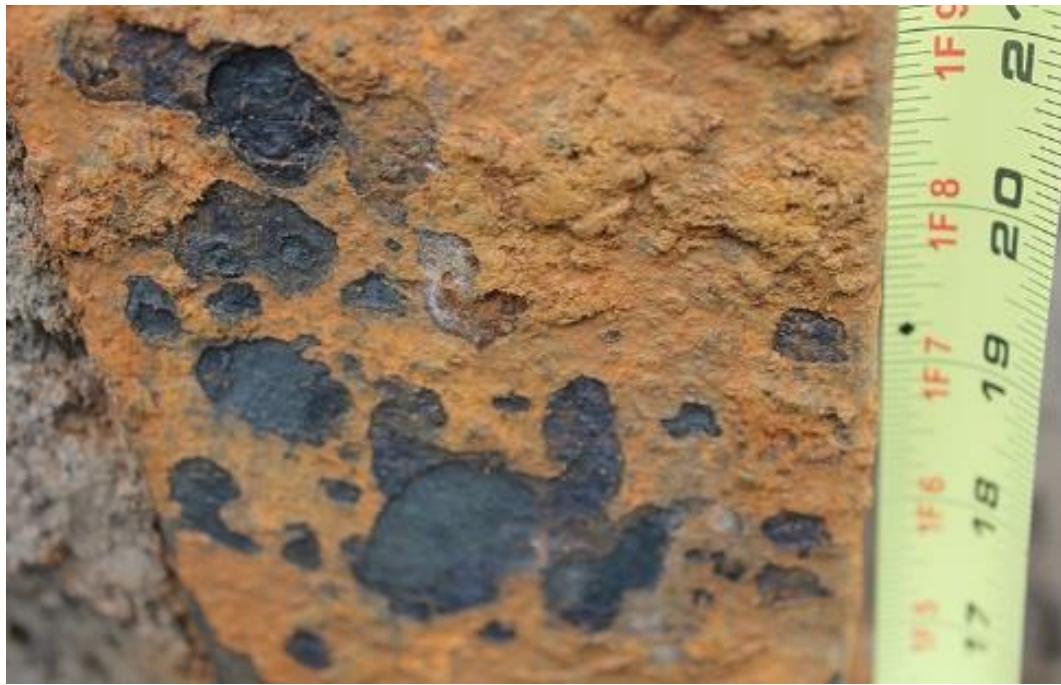
Figure 5 (b): Tower legs exhibiting signs of microbiological corrosion.

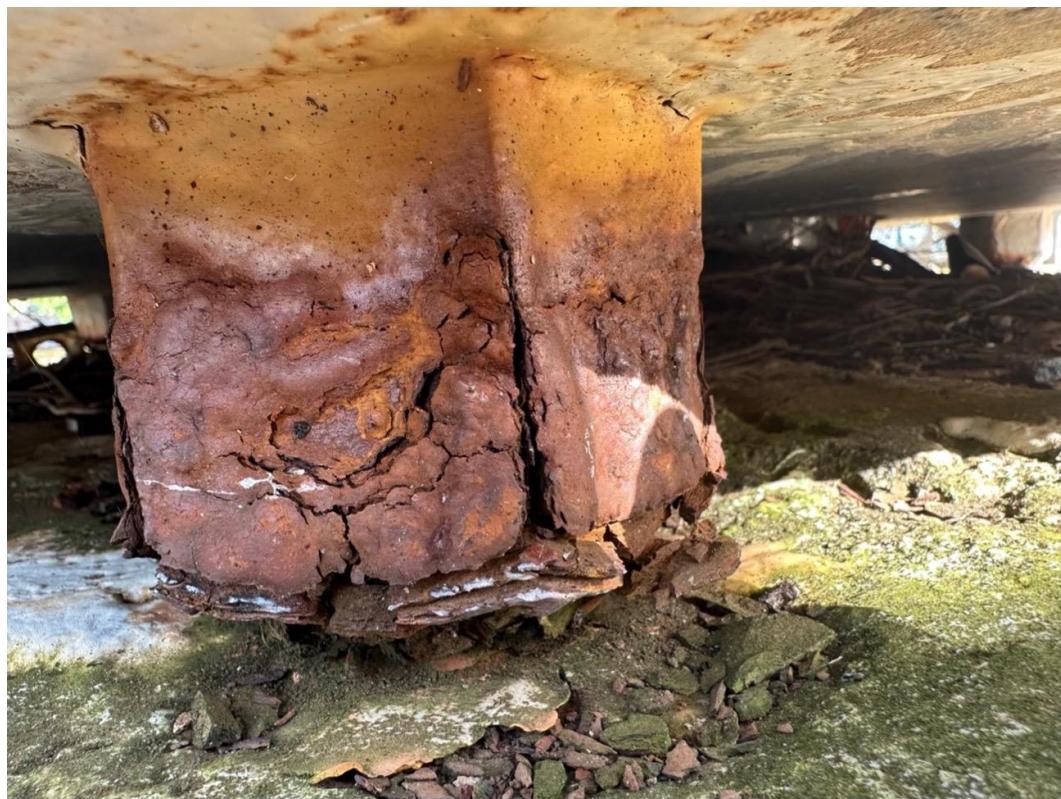
Figure 6: A galvanized anchor bolt under a base plate for a communication tower exhibiting accelerated corrosion and extensive thickness loss.

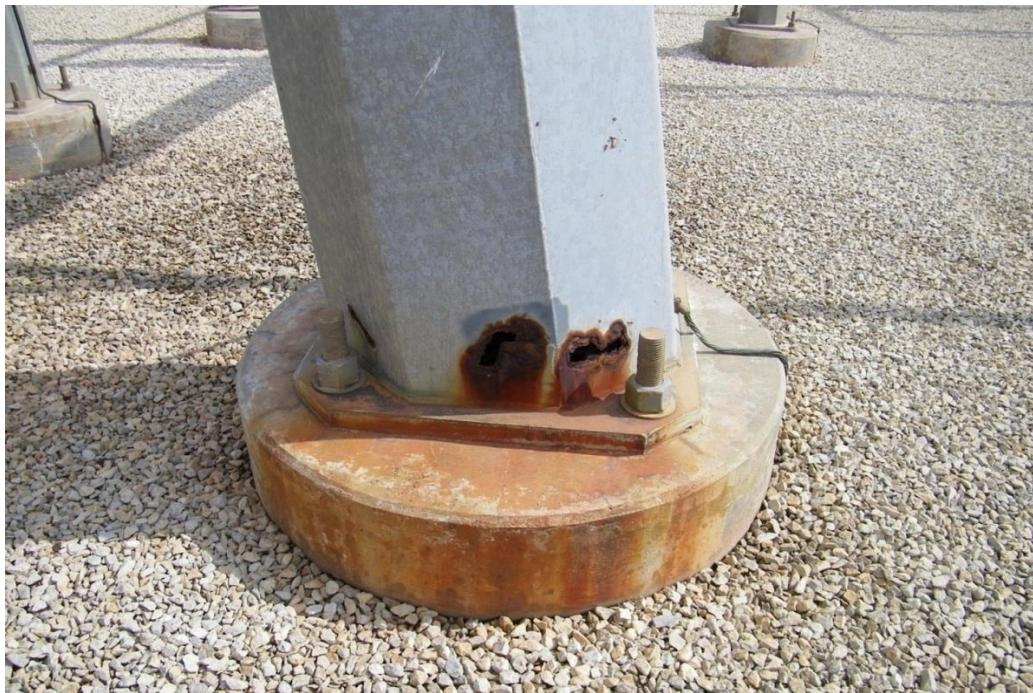
Figure 7: Internal corrosion of a substation aging galvanized pole on concrete foundation.

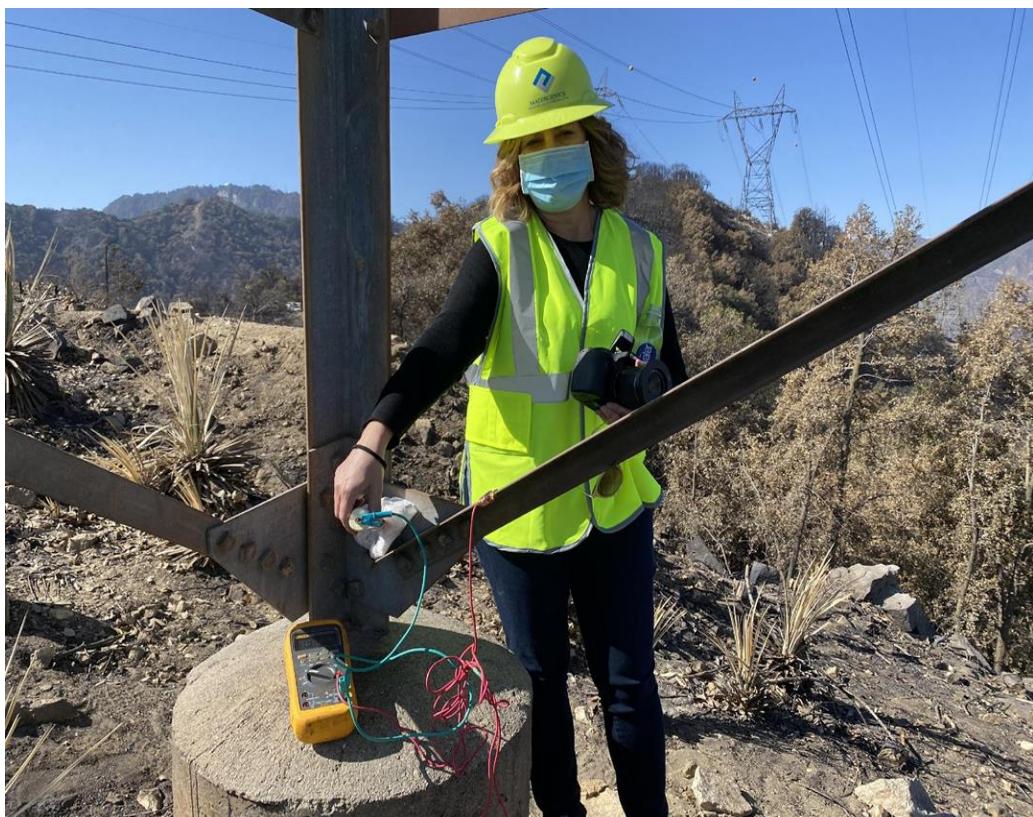
Figure 8: Measurement of corrosion potential will indicate the corrosion activity on galvanized members.

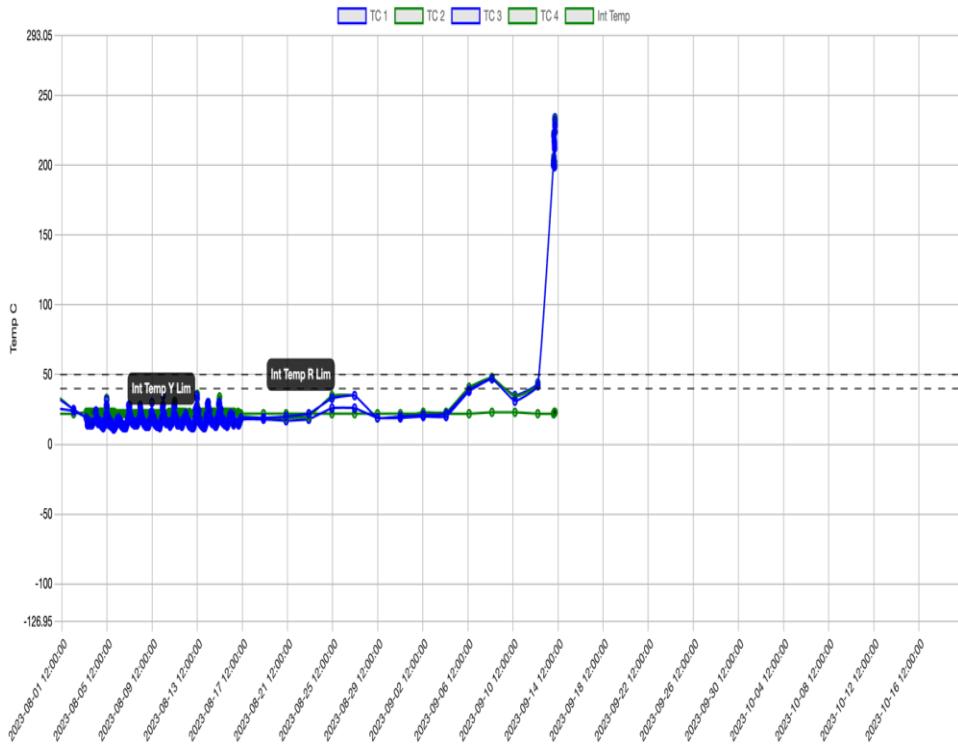
About the recent Hawaii wildfire, we believe that the temperature rise was not due to direct lava exposure and could be attributed to the underground movement of lava in that area. There does not appear to be anything above ground which would cause the temperature rise - no fires or active lava flows near the area. The area where the tower is located was inundated in 2018 by a lava flow in the Puna area. Thus, active underground lava tubes exist in the area. With the recent eruption of Kilauea, lava could be flowing in the underground lava tubes thus causing a rise in the ground temperature. Also, the tower is located near the Puna Geothermal facility. This would indicate that there is geothermal activity in the area.

Figure 11: Raise in temperature over 380 F (193°C) due to lava flow underground.

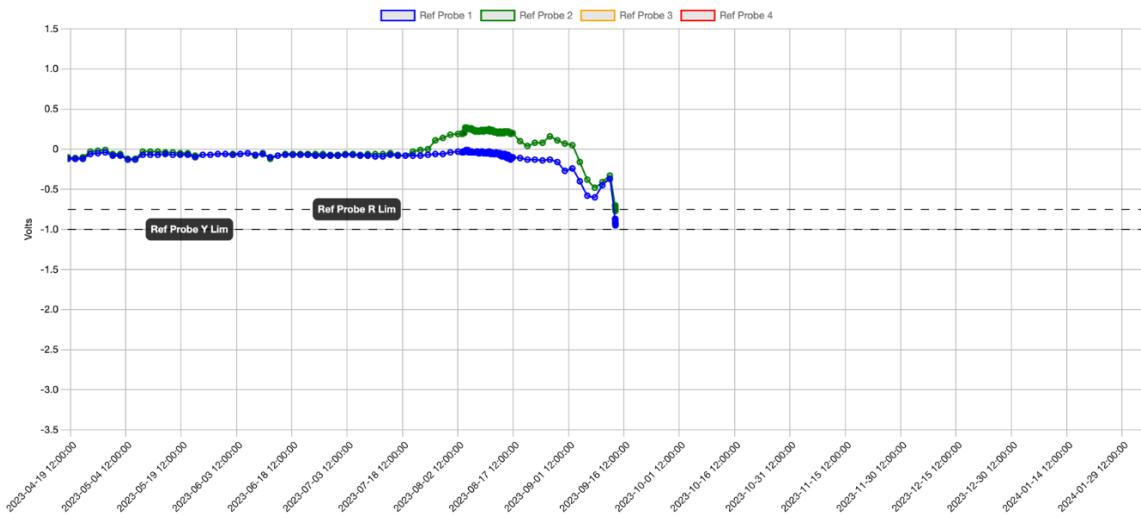
Figure 12: Rapid rise in corrosion activity detected by sensor (EnviroZense) on September 13, 2023.

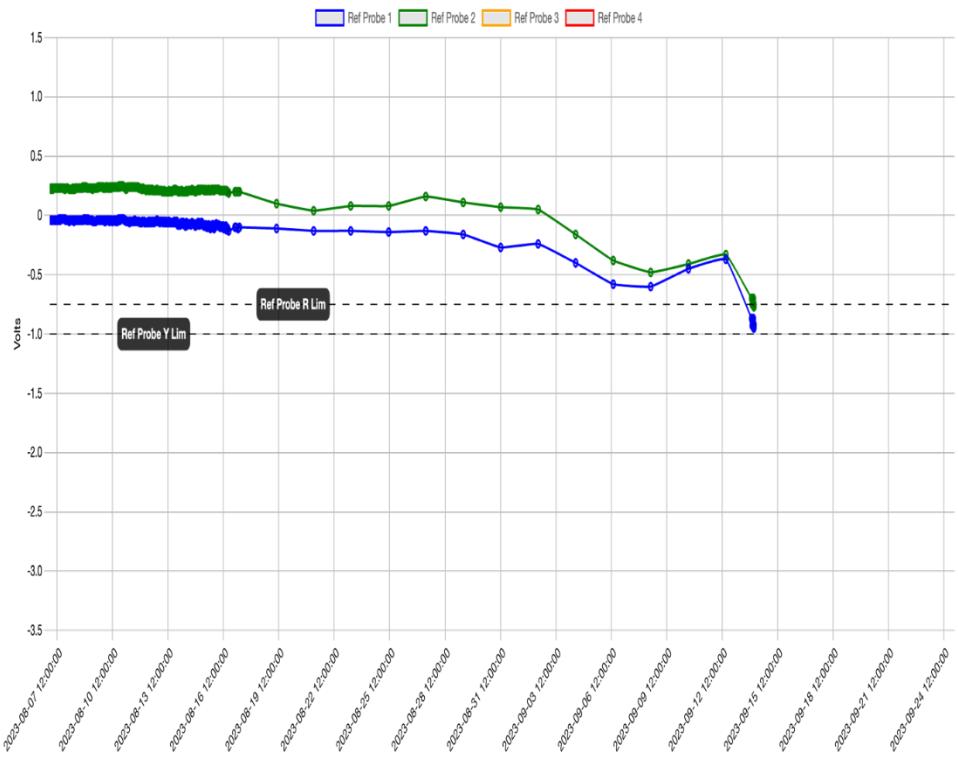
The electrochemical potentials serve as indicators of corrosion activity. By measuring the potentials near underground metallic assets, the IR drop caused by soil can be reduced. In this case, a reference electrode was installed next to a galvanized pole or a grounding copper at a tower site near the volcano. The resulting potential readings were then transferred to the corrosion engineer for analysis. The second plot Figure 12 clearly shows the change in mixed potentials, which is a direct effect of the temperature rise caused by the presence of lava in the lava tube. This increase in temperature leads to a change in the corrosion potentials and the formation of corrosion products. For galvanized assets, these readings suggest accelerated corrosion and a loss in galvanized layer thickness. All of these measurements, including temperatures reaching up to 220 degrees Celsius and potential readings, were performed using the sensor and were analyzed by the corrosion engineer in charge. He looked for critical values that indicate unacceptable risks from a corrosion engineering perspective. This case study indicated the sensor exhibited a raise in temperature due to lava flow. However, the temperature did not reach to level that had structural impact and no significant depletion of zinc or deformation of steel was observed. Corrosion data however indicated change in corrosion activity and formation corrosion products that shifted the mixed potential to more active potentials.

Figure 13: Rapid rise in corrosion activity (Blue and Green plots) detected by sensor on September 13, 2023

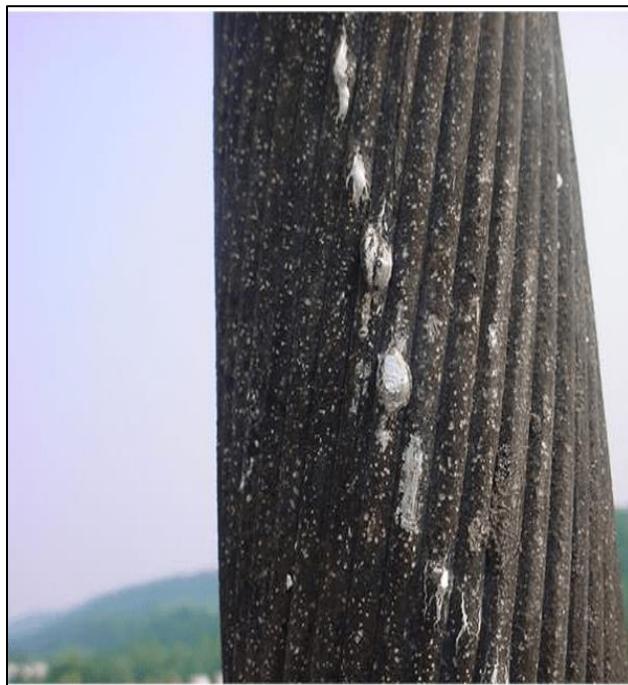
Figure 14: In another case zinc was observed due to high temperature exposure above 850 F (454°C). No such melting observed in this case.
