**Learning From Failure:  
The Key to Advancements in Metallurgy and Corrosion**

Anil Kumar Chikkam, Aaron Ulmer, Edward Larkin, and Mehrooz Zamanzadeh  
Matergenics Inc  
100 Business Center Dr  
Pittsburgh, PA, 15205  
USA

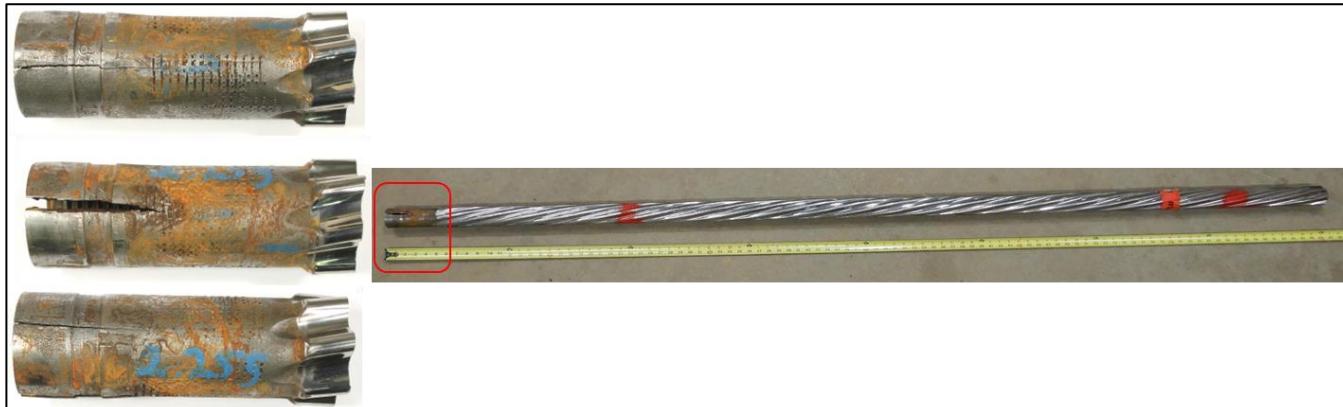
Figure 1 shows the failed rotor sample. The failed rotor had three longitudinal cracks at the box end of the rotor. The close-up of three cracks were also included in Figure 1. During the examination, several notable findings were made regarding the rotor: deep clamping marks were evident on the outer diameter of the box end, with a diameter measuring approximately 1.8500 inches (46.99 mm). Threads were observed on the inner diameter of the box end, and the observed cracks extended the full length of the threaded section. At a distance of approximately 1.0085 inches from the box end, a reduced diameter, in line with design specifications, was noted, measuring approximately 0.4795 inches, and part identification punching marks were present within this reduced diameter. Additionally, it was observed that the primary crack had propagated along the indentation mark labeled as "1," and noticeable bulging was identified in close proximity to the box end of the rotor.

**Figure 1: Photograph of the failed rotor.**

The premature failure of the downhole drilling rotor sample was characterized by the presence of three longitudinal cracks at the box end. An analysis of the chemical composition, and heat treatment condition revealed deviations from the material specification requirements, with the steel being identified as

substandard. Microexamination unveiled the presence of significant banding within the ferrite and pearlite microstructure. In conclusion, the box end failure resulted from an overload scenario, with the fracture running parallel to the rolling direction, cutting through manganese sulfide stringers and ferrite bands in the base metal matrix. The root cause of this untimely rotor failure can be attributed to the utilization of incorrect material supplied in an improper heat-treated condition, resulting in mechanical properties inferior to the manufacturer's specified values.

- Rotor material should be quenched and tempered to meet the mechanical properties. Portable hardness test is recommended on the remaining rotor samples to confirm that the rotor material is supplied in Q&T condition.
- It is recommended that punching marks should be avoided at reduced diameter.

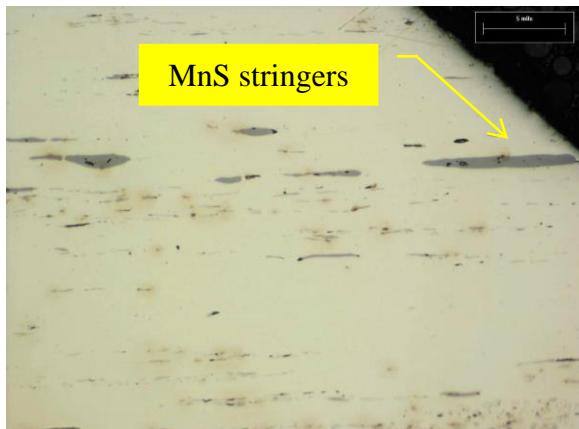
Figure 2 taken at the thread flank close to the thread root showed inclusions in the steel. Figure 3 taken at the reduced diameter showed micro-crack initiation at inclusion. Furthermore, it was observed that the microcrack is following along the MnS Stringer.

**Figure 2: Photomicrograph taken at one of the thread flanks near thread root showing significant presence of MnS stringers. As polished condition.**  
**Magnification: 100X**

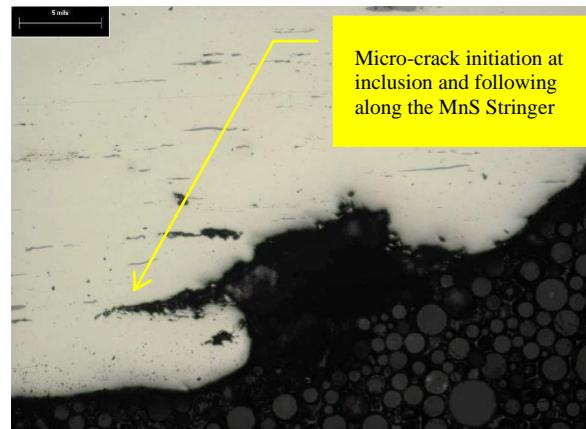
**Figure 3: Photomicrograph taken at the reduced diameter showing micro-crack initiation at inclusion and the microcrack is following along the MnS Stringer.**  
**Magnification: 100X**

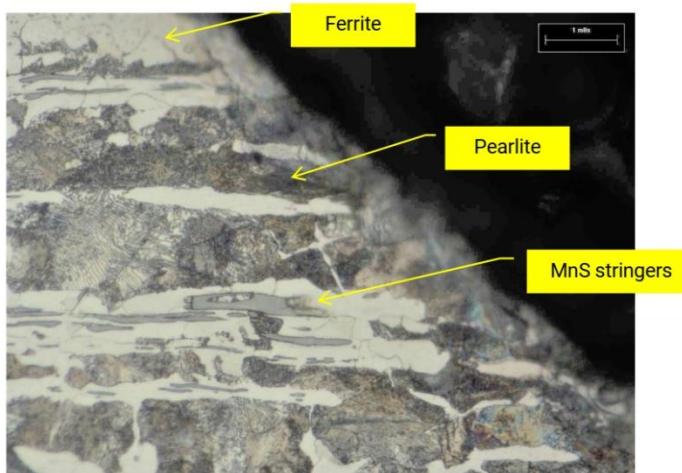
As per material specification requirements, the steel must be supplied in quenched and tempered (Q&T) condition. Q&T steel consists of tempered martensitic structure. Microexamination after etching with 2% Nital revealed ferrite and pearlite at the thread flank (Figure 4). A significant presence of MnS stringers was also detected. Figure 5 taken at the reduced diameter showed micro-crack initiation at inclusion and the microcrack is following along the MnS Stringer and bands of ferrite. Microexamination at random

**Figure 4:** Photomicrograph taken at one of the thread flanks near thread root showing ferrite and pearlite. Etched with 2% Nital. Magnification: 400X.

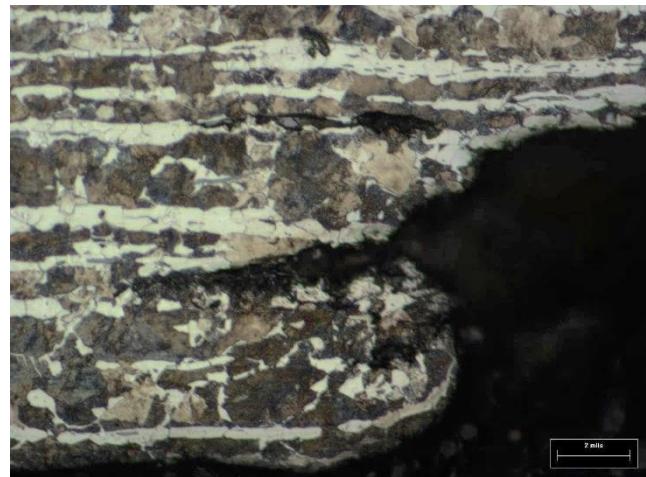
**Figure 5:** Photomicrograph taken at the reduced diameter showing micro-crack initiation at inclusion. Etched with 2% Nital. Magnification: 200X.

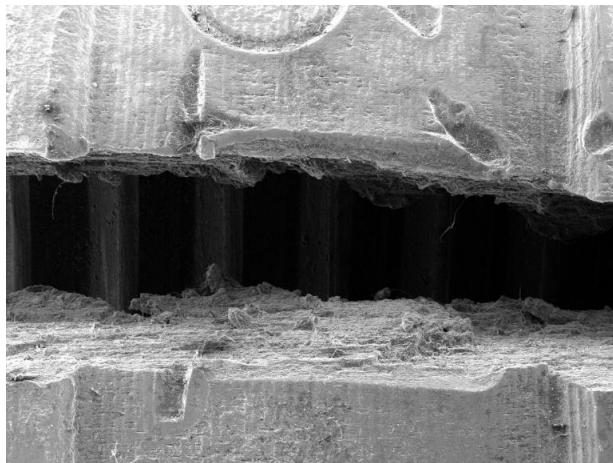
SEM examination (Figure 6) at the reduced diameter has revealed that the main crack followed along the indentation mark "1". Reduced diameter and the punching marks in the reduced diameter are stress concentration areas. Figure 7 taken on the fracture surface after ultrasonic cleaning revealed woody overload features. The morphology was identified as predominantly ductile rupture with faint indications of cleavage, and the directionality of the features was suggestive of shear overload. Fracture preferentially followed the nonmetallic inclusions in the longitudinal direction.

**Figure 6:** SEM image showing that the main crack followed along the indentation mark "1".

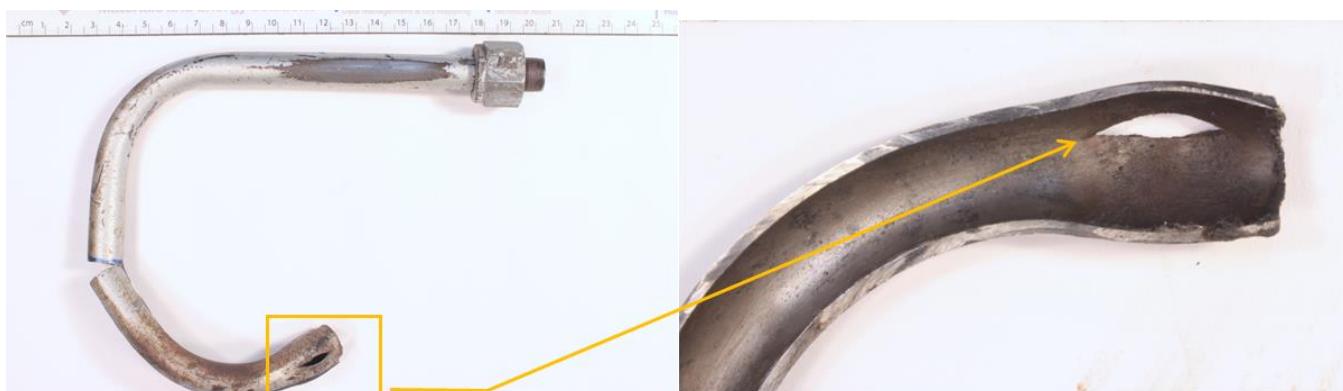
**Figure 8: Photographs showing as received failed tubing. Bulging and wall-thinning at the failed location can be clearly seen.**

Figure 8 displays the tubing sample in its as-received state after failure. Visual and Stereoscopic inspection of the failed tubing sample revealed the following physical evidence: the failure exhibited an open burst rupture with noticeable significant bulging and swelling at both the failure site and its neighboring areas. In the vicinity of the rupture, a reduction in wall thickness was observed. Remarkably, no substantial signs of corrosion were detected on either the outer or inner tubing surfaces; however, the inner surface displayed the presence of a black oxide scale.

The cracked area of the tubing that failed prematurely in service showed local bulging and thinner tube-wall, indicating a short-term overheating issue. Tests confirmed the tubing is made of low carbon steel, not stainless steel. The material's microstructure consists mainly of pearlite and ferrite. Dark voids near the fracture site suggested creep, while elongated grains indicated high-temperature deformation. Hardness measurements were similar at both unaffected and ruptured areas. The root cause analysis identified localized overheating that led to bulging and subsequent thinning, resulting in a fish mouth rupture. The problem arose from using an unsuitable material. Although the current temperature may be acceptable for stainless steel, it exceeded the limits for low carbon steel.

- When selecting tubing material, choose an appropriate option following manufacturer recommendations or consider using a suitable stainless steel material.

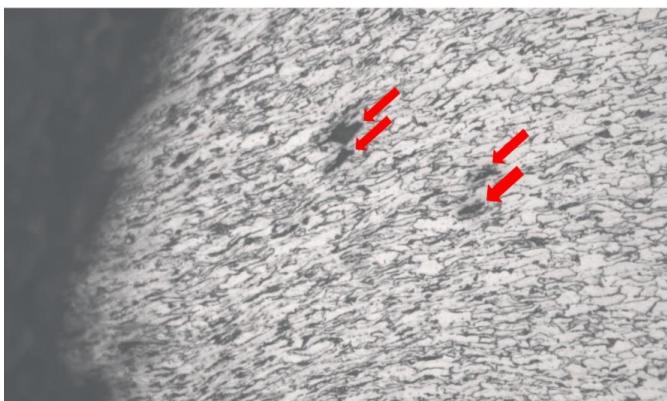
**Figure 9:** Elongated grains and the presence of some creep voids (pointed by red arrows) can also be seen. Etched with 2% Nital.

The photomicrograph in Figure 9, taken at the point of rupture, distinctly exhibits elongated grains adjacent to the fracture. Moreover, indications of creep voids are also noticeable. The presence of these microstructural features in proximity to the rupture strongly suggests the occurrence of an overheating phenomenon. The sample was further examined at higher magnifications using SEM. Elongated grains, micro cracks, and creep voids were observed (Figure 10 - 11). The SEM study confirmed the findings from optical microscopy. Regarding the un-deformed grain geometry (Figure 12) in the unaffected area, the grain shape near the fracture displayed an increase in aspect ratio. This suggests material flow under stress at elevated temperatures, leading to bulging and subsequent wall thinning.

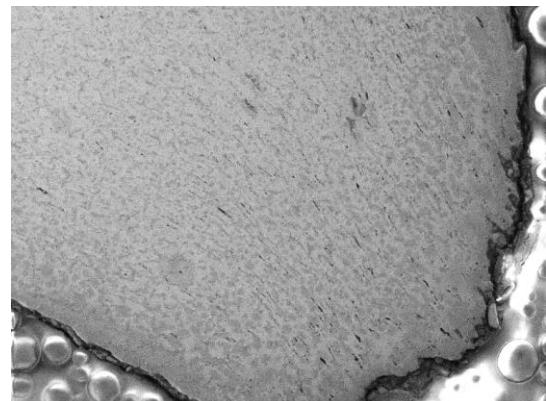
**Figure 10:** SEM image showing numerous creep voids (black spots in the material) close to the fracture.

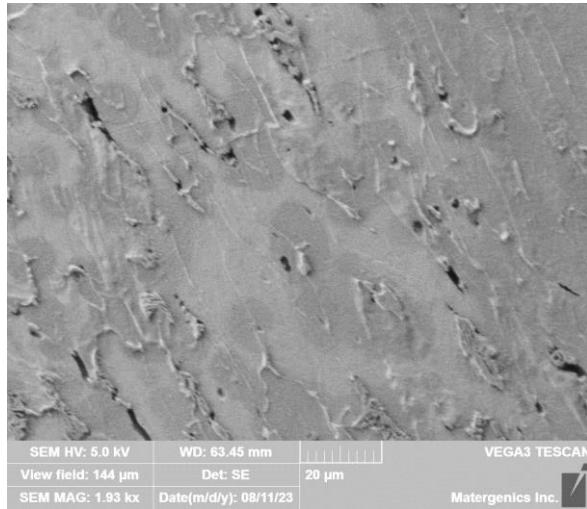
**Figure 11: SEM image showing elongated grains and the presence of some creep voids.**

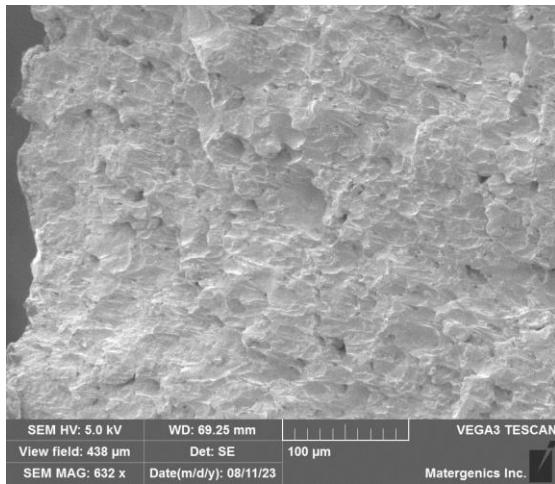
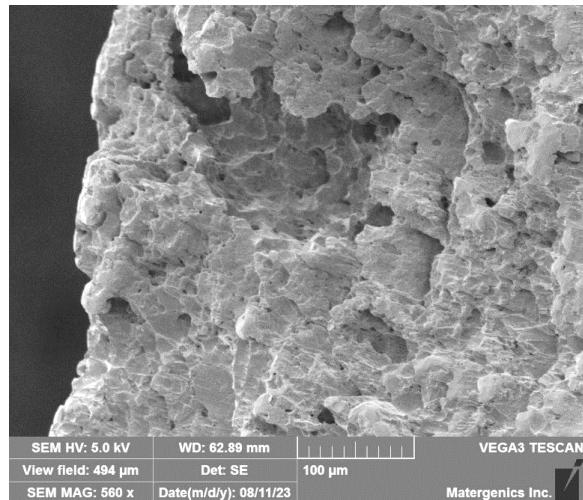
**Figure 13: SEM examination of the fracture surface revealed elongated dimples indicating ductile fracture.**

**Figure 14: SEM examination of the fracture surface revealed elongated dimples indicating ductile fracture.**

The oxides/deposits were removed from the fracture surface through ultrasonic cleaning in a soap solution. Following this, the fracture surface was examined using SEM. Figures 13 - 14, captured on the fracture surface after ultrasonic cleaning, unveiled characteristics of a dimple fracture. In SEM fractography, these dimples were identified as signs of material softening. The ductile fracture indicated that micro-voids had merged, leading to an overload failure. In such a scenario, creep deformation was accompanied by wall thinning through necking. This weakening of the alloy's strength resulted in dimple rupture. If the sole operating mechanism was creep, the failure would manifest as a thick-lipped fish mouth due to the absence of material flow or deformation to reduce wall thickness.

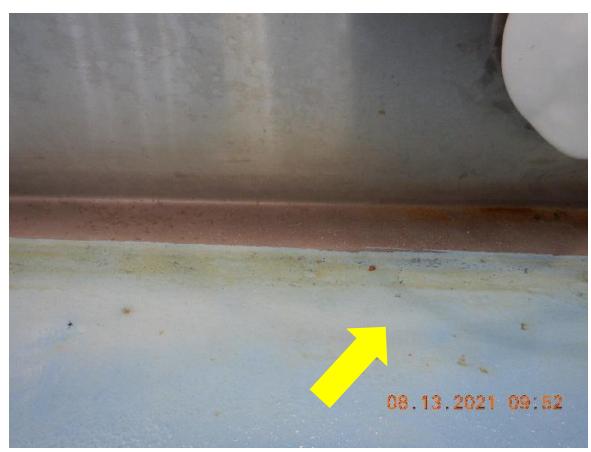
Figures 15 – 18 show images taken during the survey of the SS material. Potential survey showed anode C has higher potential compared to anodes A and B. The native potential of 304 stainless steel in the water is -0.309 V. The polarized potential of 304 stainless steel in the water is -0.755 V. A shift in potential values (difference between polarized and native potentials) of >350 V was observed. The condition of the uncoated SS frame, anodes, face rings of the LED lights, and the coating present on the SS frame bottom was checked in detail. Figure 19 shows the photograph of the coated SS material taken after draining the water. Staining was observed at the interface of the coating and the bare SS frame bottom. Irrespective of presence or absence of LED lights, staining was observed at almost entire interface i.e.,

periphery of the coating (Figures 20). However, the extent of staining is more at and around the locations where LED lights were present.

**Figure 20: Photograph showing the staining.**

- Connect light protectors to the LED niches.
- Avoid using anodes of different composition. Use anodes of the same material/alloy and from the same supplier to avoid mix-up of anode materials.
- The SS frame bottom should be properly coated without any pinholes. The adhesion of the coating to the SS frame should be strong.
  - The SS material present on the sides is not coated primarily due to esthetic purpose.
  - It is highly recommended that the SS material present on the sides should be coated with different color coating. This will reduce the amount of bare surface to be protected by sacrificial anodes.

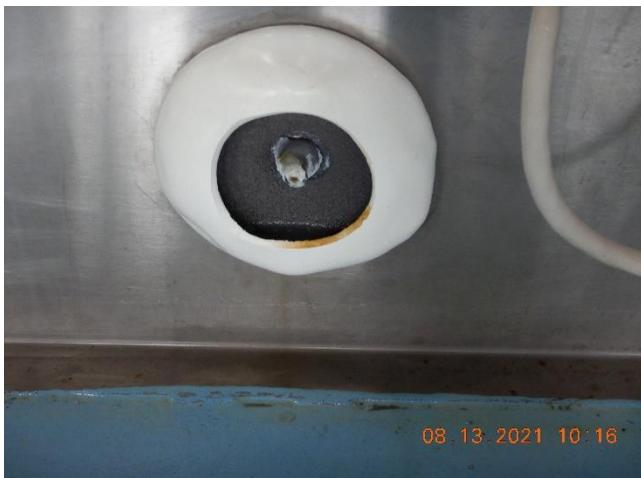
**Figure 21: Photograph showing the condition of anode 2.**

The condition of each anode was also checked. Interestingly, almost all anodes are noticeably consumed irrespective of presence or absence of LED lights near the anodes. Figure 21 shows the condition of Anode type A and Figure 22 shows the condition of Anode type B. The condition of remaining Anodes A and B are almost similar as shown in Figures 21 and 22. Figure 22 shows corrosion of SS frame at the contact area of anode 4. Anode 4 was detached, and visual examination was performed. Corrosion of SS frame where anode 4 was in contact with the frame is clearly evident. Closer examination has revealed noticeable pitting and general corrosion attack in the SS frame where anode was in contact with the frame (Figure 23). Further examination was conducted after detaching anode 3. Corrosion of SS frame where anode was in contact with the frame is clearly evident (Figure 24).

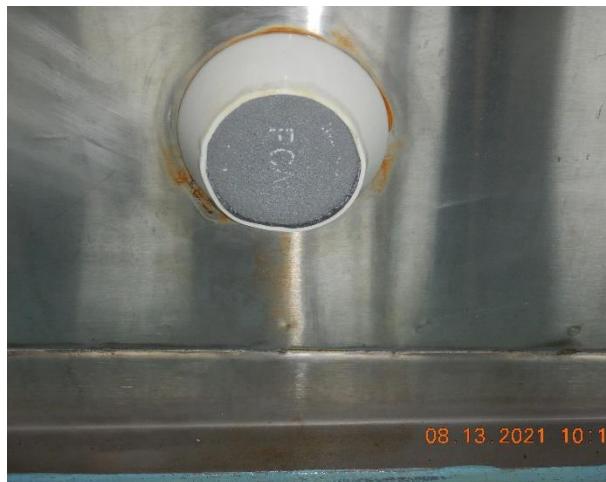
**Figure 22: Photograph showing the condition of anode 4. Corrosion of SS frame behind the anode 4 can be clearly seen.**

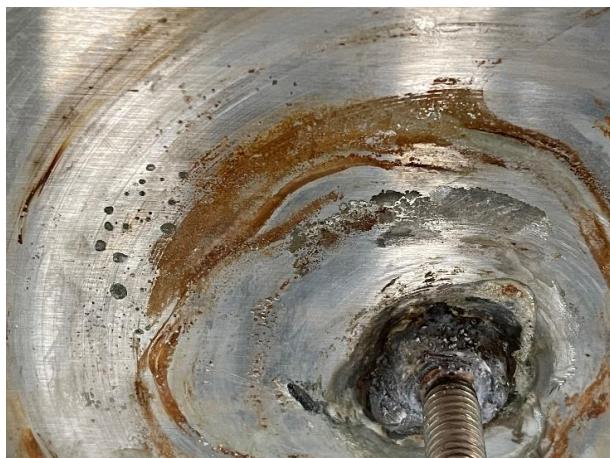
**Figure 23: Photograph showing the condition of SS frame where anode 4 was in contact with the frame. Corrosion of SS frame in contact with the rubber of the anode 4 can be clearly seen.**

Corrosion of SS frame at the contact area of anodes indicate that the rubber present around the anodes is in contact with the SS frame and it is shielding CP current from entering the contact area and resulting in the corrosion at the contact areas of anodes. It is recommended that the rubber around the anodes should be removed. However, as the rubber is firmly adhered to the anodes, it is recommended to leave a gap such that rubber is not in contact with the SS frame.

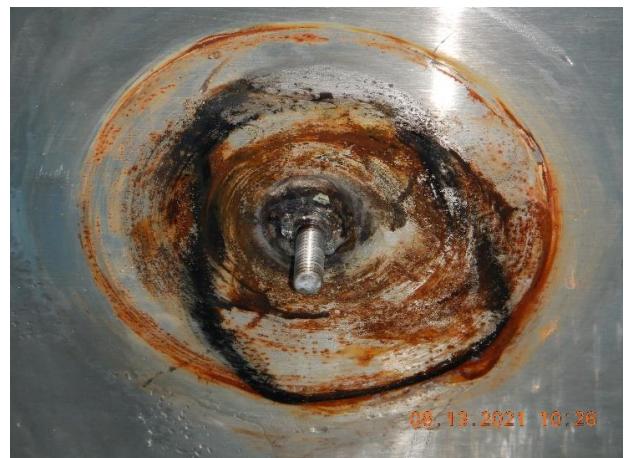
**Figure 24: Photograph showing the condition of SS frame where anode 3 was in contact with the frame. Corrosion of SS frame in contact with the rubber of the anode 3 can be clearly seen.**

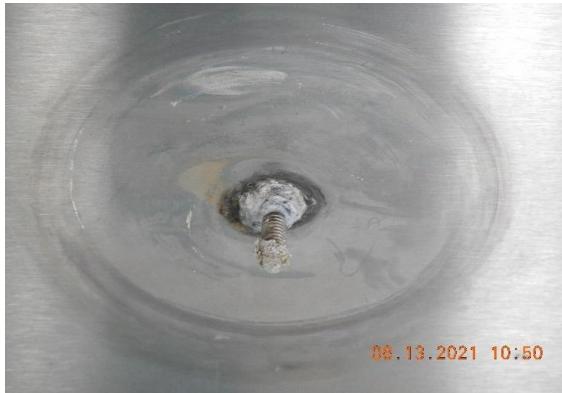
During visual examination, it was observed that the SS bolts welded to the SS frame has white deposits (Figure 25) and rust (Figure 26). Presence of deposits or corrosion products on the SS bolts will make detaching old anodes and installing new anodes very difficult. The rust seen on the SS bolt is from the anode lug, and it is seeping into the water and settling at the floor and at the periphery of the coating.

**Figure 25: Photograph showing the condition of SS bolt welded to the frame. Anode 6 is bolted at this location. White deposits can be clearly seen.**

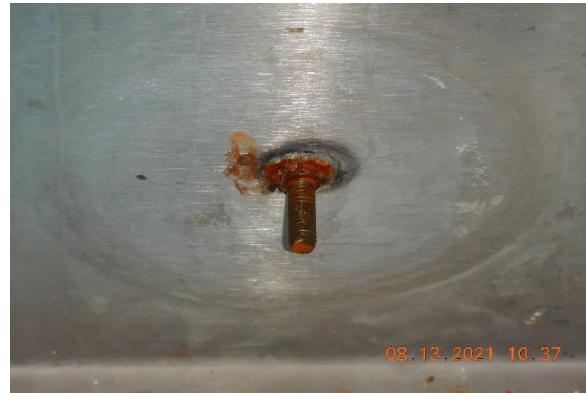
**Figure 26: Photograph showing the condition of SS bolt welded to the frame. Anode 22 is bolted at this location. Presence of rust can be clearly seen.**

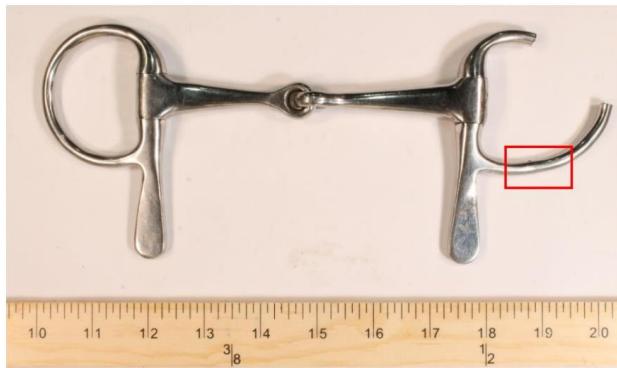
A failed SS304 bit is shown in Figure 27. Closer examination of the bit has revealed multiple cracks far away from the fracture area. Stereoscopic examination of the failed bit has revealed multiple cracks that were not visible to the naked eye (Figure 28). The observed cracks were travelling all along the circumference and not in the axial direction. Figure 29 illustrates EDS test results of the corrosion products present on the fracture surface. From EDS test results, it is evident that Sodium (Na) & Chlorine (Cl) are present in noticeable amounts.

Figure 27: Photograph showing failed bit.

Based on the analysis's conclusion, it's crucial to use high-quality, corrosion-resistant materials in bit production to prevent future failures. Additionally, addressing the impact of chlorides, possibly through specialized coatings or suitable materials, is essential to enhance durability, safety, and performance.

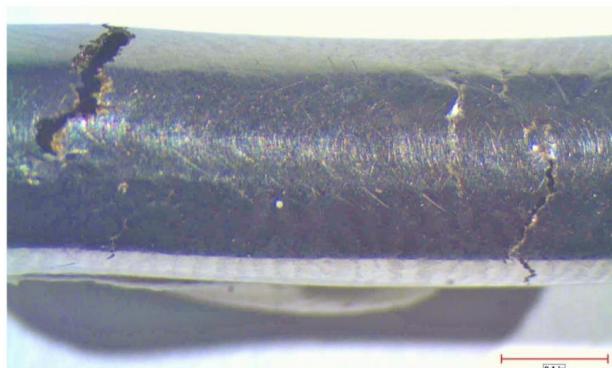
Figure 28: Closer view of the region highlighted in the red box, as shown in figure 27, showing numerous additional cracks other than the visible crack. 7X

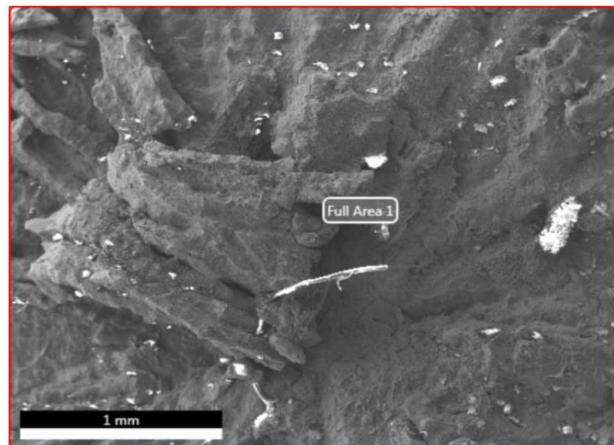
Figure 29: EDS data taken on the fracture surface clearly showing presence of Na, and Cl along with other metal constituents.

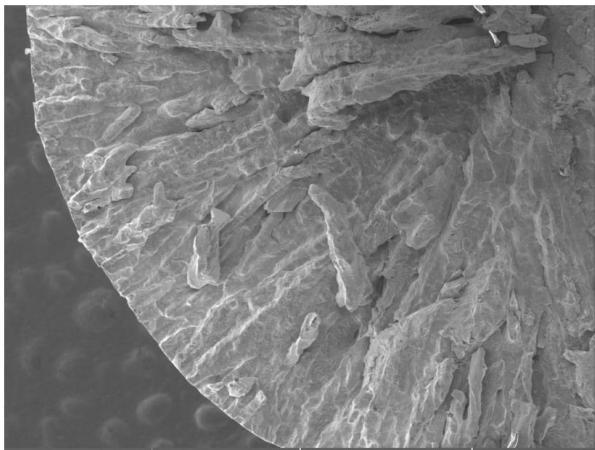
SEM examination of the fracture surface has revealed that the fracture is predominantly intergranular (Figures 30). However, some transgranular fracture was also noticed on the fracture surface but negligible when compared to intergranular fracture region (Figure 31). Microexamination has revealed presence of both surface and sub-surface intergranular cracks (Figure 32). Microexamination after etching with 60%  $\text{HNO}_3$  & 40%  $\text{H}_2\text{O}$  has revealed that the cracking is predominantly intergranular but transgranular with branching pattern at the tip of the crack (Figure 33).

**Figure 30: SEM image of the fracture surface showing intergranular fracture.**

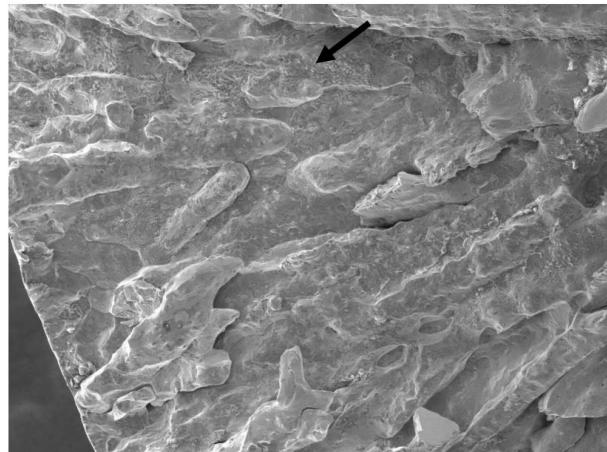
**Figure 31: SEM image of the fracture surface showing predominantly intergranular fracture. Faint indications of transgranular fracture (black arrow) are also noticed.**

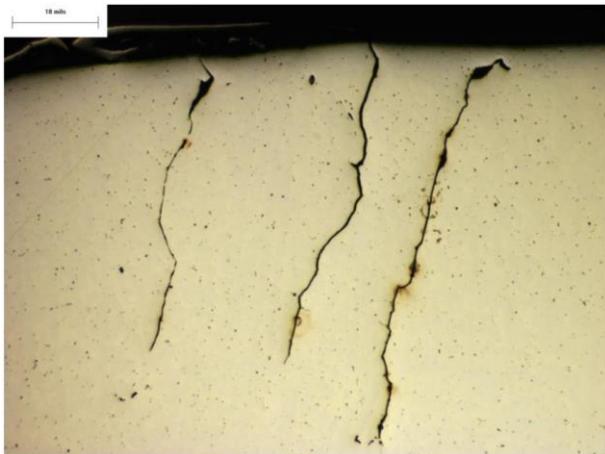
**Figure 32: Photomicrograph showing intergranular cracks at the surface. 50X. As polished condition.**

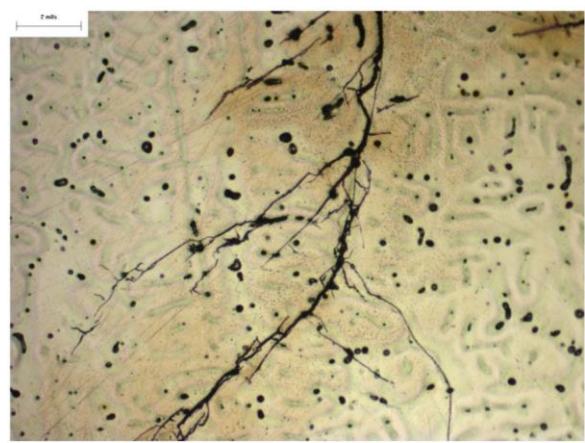
**Figure 33: Photomicrograph showing branching pattern of the crack typical of SCC. 200X. Etched with 60% HNO<sub>3</sub> & 40% H<sub>2</sub>O**

In conclusion, the leading factor behind the bit's failure can be ascribed to subpar material quality. Consequently, the progression of cracks was exacerbated by the presence of chlorides. This interaction led to the development of cracks with a branching pattern characteristic of stress corrosion cracking (SCC), representing a secondary contributing factor to the failure.
