**Metal, Moisture, And Mystery:**

**The Curious Case of The Corroding phone Charger Pin**

Anil Kumar Chikkam  
Matergenics Inc  
100 Business Center Dr  
Pittsburgh, PA, 15205  
USA

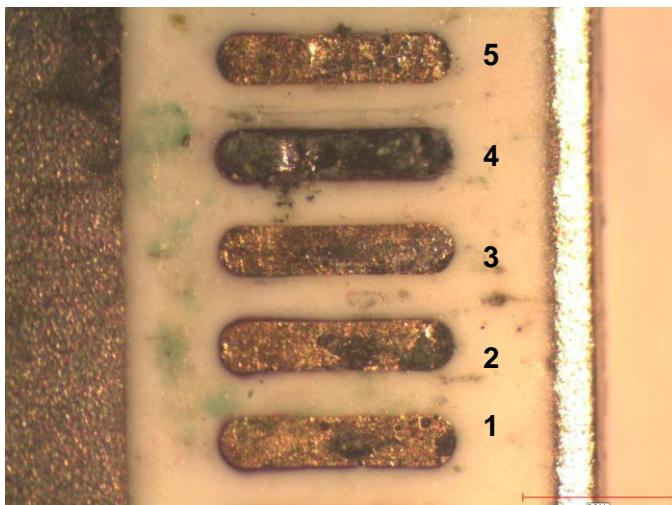
To ascertain the details of this apparent damage, a thorough examination of the corroded pins was undertaken using a stereoscopic microscope. Figure 1 presents a clear visualization of the corrosion on the fourth pin on side 1. This image starkly highlights the contrast between the corroded pin and its undamaged counterparts, revealing the significant wear and tear it has undergone. This figure underscores the evident corrosion, reinforcing the initial visual assessment.

**Figure 1: Stereoscope image showing that the fourth pin has corroded compared to the remaining pins (side 1). 25X**

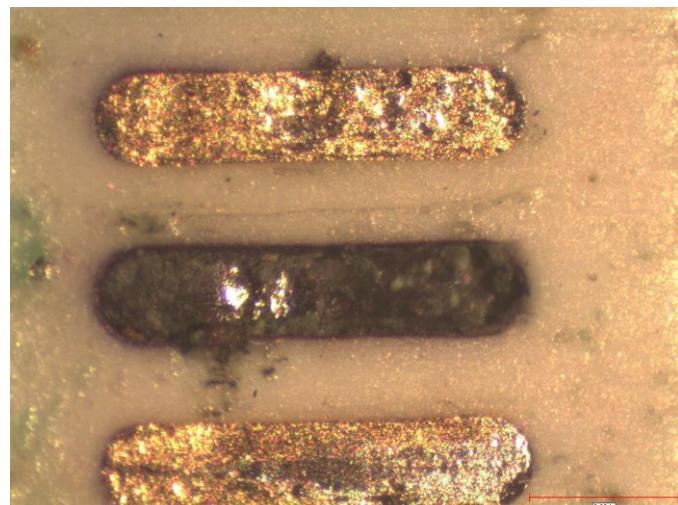
A closer inspection, as illustrated in Figure 2, provides an in-depth view of the corroded pin. This closer perspective uncovers a profound groove in the pin, suggesting the possible complete erosion of the material at this specific point due to extensive corrosion. This finding points towards the potential compromise in the functionality of the charger due to the damage to this pin.

**Figure 2: Closer view of fourth pin (side 1). 45X**

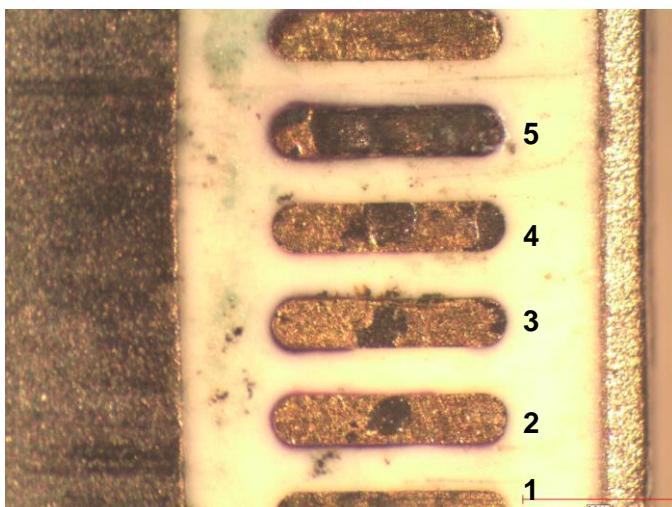
Similarly, observations and examinations were extended to side 2 of the charger. As with the previous observations, noticeable corrosion was found on the fifth pin, as documented in Figures 3 and 4. The images capture the evident damage to the pin, mirroring the corrosion found on side 1, and further solidifying the conclusions drawn from the examinations conducted.

**Figure 3: Stereoscope image showing that the fifth pin has corroded compared to the remaining pins (side 2). 25X**

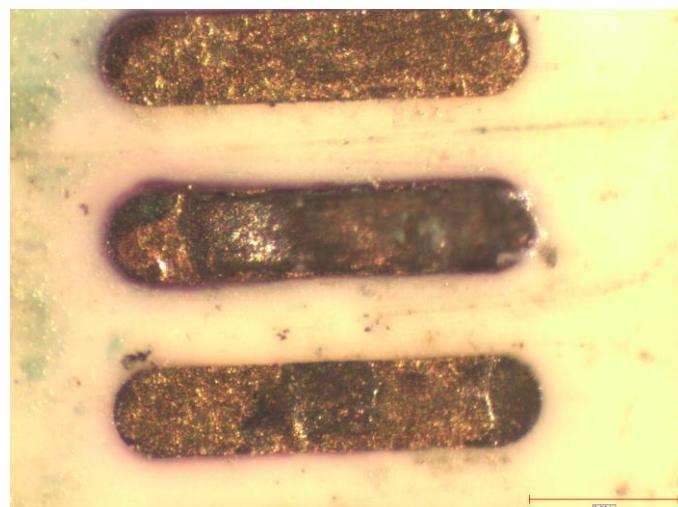
**Figure 4: Closer view of fifth pin (side 2). 45X**

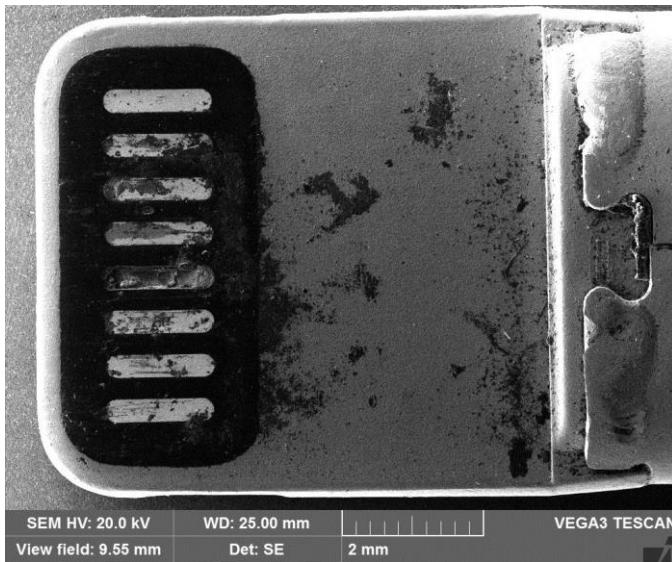
As shown in Figure 5, the SEM images provided a clear and enhanced view of the fourth pin, affirming the visible corrosion observed earlier. The highly magnified image accentuated the corroded surface, adding concrete visual evidence to support the initial observations.

**Figure 5: SEM image showing that the fourth pin has corroded compared to the remaining pins (side 1).**

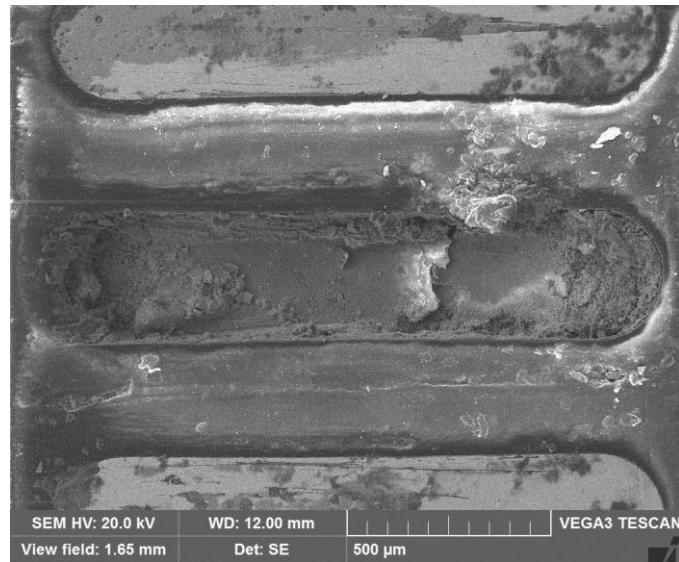
Figure 6 further solidifies these findings. The SEM images vividly captured the extent of the damage to pin 4, confirming the total erosion of the material at this specific location. The advanced imaging allowed for a conclusive determination, evidencing the complete degradation due to the relentless corrosion.

**Figure 6: Closer view of fourth pin (side 1).**

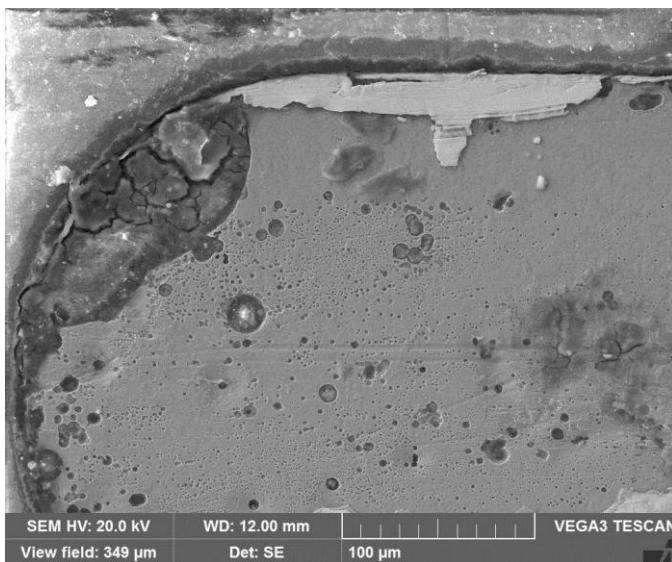
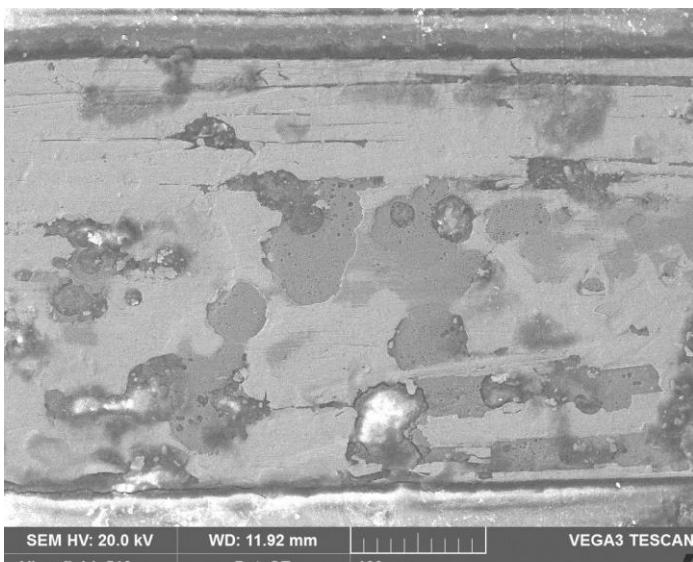
Despite the remaining pins appearing intact and uncorroded during the initial visual examinations, the SEM analysis brought forth unexpected findings. Figures 7 and 8 unveil that the coating on these pins had been eliminated, laying bare the underlying substrate which was in the process of corroding. This revelation, possible only under the high magnification and detailed imaging of SEM, emphasizes the deceptive extent of the corrosion. Even seemingly undamaged pins were undergoing a corrosive process.

**Figure 7: SEM image showing that the coating on the fifth pin is removed, and the underlying substrate started corroding.**

**Figure 8: SEM image showing that the coating on the third pin is removed, and the underlying substrate started corroding.**

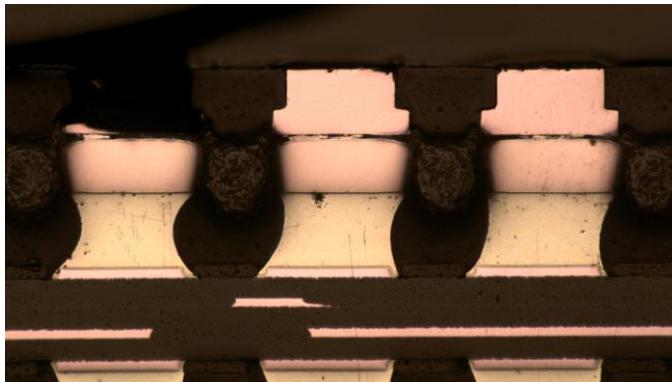
Upon examining the etched cross-sections under an optical microscope, critical observations were made. Figure 9, captured at the corroded pin, provides a definitive view of the complete corrosion of the copper material. This image starkly highlights the extensive damage, underscoring the severity of the corrosion. A closer microscopic inspection, as shown in Figure 10, provides further revelations. Even the pin that appeared relatively unaffected to the naked eye was found to have undergone corrosion of the copper substrate. Additionally, this examination uncovered the presence of three distinct coating layers enveloping the copper substrate, providing further insights into the pin's construction and potential vulnerability to corrosion.

**Figure 9: Photomicrograph showing that the fourth pin top copper material is totally corroded. Magnification: 50X**

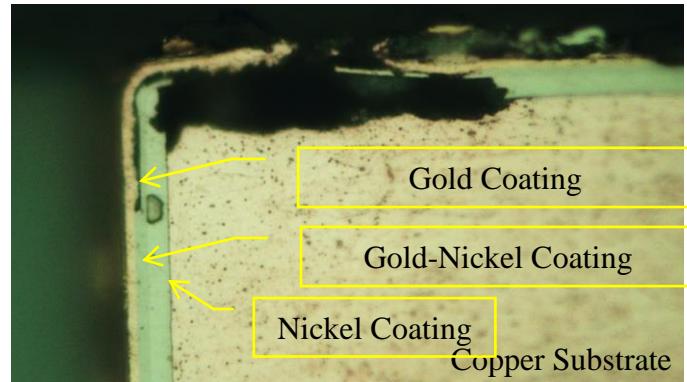
**Figure 10: Photomicrograph of the unaffected pin to the naked eye also showed signs of corrosion. Magnification: 1000X**

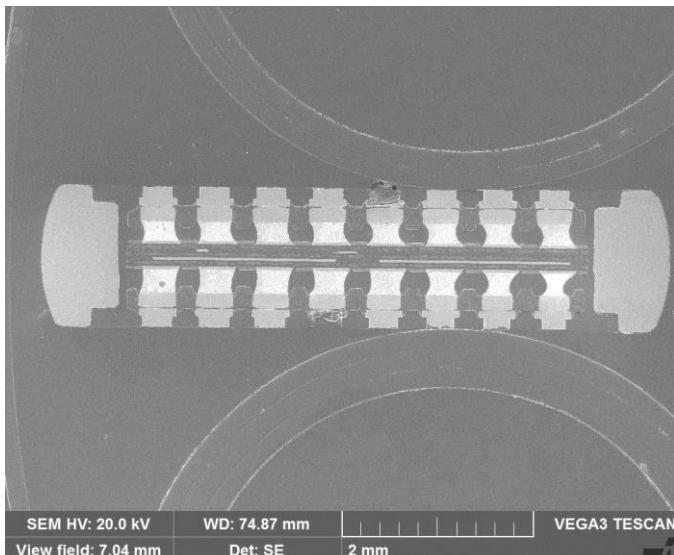
Following the completion of the optical microscopic examination, the cross-sections were subjected to further in-depth scrutiny using SEM. Figure 15 provides a comprehensive SEM visualization of all the pins from the corroded charger. This broad view captures the overall state of each pin, offering a holistic perspective of the damage and condition of the entire set.

**Figure 15: SEM image showing comprehensive visualization of all the pins from the corroded charger.**

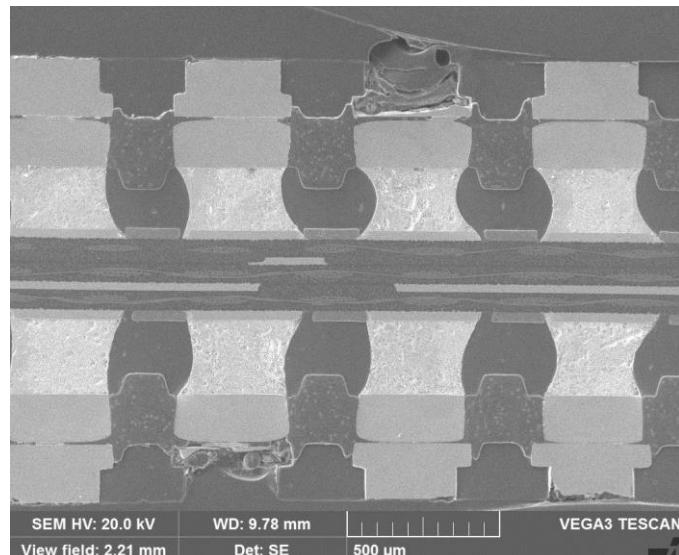
Moving into a more detailed analysis, Figure 16 is a focused SEM image specifically taken at the location of the corroded pins. This high-magnification image offers a stark and clear representation of the severe corrosion affecting the copper material. The SEM technology reveals the depth, spread, and intensity of the corrosion, presenting a comprehensive picture of the damage endured by the pins.

**Figure 16: SEM image specifically taken at the location of the corroded pins.**

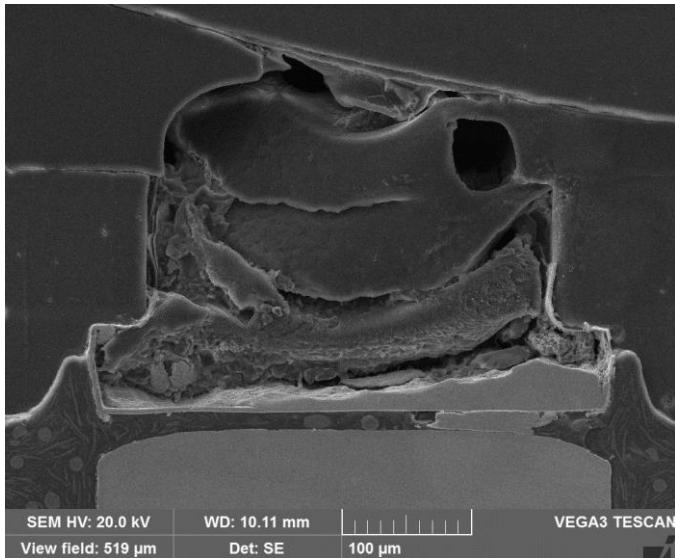
Figure 17 provides an even more magnified examination of the corroded pin, accentuating the details of the corrosion damage. The degradation of the copper material is prominently showcased, providing profound insights into the nature and extent of the damage.

**Figure 17: SEM image clearly showing that the copper material of the pin is totally corroded.**

One of the paramount discoveries stemming from the EDS analysis pertains to the corroded pin's composition. The data indicates a pronounced concentration of both carbon and oxygen within certain deposits on the corroded pin. This elevated presence of carbon and oxygen suggests a noteworthy phenomenon. It raises the possibility of an electrical spark gap occurring between the phone charger pin and its corresponding mating pin on the phone.

The spark, due to its high temperature, could cause localized heating leading to the decomposition of any organic material present, producing carbon. Now, when such sparks are continuous or frequent, they can lead to degradation of the material. Over time, the constant high-temperature sparks cause wear and material loss. The carbon and oxygen-rich deposits can further act as sites for corrosion, especially in the presence of moisture, leading to accelerated degradation of the pin.

- The Spark Gap Factor:** The fourth pin's specific susceptibility to the effects of spark gaps is of paramount importance. When spark gaps occur, they can lead to localized high-temperature events, producing micro-environments of rapid heating and subsequent cooling. This can result in material modifications, potential micro-cracks, and localized deposits, especially of carbon and oxygen.

- The three-layer coating, while effective to an extent, may need reinforcement. Consider the application of additional or thicker protective layers, especially focused on the fourth pin which seems more susceptible to degradation.
- Investigate coatings designed to withstand high-temperature fluctuations, reducing the risk from spark gaps.

- Given that the fourth pin exhibits a unique vulnerability to spark gaps and subsequent corrosion, it's crucial to re-examine its design and positioning. There might be an inherent design flaw that predisposes it to these vulnerabilities.

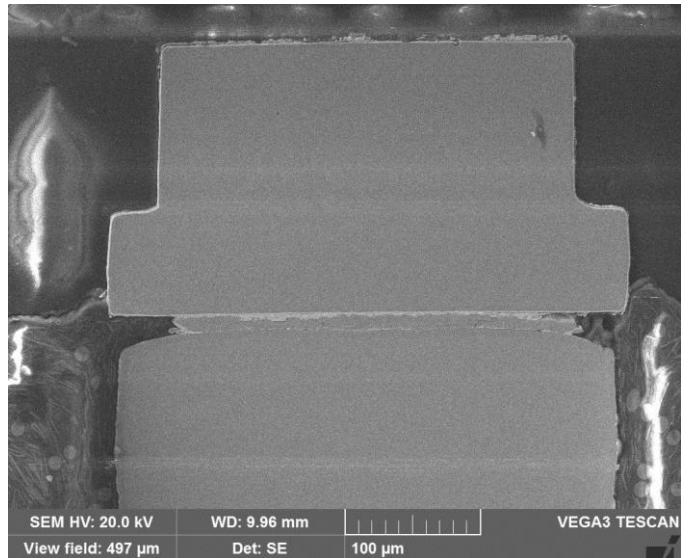
In contrast, Figure 18 displays the SEM image of a pin that was relatively unaffected, or at least less visibly damaged, when compared to the corroded ones. This image serves as a benchmark for comparison, emphasizing the difference in structural integrity, surface quality, and overall health of the pins. By juxtaposing the corroded and unaffected pins, a clear and undeniable contrast emerges, highlighting the disparity between the two states.

**Figure 18: SEM image of a pin that was relatively unaffected.**
