**Field Metallography and Replication on Liquefied Natural Gas Assets:
Non-Destructive Metallurgical Testing to complement other regular
Non-Destructive Tests**

This paper provides case studies of materials in Natural Gas Processing facility where FMR was used as an NDT tool without sectioning the component. This paper discusses the damage mechanisms such as sigma phase embrittlement, stress relaxation cracking and creep.

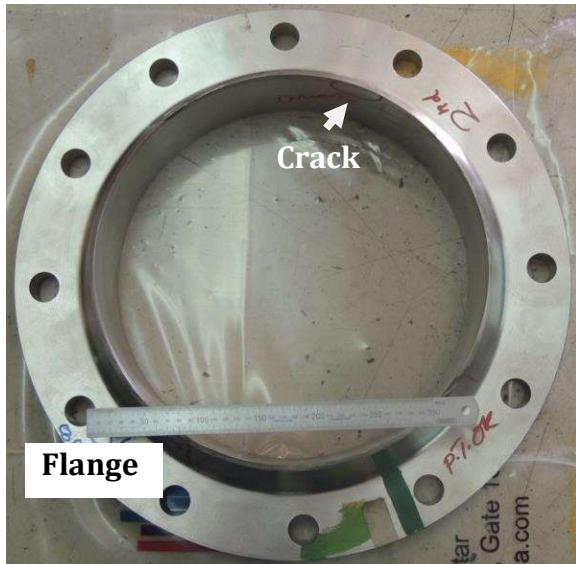
Figure 1 shows the condition of the flange. Visual examination has revealed a crack emanating from the weld and propagating into the flange material. No evidence of cracks in the pipe material. Pipe was detached from the flange and the weld metal was gouged (Figure 2). Dye penetrant testing (DPT) was performed to verify the presence of undetected defects at the inner & outer surface of the flange (Figure 3). The test did not reveal any other significant defects on the surface except for the indication of the visible crack itself (Figure 4).

Figure 1: Photograph showing the flange with a crack.

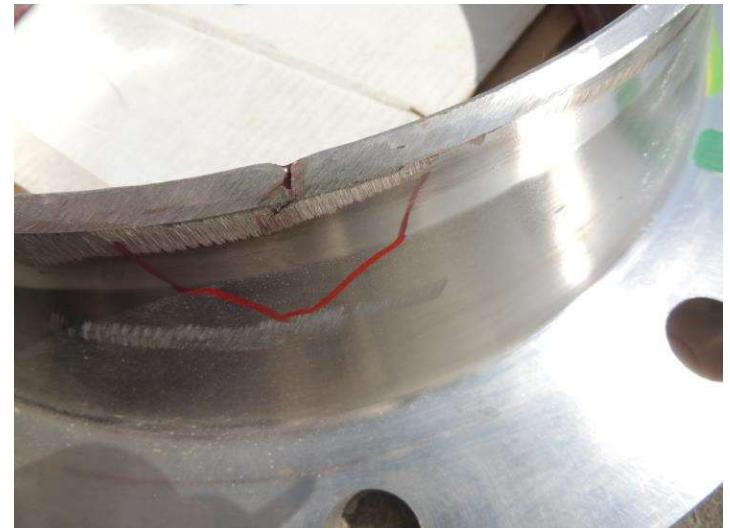
Figure 2: Photograph showing crack in the bevel of the flange.

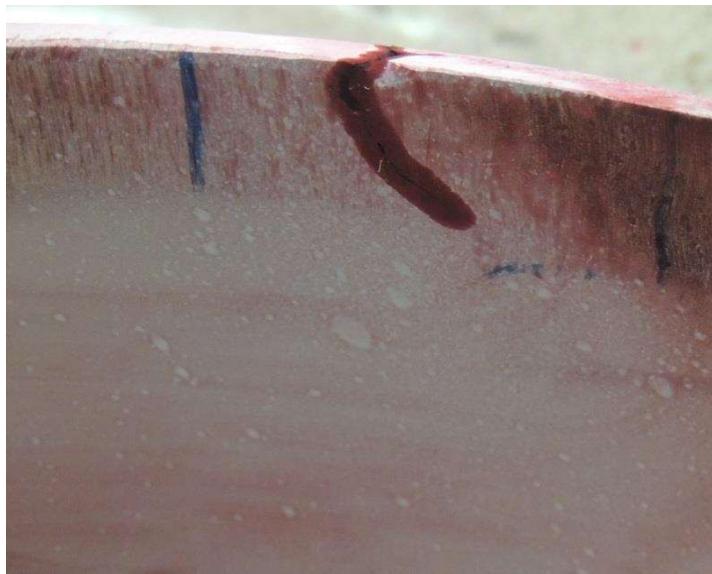
Figure 3: DPT of the as received flange on the inner surface.

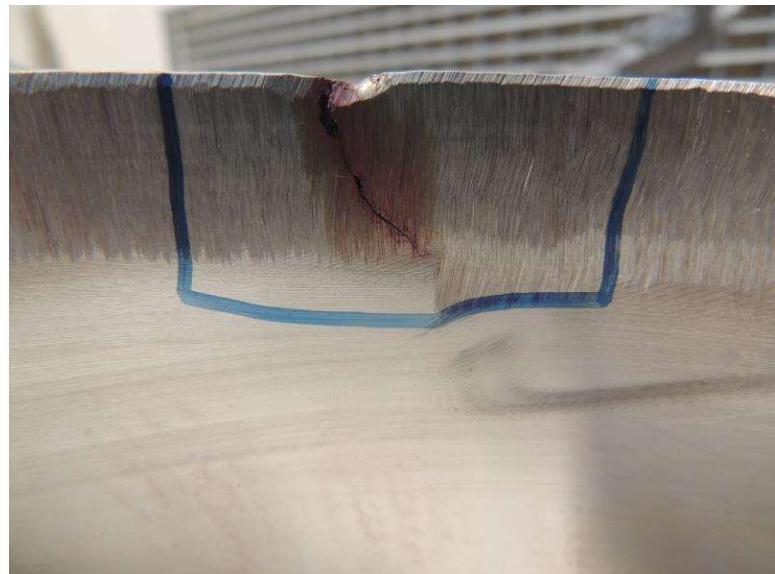
Figure 4: No other defects were observed other than the visible crack.

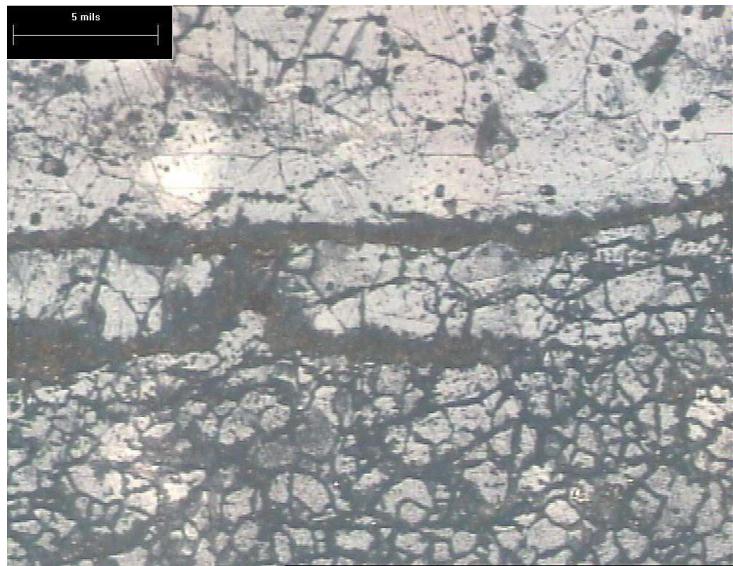
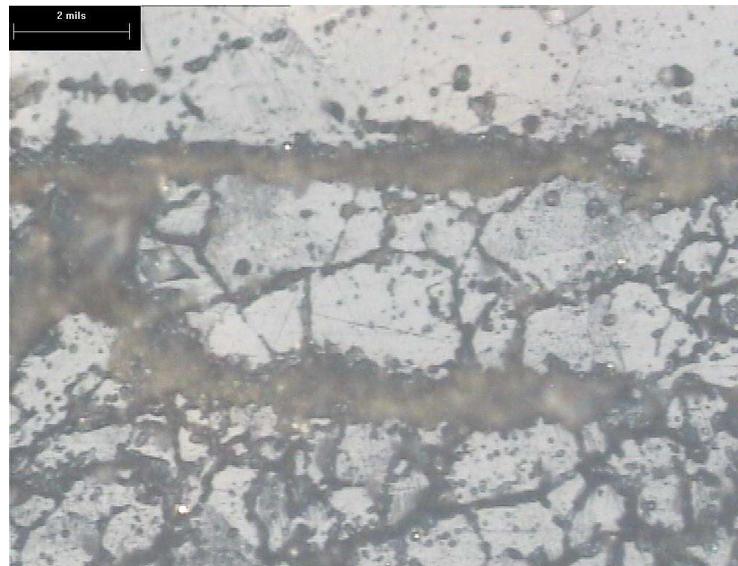
Figures 5 and 6 show that the microstructure around the cracks consist of sigma phase at austenite grain boundaries (GB). Sigma phase is the main particle precipitated at austenite grain boundaries in S31254 stainless steel during solution treatment from 950 - 1150 °C.⁴ Chemical analysis test results showed that carbon content of the flange is <0.01 wt%, so possibility of sensitization is not possible.

From the combined test results of in-situ testing and laboratory investigation, it is evident that sigma phase is present in the flange material. Inappropriate heat treatment is the reason for the quantity and type of deleterious phases existing in the flange material. Appropriate heat treatment and controlled chemical composition organize the phases in the material.

Figure 5: Photomicrograph showing cracks, distributed sigma islets and network of highly sensitized grains. Magnification: 100X

Figure 6: Closer view of Figure 5. Magnification: 200X

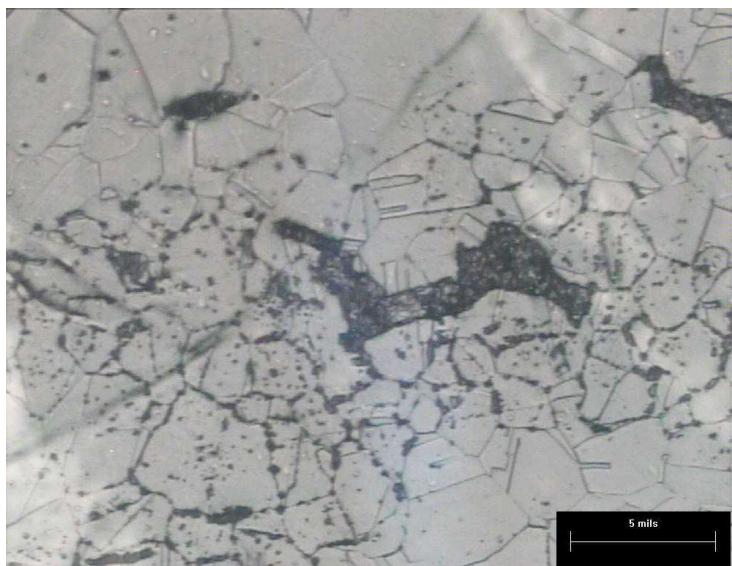
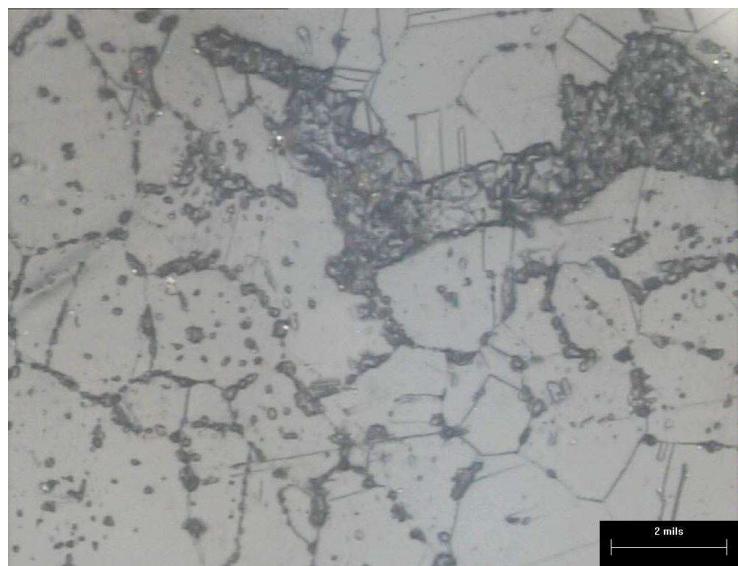
SMO flanges of other sizes were also checked for the presence of the sigma phase to determine the fitness for service capability of the flange material. Replica was taken at the inner surface (Figures 7 and 8) of the 24 inch (60.96 cm) diameter flange. Microstructure consists of equiaxed austenite grains with presence of sigma phase along grain boundaries and sensitized grains. Replica was also taken on the bevel (Figures 9 and 10) and the

Figure 7: Photomicrograph showing equiaxed austenite grains with presence of sigma phase along grain boundaries. Magnification: 100X

Figure 8: Closer view of Figure 7. Magnification: 200X

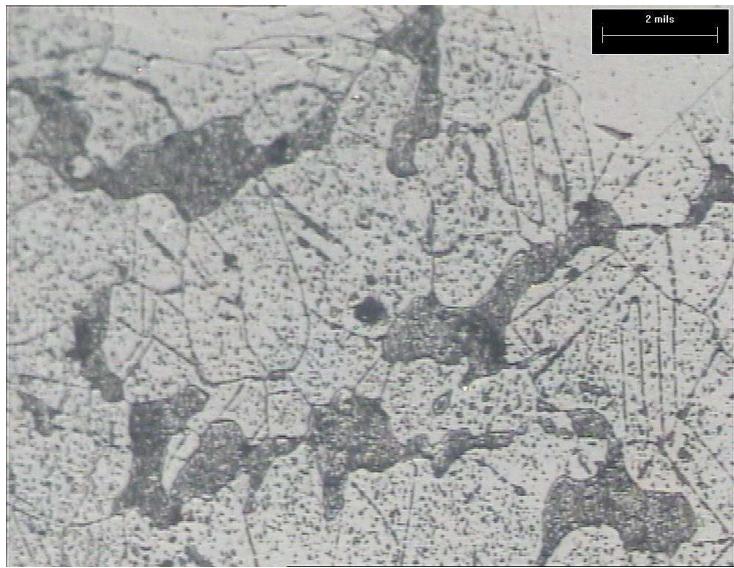
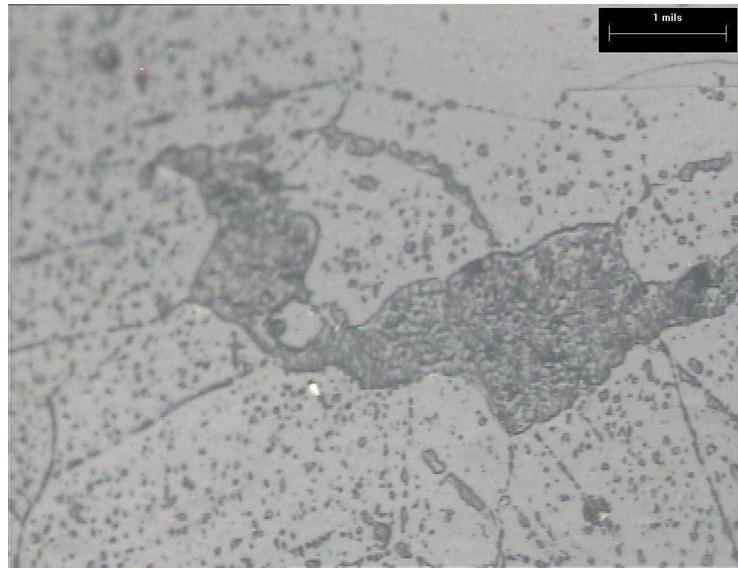
Figure 9: Photomicrograph showing equiaxed austenite grains with presence of sigma phase along grain boundaries. Magnification: 200X

Figure 10: Closer view of Figure 9. Magnification: 500X

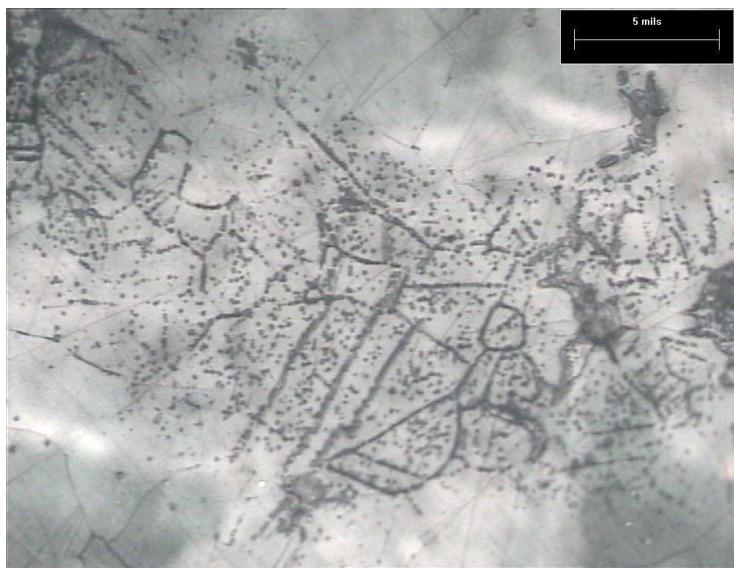
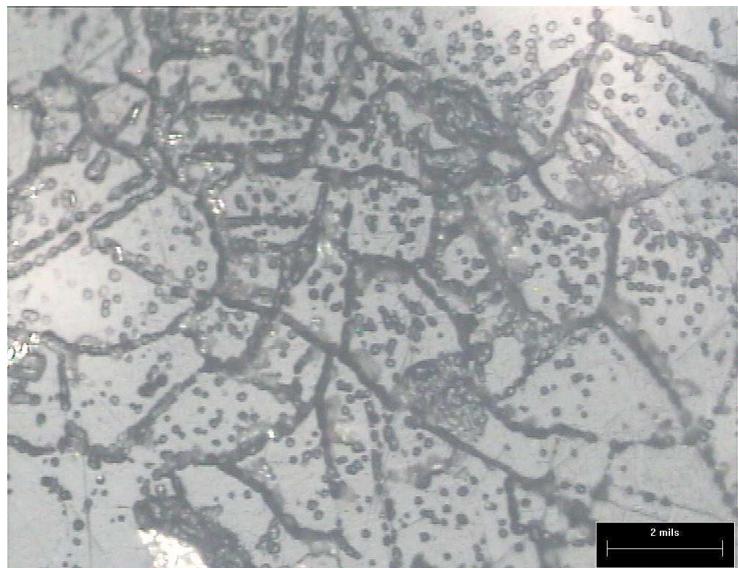
neck (Figures 11 and 12) of the 8 inch (20.32 cm) diameter flange. Observed microstructure is similar to the ones observed in 14 inch (35.56 cm) and 24 inch (60.96 cm) diameter flanges. Figures 13 and 14 show equiaxed austenitic structure that is free from sigma phase and sensitization; a typical microstructure.

Figure 11: Photomicrograph showing equiaxed austenite grains with presence of sigma phase along grain boundaries. Magnification: 100X

Figure 12: Closer view of Figure 11. Magnification: 200X

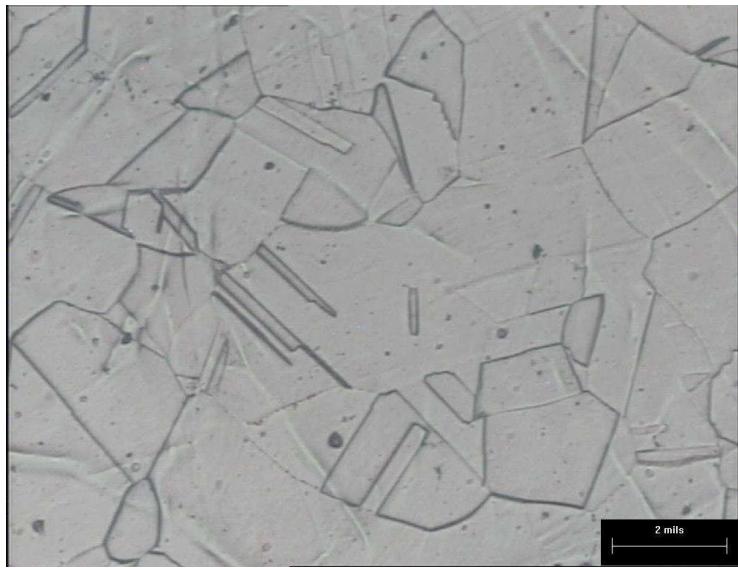
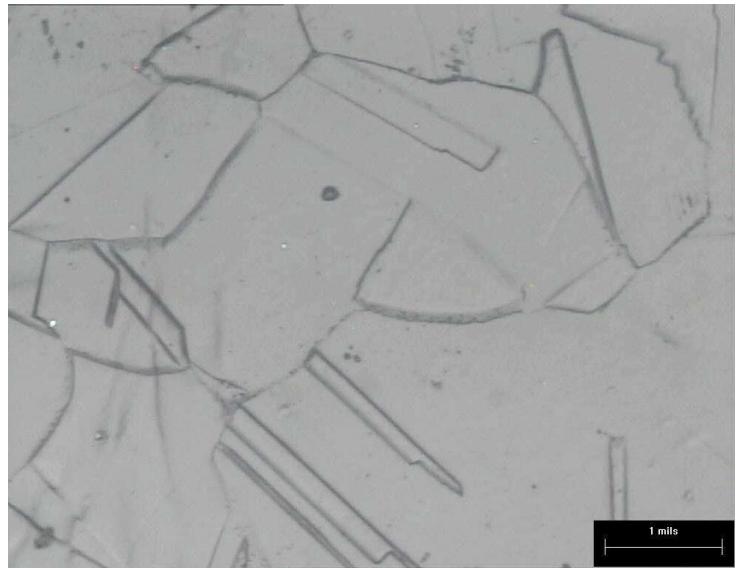
Figure 13: Photomicrograph showing equiaxed austenite grains. Magnification: 200X

Figure 14: Closer view of Figure 13. Magnification: 500X

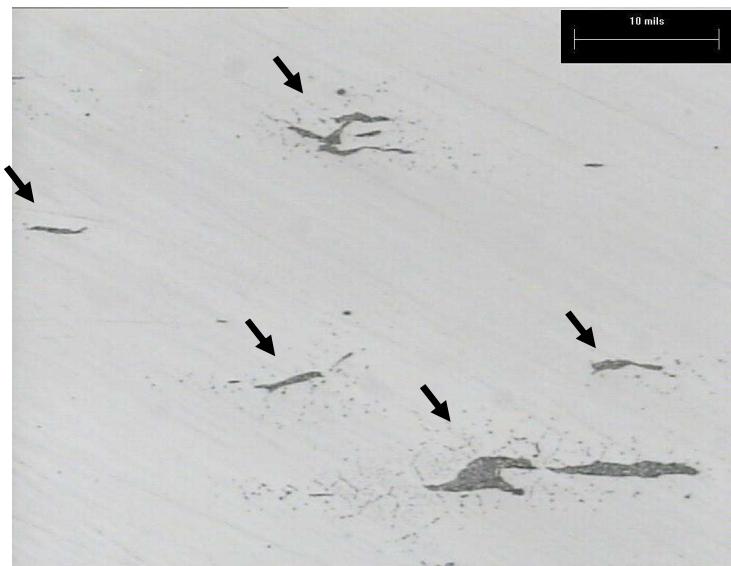
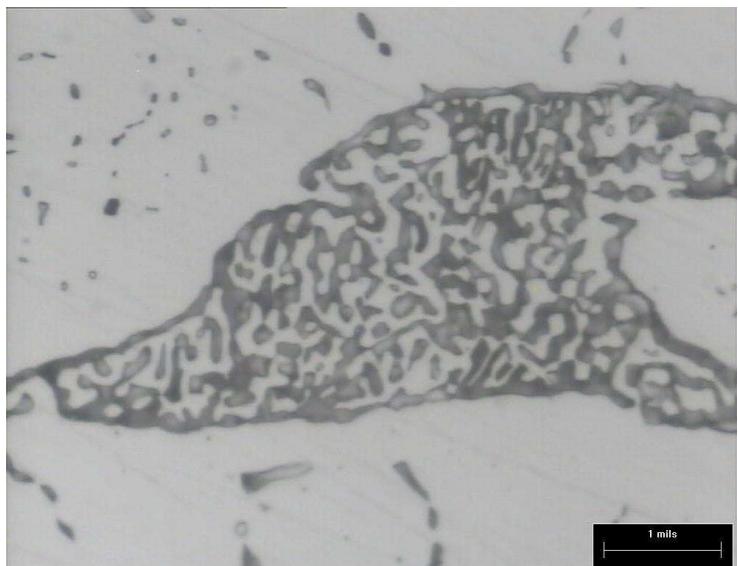
Microexamination of the two cross-sections revealed sigma phases which suggest that the material is not properly heat treated.

Figure 15: Optical micrograph shows presence of sigma phases indicated by arrows. Magnification: 50X. Electrolytic Etched with Marble's reagent for 10 secs.

Figure 16: Closer view of the sigma phase shown in Figure 15. Magnification: 500X. Electrolytic Etched with Marble's reagent for 10 secs.

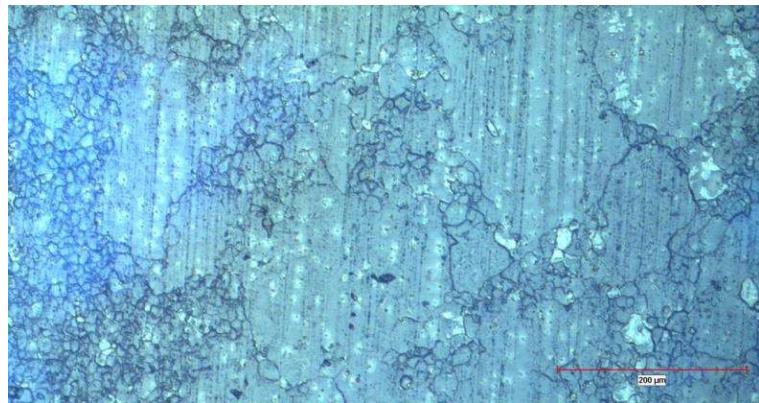
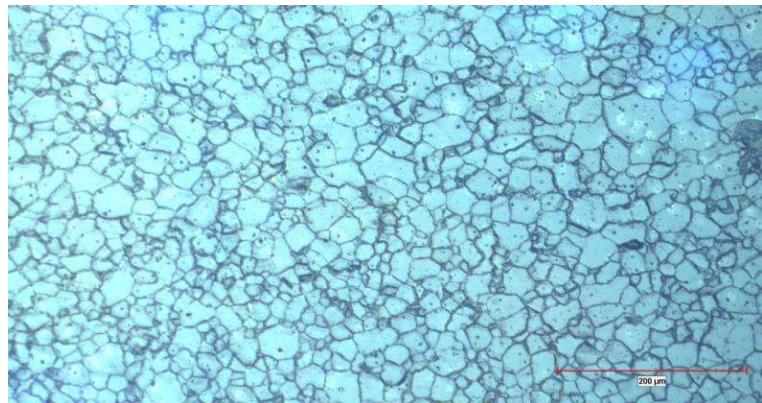
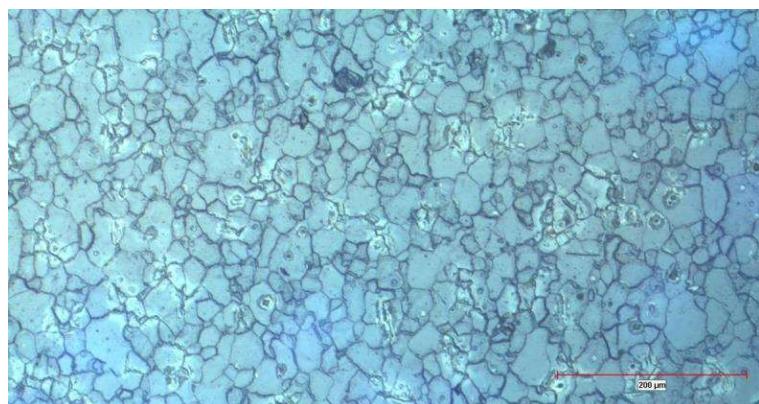
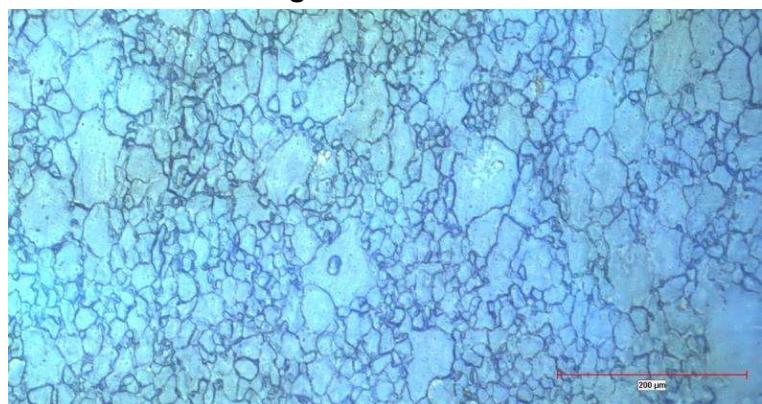
In-situ metallography and replication revealed that the microstructure of the tube is not uniform (Figures 17 – 20). General microstructure of ASME SA-213 Grade T11 (UNS K11597) super heater tube consists of ferrite and pearlite. However, only ferrite phase was observed with some evidences of carbides at the grain boundaries. The microstructure along the tube OD was mostly decarburized and grain coarsening was also observed.

Figure 17: The microstructure is mostly decarburized. Grain coarsening can be clearly seen. Magnification: 200X

Figure 18: The microstructure is mostly decarburized. No evidence of pearlite in the examined area. Magnification: 200X

Figure 19: The microstructure is mostly decarburized. No evidence of pearlite in the examined area. Magnification: 200X

Figure 20: The microstructure is mostly decarburized. Grain coarsening can be clearly seen. Magnification: 200X

FMR findings indicate that the super heater tubes are overheated. As a proactive measure, the following steps as a part of condition assessment of the super heater tubes is recommended to be performed annually or semi-annually: 1) visual inspection with photo documentation, 2) oxide thickness measurements using ultrasonic or eddy current units, if possible 3) wall thickness measurements using ultrasonic thickness gage, 4) Dye penetrant testing, 5) hardness testing using portable hardness tester and 6) FMR at the same spots.

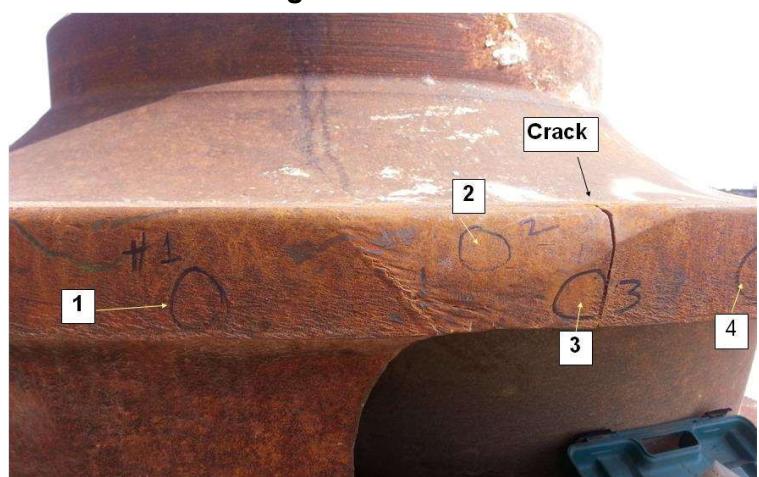
Visual examination of the impeller revealed that the crack was present at the hub (Figure 21). It was observed that the material was gouged at this location (as received condition) and the crack is restricted only to the gouged location. Four locations around the crack were considered for in-situ metallography. The selected location was ground and polished to 1 μm surface finish and examined under portable field microscope to ensure that surface is free from scratches and replicas can be taken from the polished area. Then, the polished area was etched with Nital for 30 seconds. The etched region was examined under portable field microscope to ensure that microstructure is revealed. If microstructure is not revealed repeat the etching step for another 30 seconds. One side of the replica film was wetted with acetone and the wetted side was placed on the etched surface. The film was pressed against the surface for 30 seconds. The film was allowed to dry for 15 minutes. After the replica film was dried, the film was removed, and the other side was adhered to the glass slide for subsequent microscopy.

Figure 21: Photograph of the impeller.

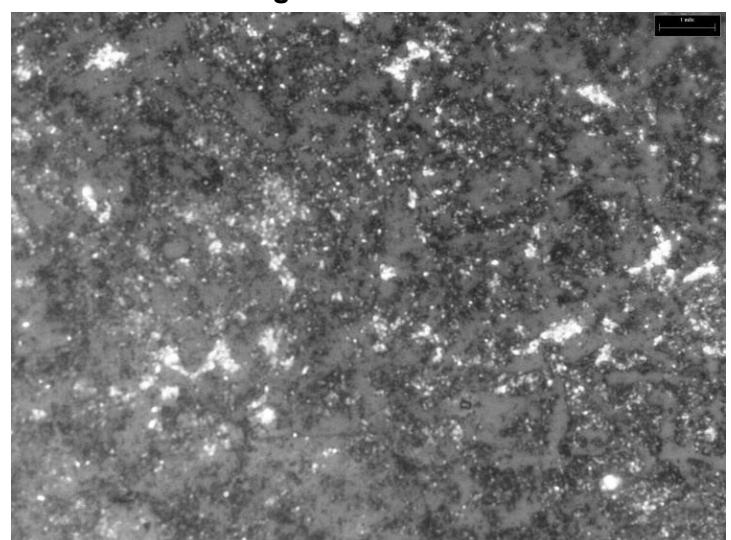
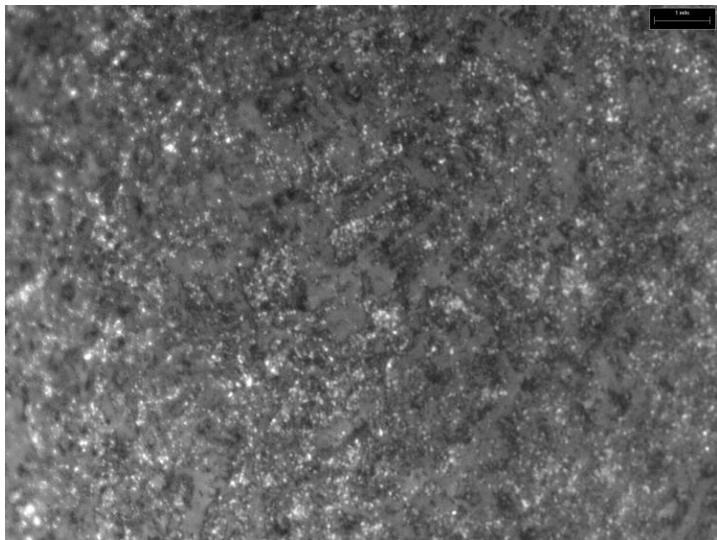
Figures 22 and 23 of the replicas 1 and 4 taken on the either side of the crack (at a distance of more than 100mm) has revealed that the base material has tempered martensitic structure typically seen in quenched and tempered carbon steels. Further examination also revealed retained austenite in the examined areas.

Figure 22: Replica taken at location 1 shows tempered martensite (dark phase) and retained austenite (bright spots). Magnification: 500X

Figure 23: Replica taken at location 4 shows tempered martensite (dark phase) and retained austenite (bright spots). Magnification: 500X

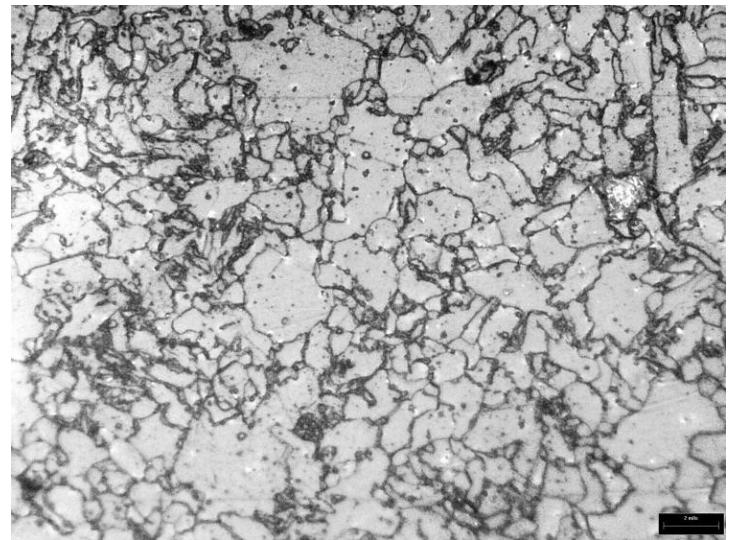
Replicas 2 and 3 were taken in the gouged location. Optical microscopy of replica 2 revealed recrystallized structure i.e., fine grains of ferrite and pearlite in some regions and the other regions had coarse ferrite grains and bainitic structure (Figure 24). Replica 3 is close to the weld. Optical microscopy of replica 3 revealed lower bainitic structure in heat affected zone close to the base metal (Figure 25). Microexamination points that the material is not uniform. The impeller material (quenched and tempered alloy steel) is repaired by the supplier and gouged location is clearly visible to the naked eye.

Figure 24: Replica taken at location 2 shows fine grains of ferrite and pearlite. Magnification: 200X

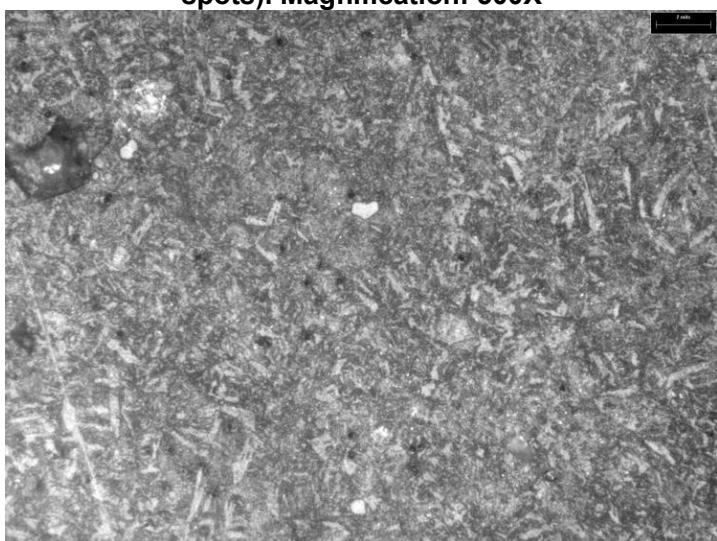
Figure 25: Replica taken at location 3 shows lower bainitic structure. Magnification: 200X

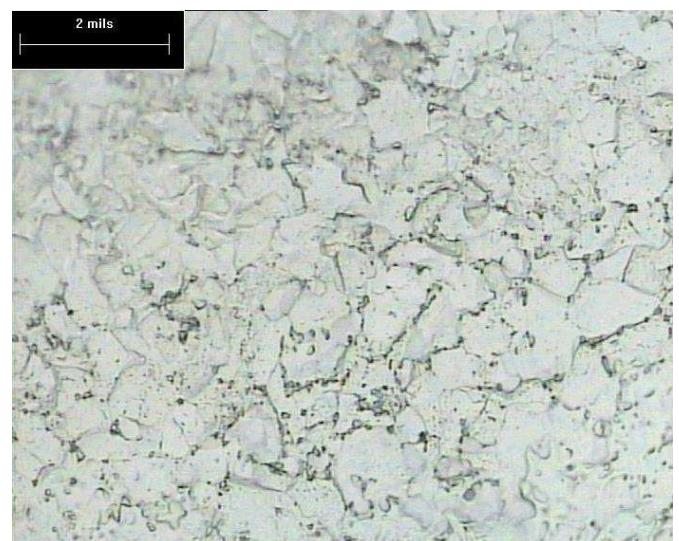
Figure 26: Photomicrograph showing coalesced grains of coarse ferrite with fine dispersed carbides. Magnification: 200X

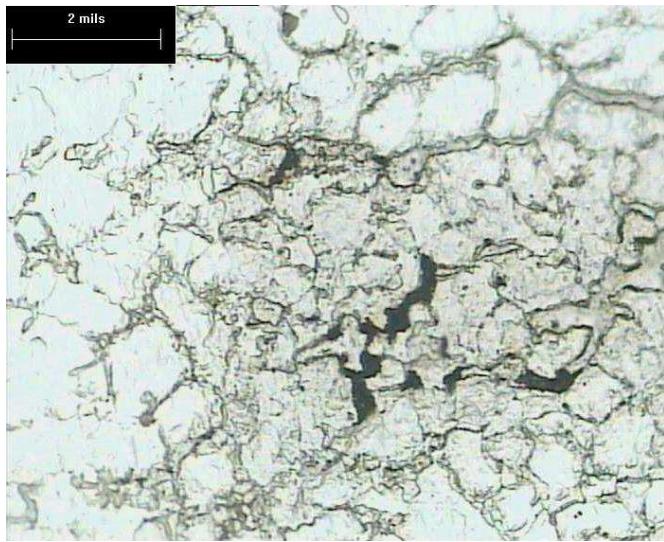
The selected location was ground and polished to 1 µm surface finish and examined under portable field microscope to ensure that surface is free from scratches and replicas can be taken from the polished area. Then, the polished area was etched with Nital for 30 seconds. The etched region was examined under portable field microscope to ensure that microstructure is revealed. If microstructure is not revealed repeat the etching step for another 30 seconds. One side of the replica film was wetted with acetone and the wetted side was placed on the etched surface. The film was pressed against the surface for 30 seconds. The film was allowed to dry for 15 minutes. After the replica film was dried, the film was removed, and the other side was adhered to the glass slide for subsequent microscopy. Optical microscopy of the replica gathered from visually unaffected area has revealed coalesced grains of coarse ferrite with some precipitated carbides at the grain boundaries (Figure 26). Typically ASTM A106 Gr. B (UNS K03006) material is delivered in the normalized condition e.g. the microstructure usually consists of fine equiaxed grains of ferrite and pearlite. Replica collected from the suspected location has exhibited heavy carbide precipitation and voids most likely caused by creep (Figure 27).

FMR findings revealed indications of creep damage which indicates possible prolonged exposure to temperatures near or exceeding the austenitising temperature (approx. 750 - 900°C (1382 - 1652 °F)).

Figure 27: Photomicrograph showing coarse ferrite with network of heavy grain boundary carbide precipitation. Voids (dark spots) are visible at some areas. Magnification: 200X

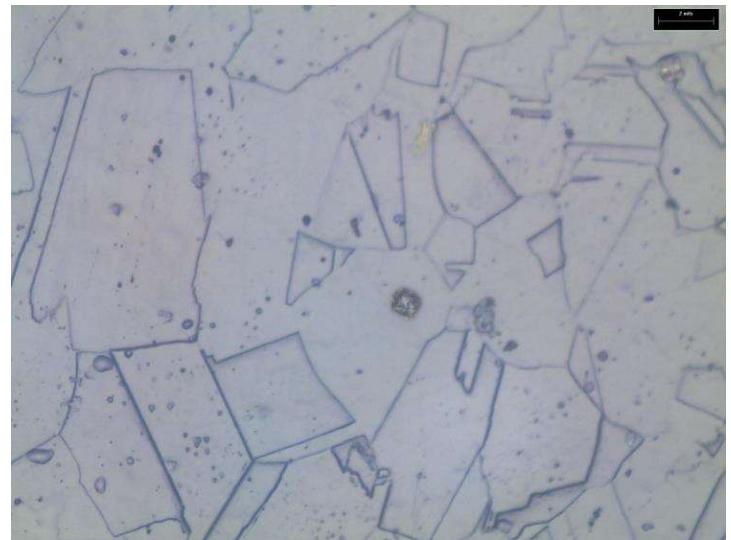
FMR was conducted on the cracked pipe spool at both unaffected and cracked locations. Optical microscopy of replica collected from unaffected area has revealed equiaxed austenitic structure with evidences of annealing twins (Figure 28). No microstructural anomalies were observed in the examined area. Optical microscopy of replica collected from cracked area revealed cracks in the examined area (Figures 29 and 30). Interestingly, the cracks were confined only to the regions with prior cold worked grains. The cracks were similar to stress relaxation cracking.

Figure 28: Photomicrograph showing equiaxed austenitic structure with evidences of annealing twins. No microstructural anomalies were observed in the examined area. Magnification: 200X

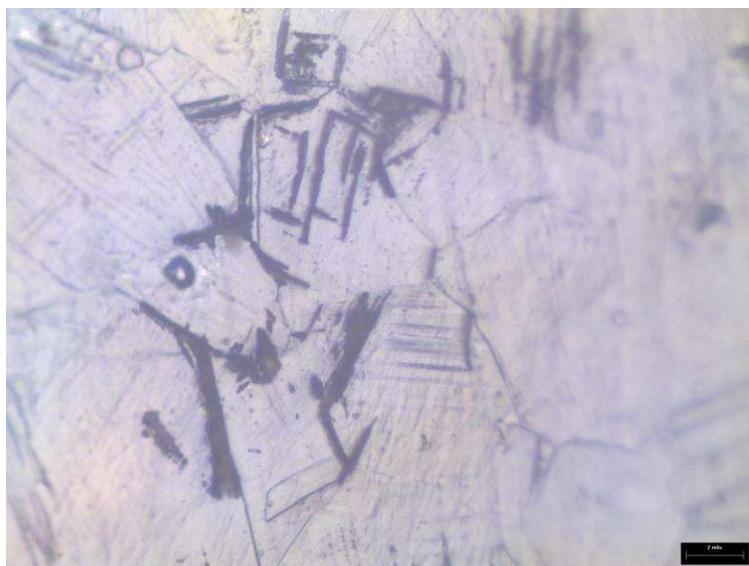
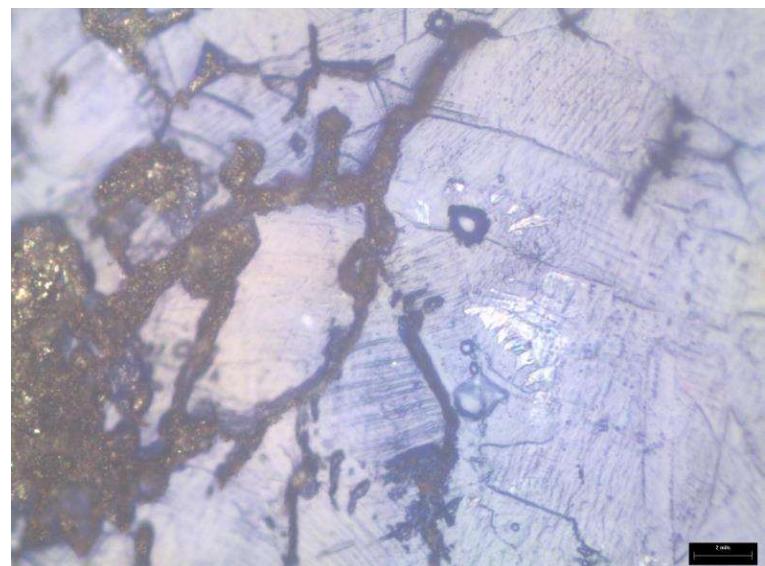
Figure 29: Photomicrograph showing cracks in the examined area. Interestingly, the cracks were confined only to the regions with prior cold worked grains. The cracks were similar to stress relaxation cracking. Magnification: 200X

Figure 30: Photomicrograph showing cracks in the examined area. Interestingly, the cracks were confined only to the regions with prior cold worked grains. The cracks were similar to stress relaxation cracking. Magnification: 200X

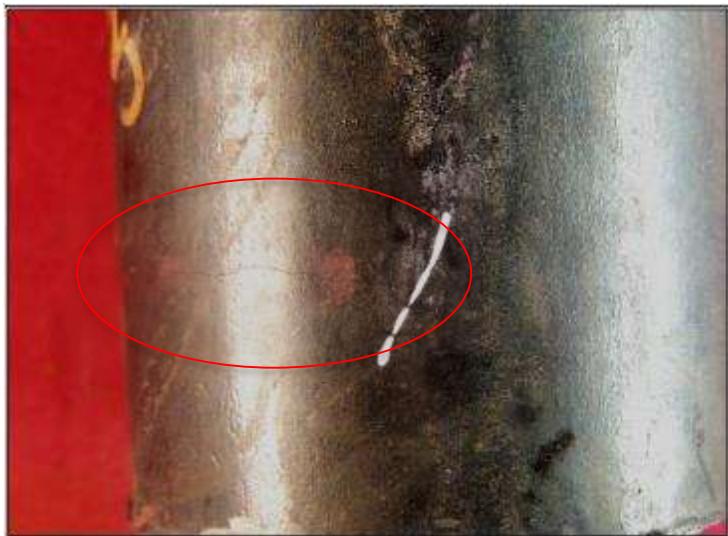
Visual examination of the as received failed regeneration heater coil segment has revealed circumferential crack on the outer surface (Figure 31). No evidence of loose corrosion products on the coil.

Figure 31: Photograph of the as received failed regeneration heater coil or affected sample which had a crack.

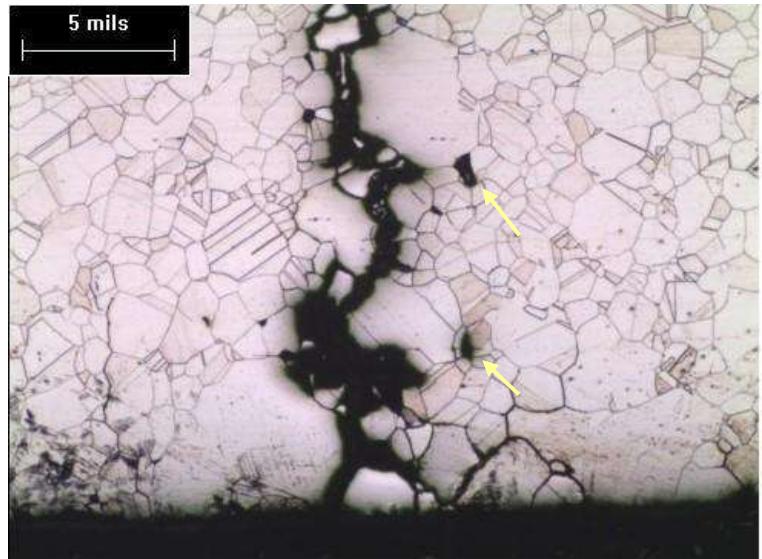
General microstructure should contain equiaxed austenite grains with presence of annealing twins typical of solution annealed stainless steel as the material is supplied in annealed condition after heavy cold working. However, during optical microexamination, coarse grains were observed along the outer surface. Besides, austenite grains with strain lines were also observed along the outer surfaces (Figure 32). Intergranular crack was observed.

Figure 32: Photomicrograph showing intergranular crack and variation in the grain sizes is also clearly evident. Isolated voids (yellow arrows) were also seen. Austenite grains with strain lines were also seen at the outer surface. Magnification: 50X

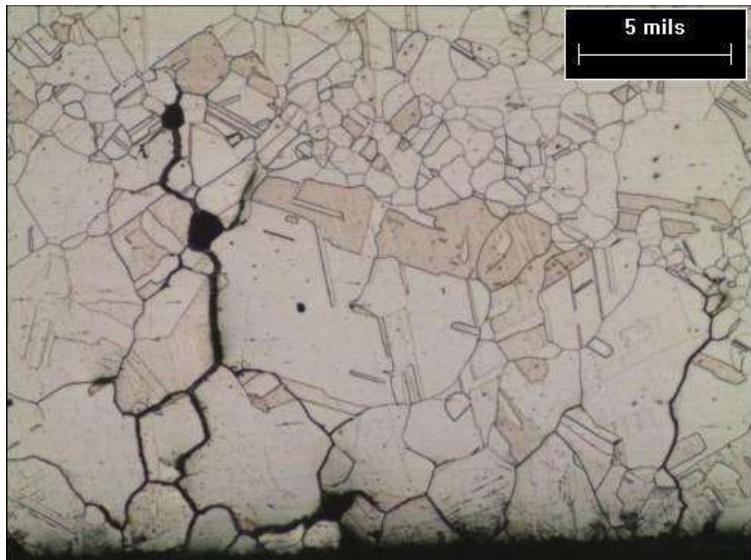
Interestingly, even the unaffected coil segment has microstructural evidences similar to affected coil segment i.e., coarse grains, sensitized grains, intergranular cracks (not visible to the naked eye) and oxide filled grain boundaries (Figure 33). Presence of sensitized grains through thickness, along circumference and in both affected and unaffected regions indicates that the coil was operating in a temperature range susceptible to sensitization 520° - 800°C (968 – 1472°F). As the service temperature is 533 - 577°C (991 - 1071°F), which falls within sensitization temperature window, observed sensitized grains is expected.

Figure 33: Photomicrograph showing intergranular cracks and coarse grains at the outer surface in another location. Magnification: 50X

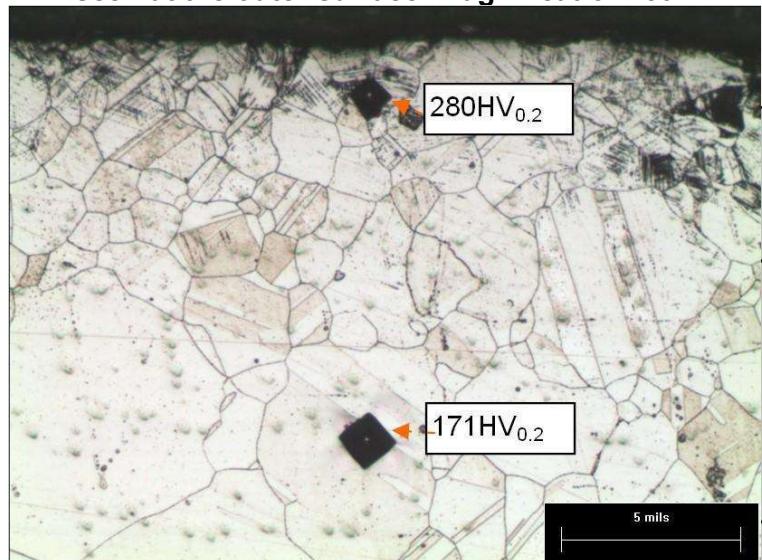
Transverse cross-section was extracted from the tip of the crack for microhardness test using Vickers method in accordance with ASTM E 384 (0.200 kgf load). The hardness test was performed at the outer surface and midwall thickness (Figure 34). Grains with strain lines have shown very high hardness values compared to grains free from strain lines. Microhardness test results indicate that deformation induced stresses (residual) that are induced during cold working process are still existent in some of the grains at the outer surface.

Figure 34: Photomicrograph taken at the OD in the vicinity of the crack showing hardness value above 200 HV_{0.2}. Magnification: 100X
