**AC Interference Corrosion, Corrosive Soil, Design Issues,  
Zinc Ribbon and Corrosion Mitigation**

Mehrooz Zamanzadeh, Peyman Taheri, and George T. Bayer  
Matergenics, Inc.  
100 Business Center Drive  
Pittsburgh, PA 15205

Julian Hristov and Kevin Groll  
Matcor, Inc. by BrandSafway  
1423 Wadsworth Street  
Houston, TX 77015

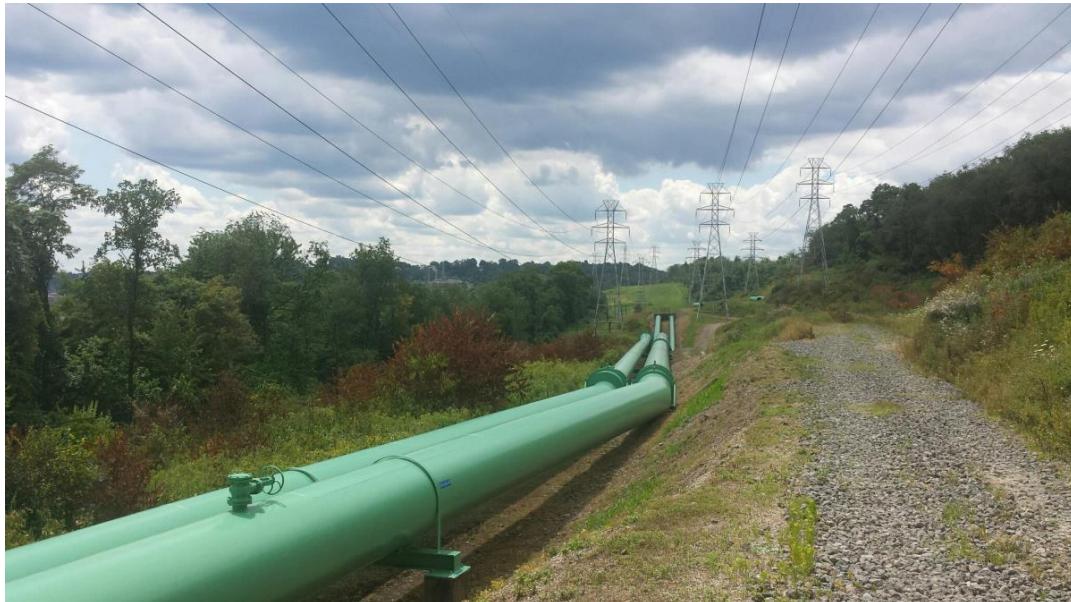
**Figure 1: Photograph of aboveground natural gas pipelines co-located with electrical transmission lines.**

Pipelines collocated in a right-of-way (ROW) with AC power lines, paralleling at a distance, or crossing power line ROWs may be subject to AC interference. Figure 1 is a photograph of aboveground natural gas pipelines co-located with electrical transmission lines. AC current induced on a pipeline may cause severe corrosion damage. Figures 2 through 4 are photographs showing the effects of stray current corrosion. Current from AC fault events may damage pipeline coatings, burn isolation devices or melt metal in extreme cases. Those tasked with maintaining pipelines require an in-depth understanding of the locations where pipelines are at risk of AC interference. Many factors are associated with increased AC interference and corrosion risk. These factors include: Soil resistivity, coating condition, cathodic protection levels, co-location length, crossing angle and separation distance. Traditional indirect assessment tools may be inadequate in identifying areas at risk for AC corrosion.

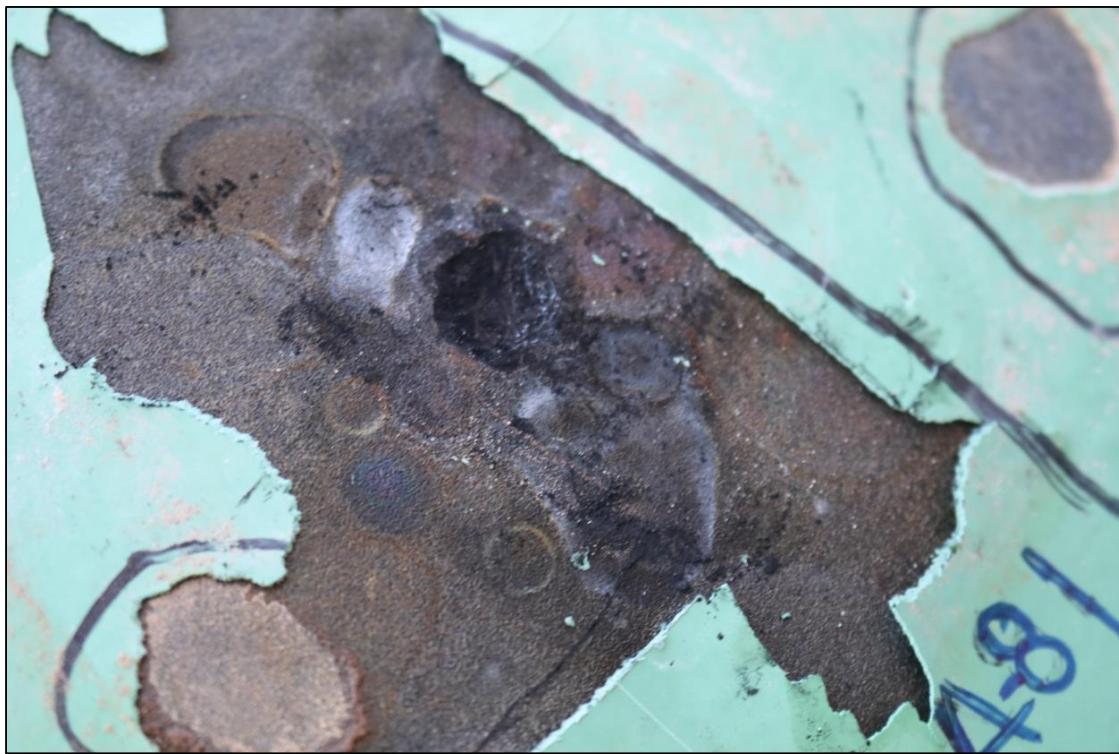
**Figure 2: Close-up photograph of AC stray current corrosion penetrating deep into the pipe wall.**

Inductive coupling occurs during normal operating conditions and is the primary cause of AC corrosion. AC corrosion occurs where AC current flows between the pipe and soil at pipeline coating defects. Inductive coupling may also cause unsafe step-touch voltages on a pipeline. AC mitigation systems dissipate the induced voltages to safe levels and prevent AC current from transferring between the pipe and soil.

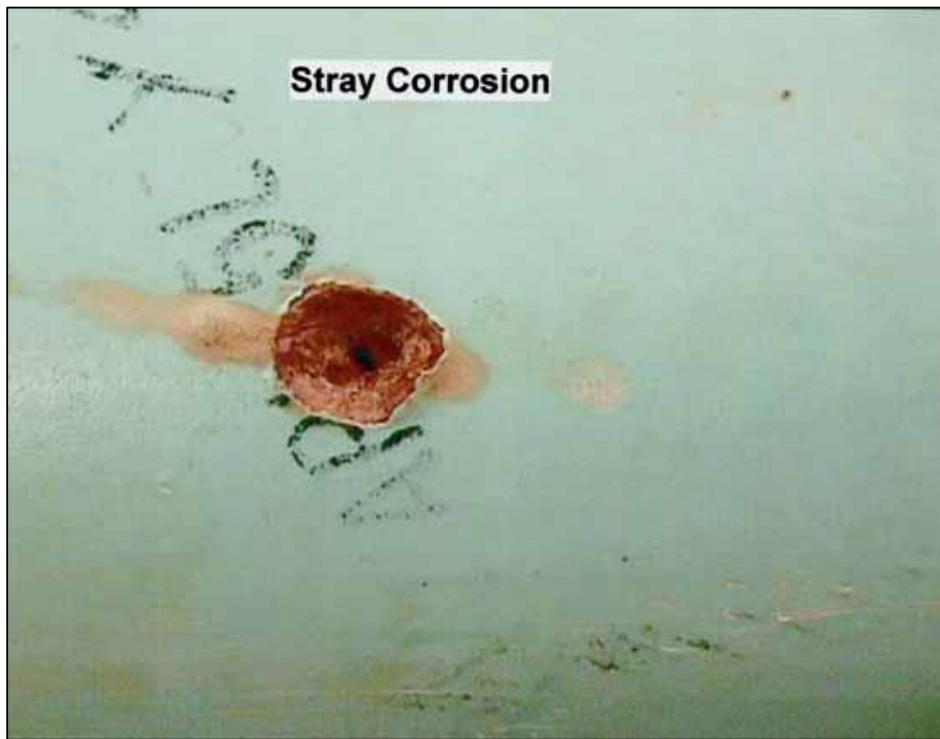
**Figure 3: Photograph of localized corrosion due to DC stray current. The appearance of DC stray current corrosion is similar to that AC stray current corrosion. Site testing is required to distinguish between AC or DC stray current corrosion damage.**

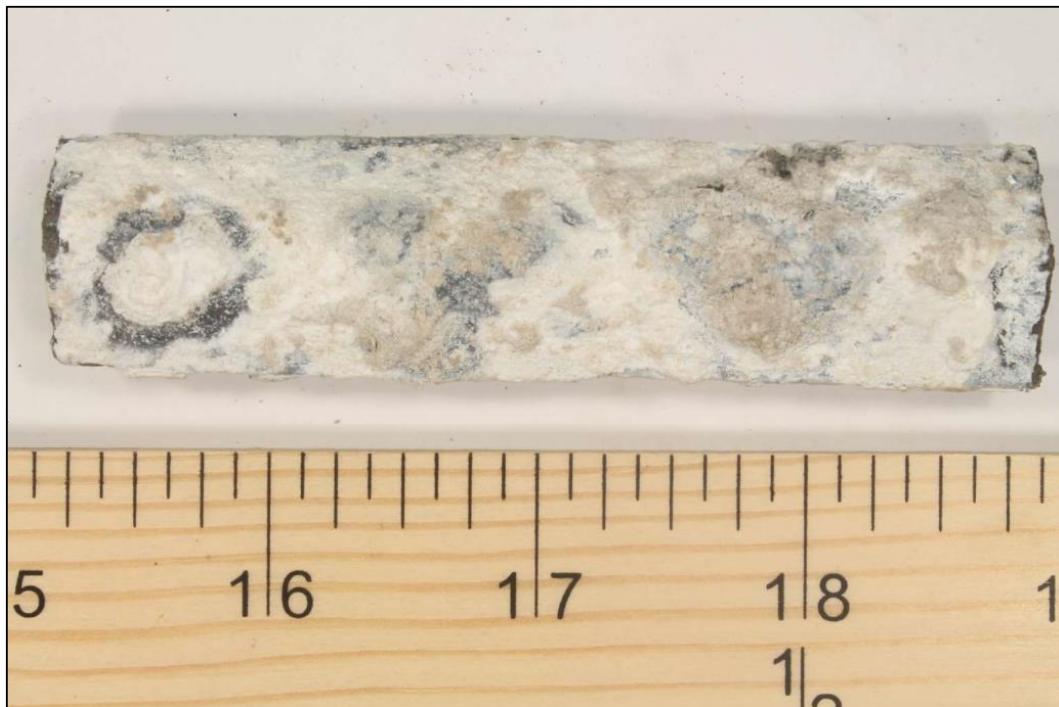
The client was experiencing corrosion of zinc ribbon used for AC mitigation of their buried natural gas transmission pipelines in the western United States. Corrosion of the zinc ribbon conductors had resulted in reduced AC mitigation. The authors were requested to assist in determining the cause of the corrosion problem.

Comprehensive analyses of the corroded zinc ribbon and the soil in which it was buried were performed. Figures 5 and 6 present photographs of the corroded zinc ribbon. A review of the client's AC mitigation system for the specific area was performed.

**Figure 5: Photograph of corroded zinc ribbon from corrosive soil in Western United States.**

The design engineer should have considered life expectancy of different conductors in the native soils and use of selective backfills or alternative corrosion-resistant conductor materials to meet expected service life of the AC mitigation system.

Conductor and backfill materials should be selected by a corrosion engineer to meet the life expectancy of the system. Corrosion rates for the conductor materials and risk of passivation (which creates risk of increased resistance between the conductor and earth) should be assessed.

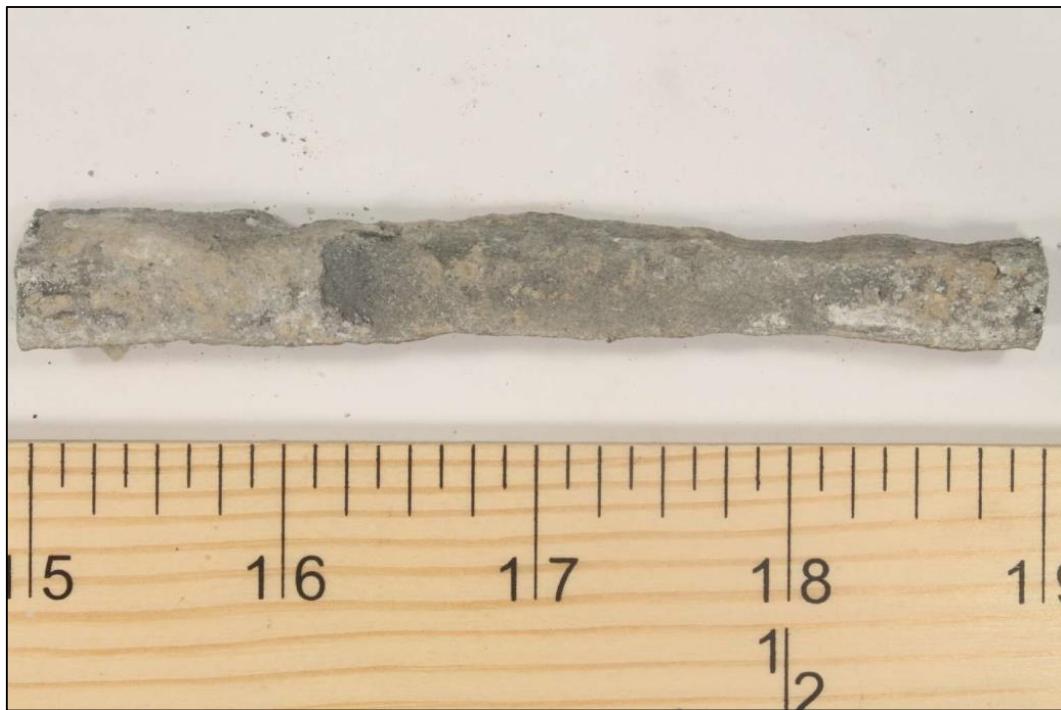
**Figure 6: Photograph of corroded zinc ribbon from corrosive soil in Western United States – corrosion products removed for analysis.**
