Corrosion Risk Assessment, Failure Analysis and Corrosion Mitigation for Aboveground Storage Tanks and Case Histories

M. Zee, PhD

Matergenics, Inc

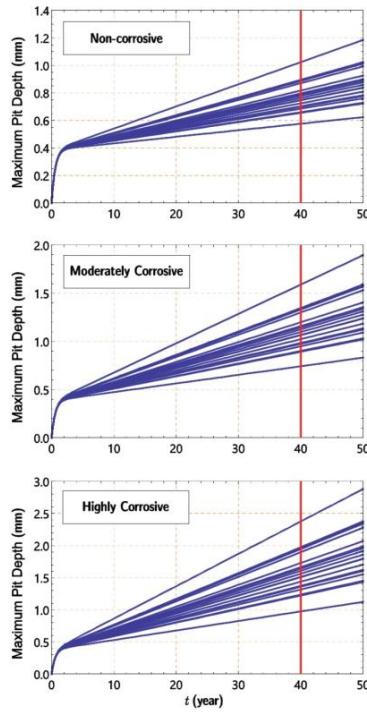
Figure 1: Photograph showing three different corrosivity rating and resulting penetration rates that can be used for remaining life determination.

A mathematical model to estimate the localized corrosion penetration and propagation in buried structures has been developed considering soil chemistry in the field (pH, resistivity, redox potential, and electrochemical potential at the soil–metallic structure interface) under the tank. According to many test results, this model provides an adequate description of thickness loss due to corrosion attack. This type of predictive modeling provides good damage prediction by using soil corrosivity parameters typically measurable in field. The plots (Figure 1) provide three different corrosivity rating and resulting penetration rates that can be used for remaining life determination.

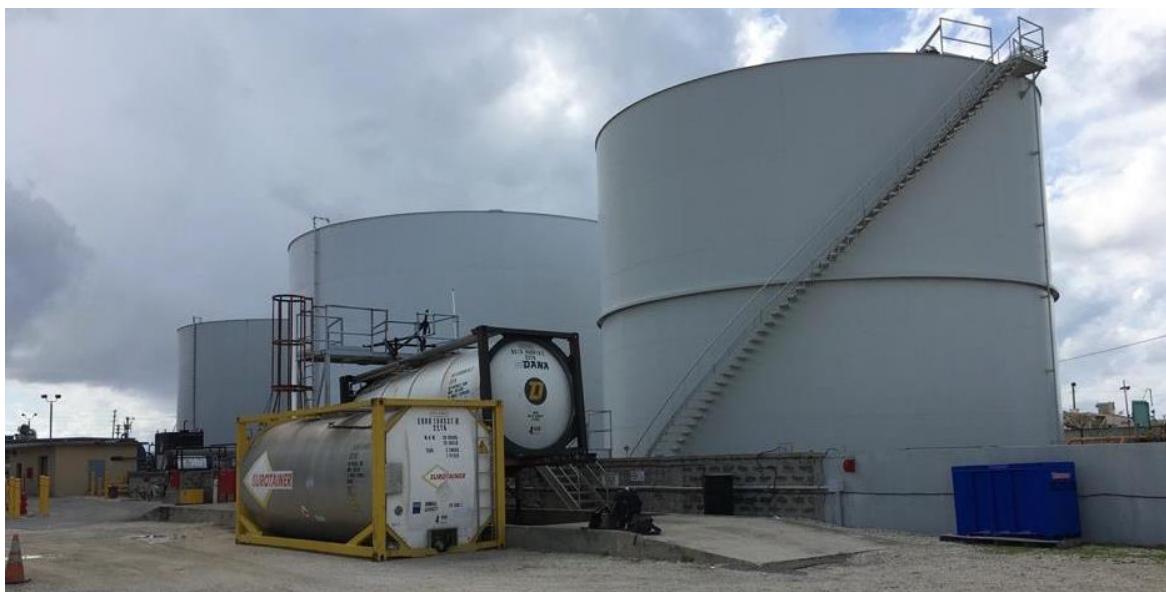
Figure 2: Photograph showing Fuel storage tanks.

Tank considered for inspection is shown in Figure 2. Tank internal photographs are shown in Figures 3 and 4. There is extensive thickness loss and perforation observed on bottom plate.

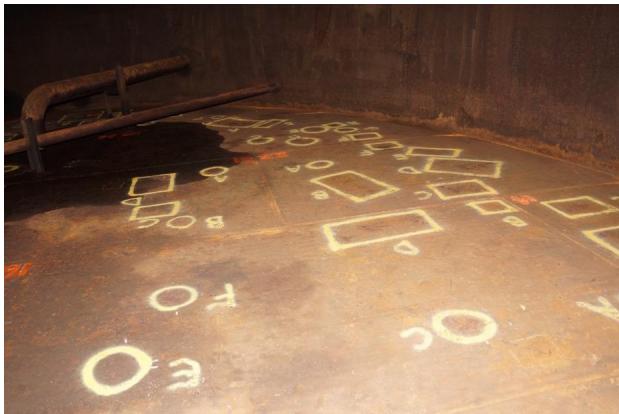
Figure 3: Photograph exhibiting perforated areas due to external corrosion. Perforated areas are randomly distributed.

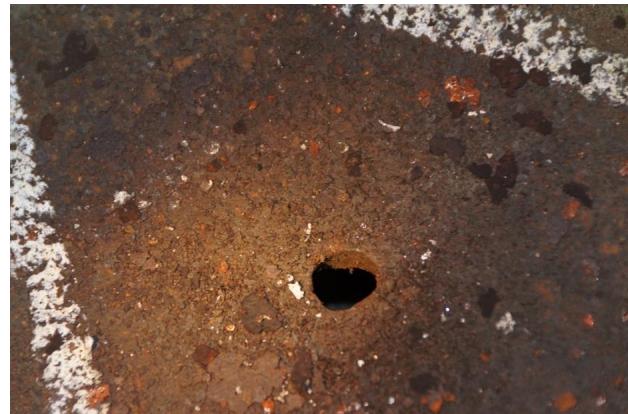
Figure 4: Close up of a perforated area

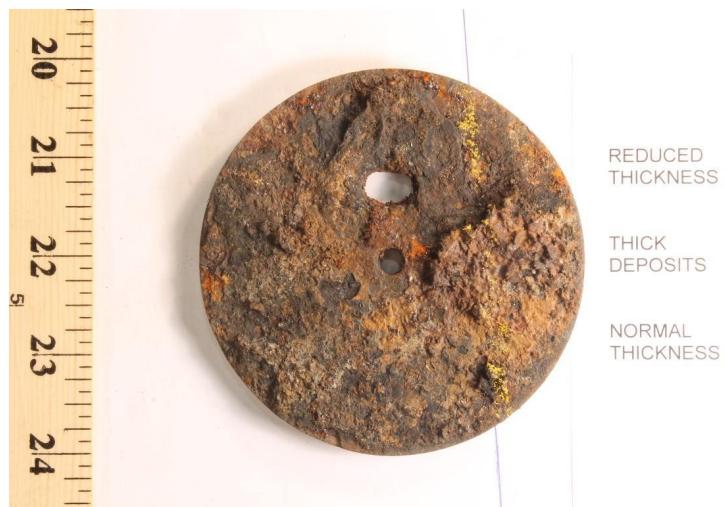
The underside of the sample taken from tank bottom plate is shown in Figure 5. Note that the second, circular hole in the center of the sample diameter is a drilled hole needed for sample removal. Thick corrosion products and deposits were observed on one area of the bottom plate underside. Loss of plate thickness due to corrosion was also observed in some areas including around the hole. Figure 6 shows the locations of maximum corrosion product thickness, and loss of thickness due to corrosion with respect to the hole. The line in Figure 5 shows the plane of cutting and cross section examination. The hole in the tank bottom as viewed from the outside of the tank is shown in Figure 7. The hole in the tank bottom as viewed from the inside of the tank is shown in Figures 8. No appreciable corrosion was observed on the inside surface of the tank bottom plate.

Figure 5: Photograph showing the hole in the tank bottom as viewed from the outside of the tank. Note-circular hole in center is a drilled hole.

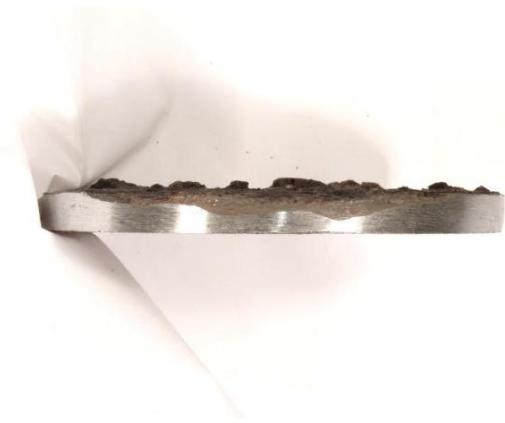
Figure 6: Photograph shows the locations of maximum corrosion product thickness and loss of thickness due to corrosion.

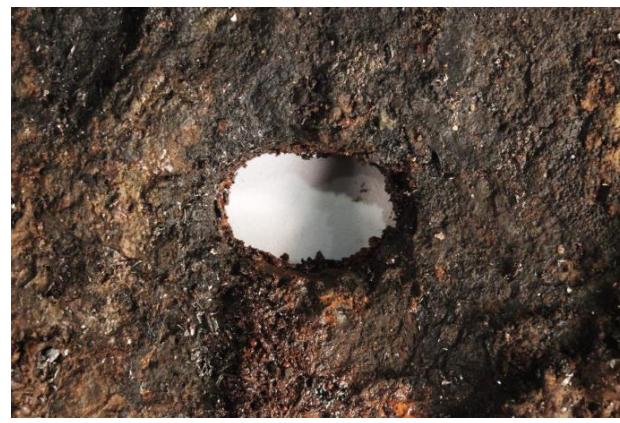
Figure 7: Photograph showing the hole in the tank bottom as viewed from the outside of the tank.

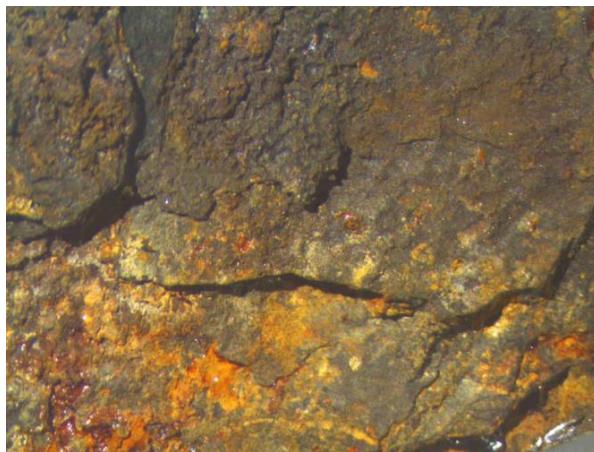
The corrosion products on the underside of the tank bottom plate were examined at moderate magnifications using an optical stereomicroscope. The corrosion products are shown in Figures 9 - 10.

Figure 9: Photograph at 7x showing the corrosion products on the underside of the tank bottom.

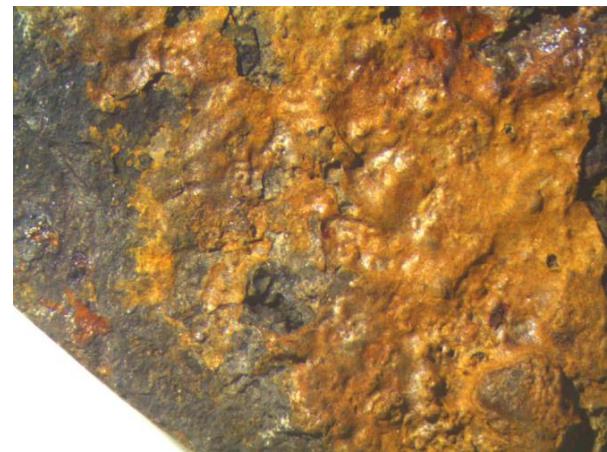
Figure 10: Photograph at 7x showing the corrosion products on the underside of the tank bottom.

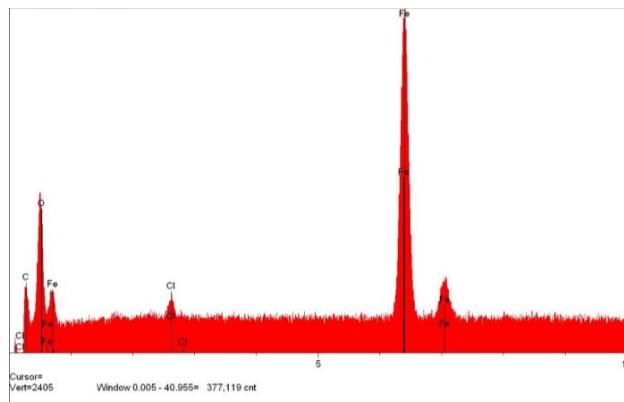
Qualitative analysis of the corrosion products on the underside of the tank bottom plate was determined using a scanning electron microscope (SEM) equipped with an energy dispersive x-ray spectrometer (EDS). A spectrum of the bright orange corrosion products is shown in Figure 11 and consisted primarily of iron (Fe) and oxygen (O) plus lesser amounts of carbon and chlorine (Cl). A spectrum of the black corrosion products is shown in Figure 12 and consisted primarily of iron (Fe) and oxygen (O) plus lesser amounts of aluminum (Al), silicon (Si), sulfur (S), chlorine (Cl), calcium (Ca), chromium (Cr), manganese (Mn) and copper (Cu).

Figure 11: EDS spectrum of the bright orange corrosion products.

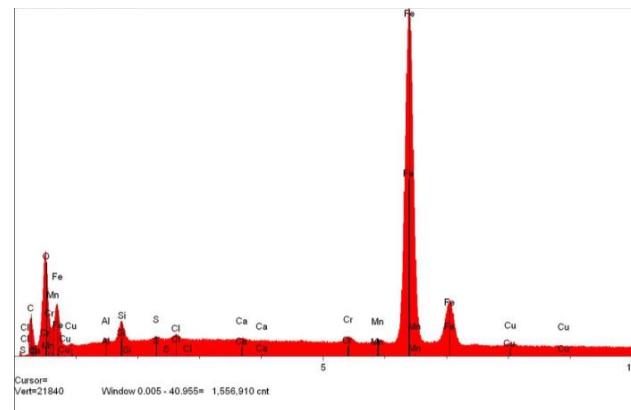
Figure 12: EDS spectrum of the black corrosion products.

Note the presence of chlorides and sulfur containing compounds.

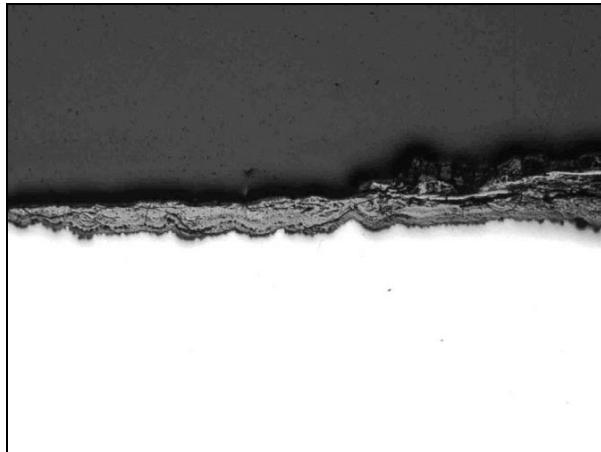
Transverse cross sections through an area of minimal plate thickness loss, maximum plate thickness loss, and maximum corrosion product thickness were prepared for subsequent metallographic examination. In the as polished condition the corrosion in a lightly corroded area of the tank bottom underside is shown in Figures 13 and 14. A layer of mill scale was observed within the corrosion products that had been lifted by corrosion occurring underneath the mill scale layer (Figure 15). The thick corrosion product layer is shown in Figure 16.

Figure 13: Photograph at 50x showing corrosion of the underside of the tank bottom in an area of minimal corrosion. As polished.

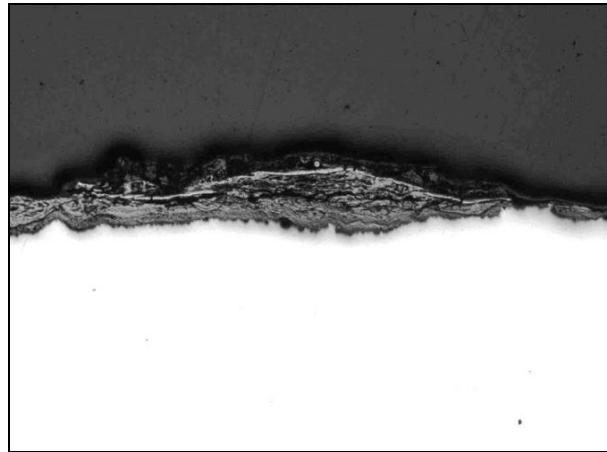
Figure 14: Photograph at 50x showing corrosion of the underside of the tank bottom in an area of minimal corrosion. As polished.

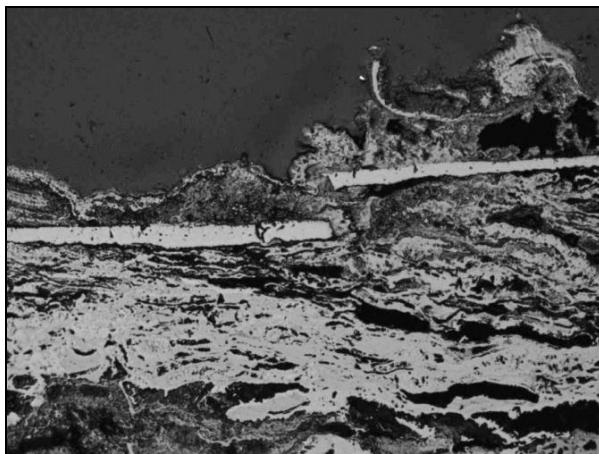
Figure 15: Photograph at 200x showing mill scale within the corrosion products. As polished.

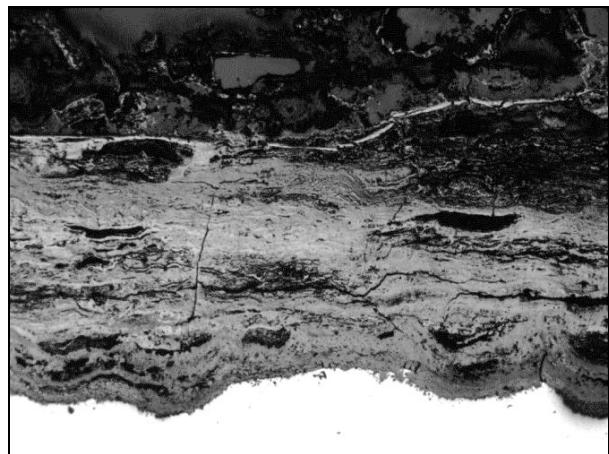
Figure 16: Photograph at 50x showing the thick corrosion products on the underside of the tank bottom. As polished.

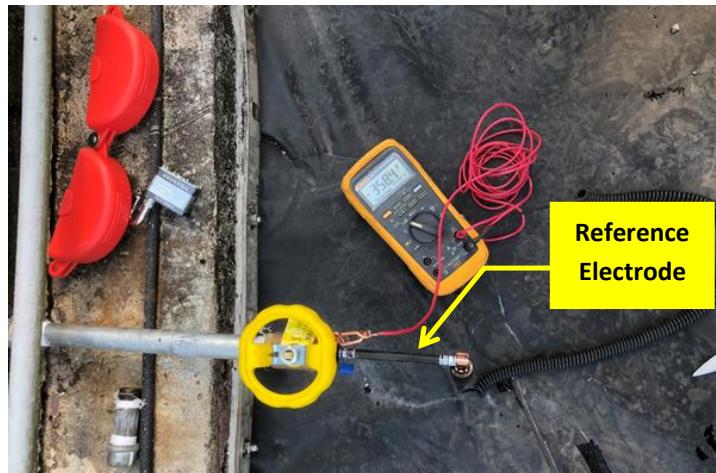
In-situ potential measurements was performed by placing a copper/copper sulphate (CuSO_4) reference electrode in the electrolyte (sand between tank bottoms) and electrically connecting a high impedance potential measuring instrument, high impedance voltmeter, between the reference electrode and the top tank bottom (Figure 17). Potential measurements revealed that at least -850 mV instant OFF and 100 mV shift NACE CP criteria are not satisfied which indicates that there is no cathodic protection for the tanks.

Figure 17: Photograph showing that reference electrode is pushed into the sand from the slot available between both tank bottoms and the tank bottom – to – sand potential was measured.

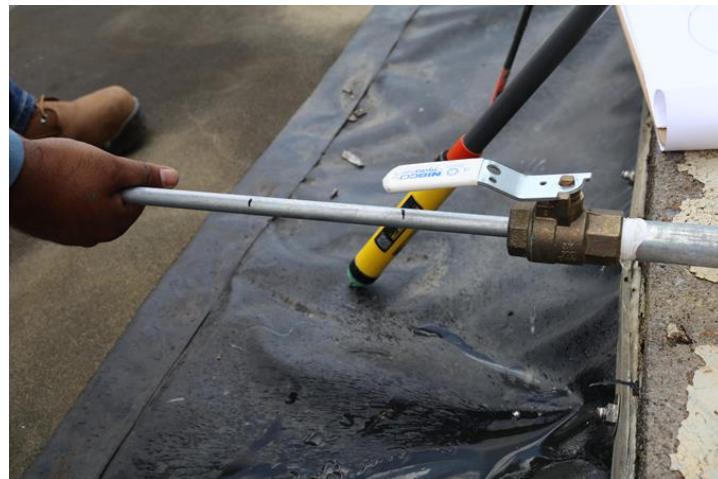
Current requirement test was performed to identify the number of anodes to be placed between the tank bottoms in order to establish cathodic protection of the tank bottoms. During this test, 15 feet (4.57 m) long randomly perforated PVC pipe was inserted in between the tank bottoms and then 15 feet (4.57 m) long carbon steel rod was inserted inside the PVC pipe. PVC pipe was used to avoid the contact between carbon steel rod and the tank bottoms. In this case, carbon steel rod is the auxiliary electrode (Figure 18).

Figure 18: Photograph showing placing of auxiliary electrode in between the tank bottoms.

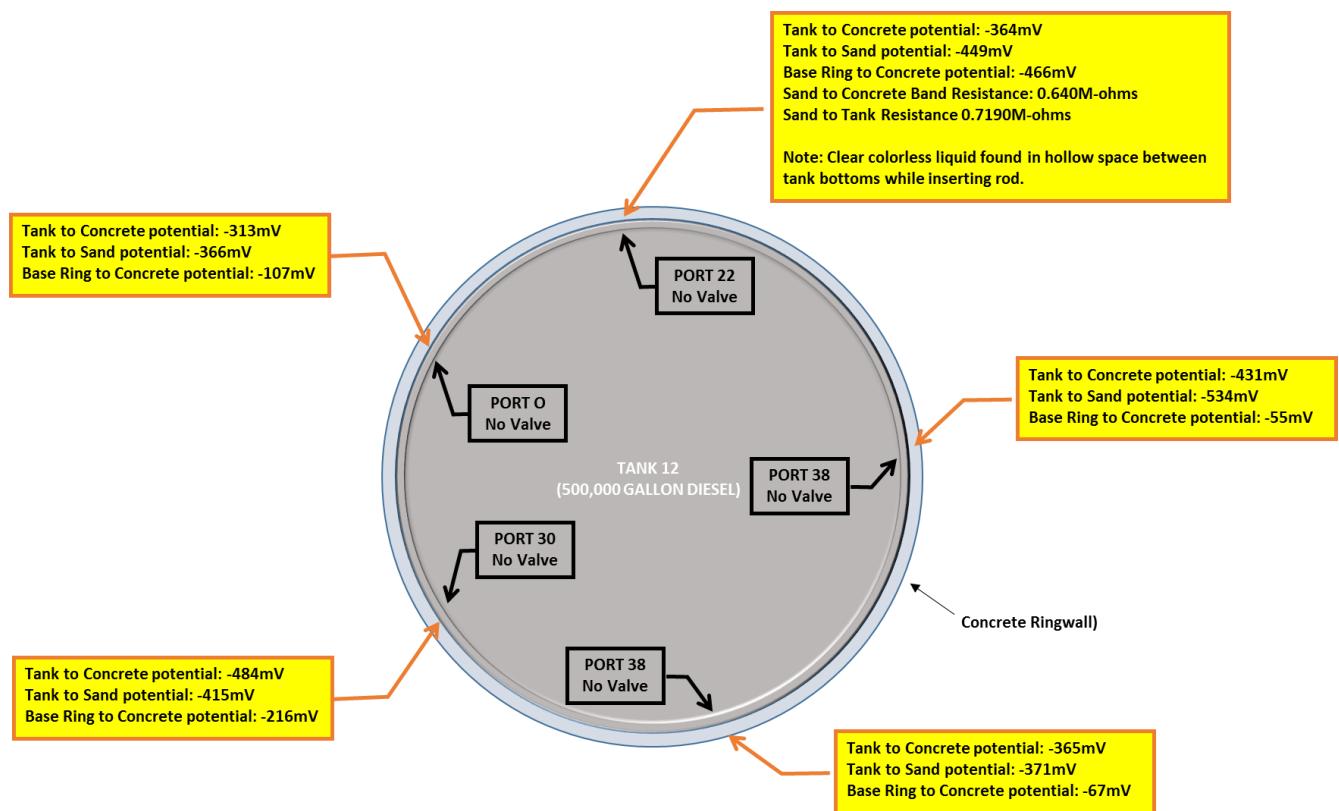
Figure 19: Photograph showing that at least -850 mV with the CP applied criteria is not satisfied which indicates that there is no cathodic protection for the tanks. Reference electrode is pushed into the sand from the slot available between both tank bottoms

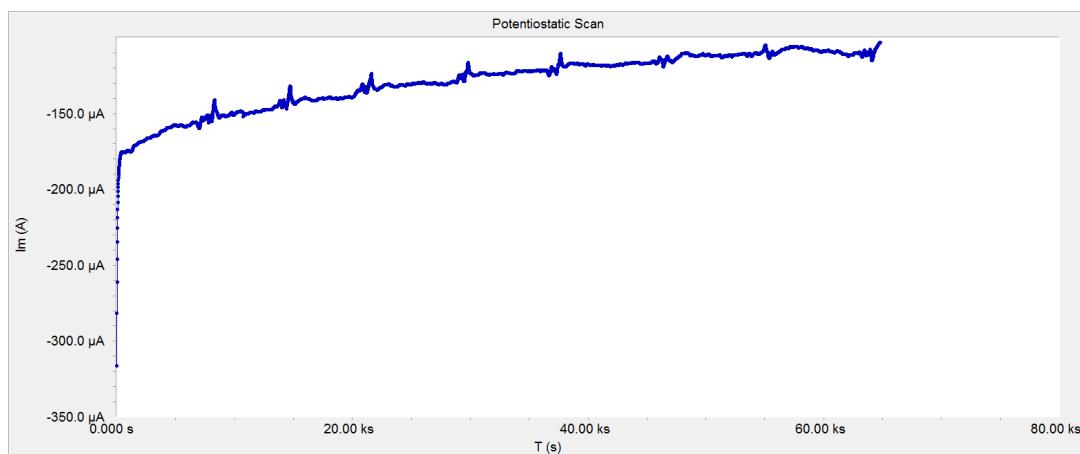
Figure 21: Photograph showing potentiostatic scan plot

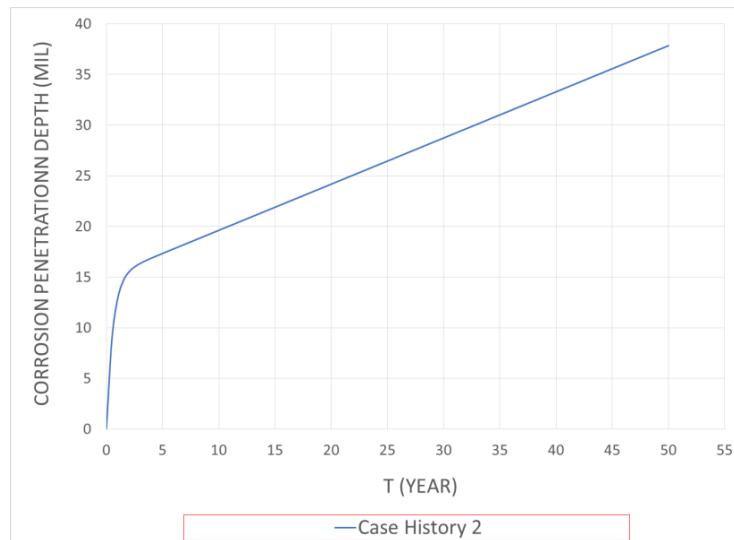
During site visit, sand sample was also collected from the interstitial space between two tank bottoms of the storage tank. The collected sand sample was analyzed in the lab. The test results are shown in Table 5. Moreover, corrosion rate was also predicted (Figure 22).

Figure 22: Photograph showing resulting penetration rates that can be used for remaining life determination.

Considering the challenges with installation of anodes in between the tank bottoms, consideration of the injection of VCI/contact inhibitor between the tank bottom plates is recommended. A promising industrial practice is to introduce VCI materials under tank bottoms to either supplement existing CP systems or provide protection in its absence.
