Mitigating Stray Currents in 5G-Connected Metallic Structures: A Comprehensive Solution

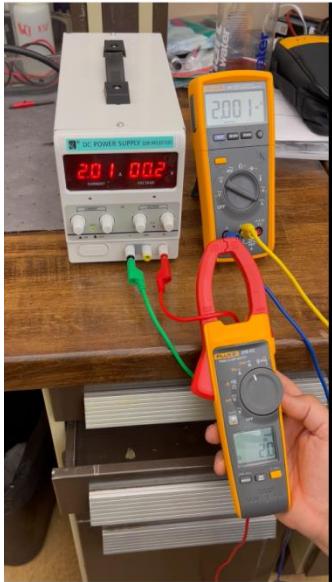
Figure 1: Photograph taken during the verification of clamp-on ammeter.

Either a clamp-on ammeter or a swain meter was positioned around the tower grounding conductor, cabinet grounding conductor, pole grounding conductor, and hybrid cables to measure and note the detected current values. Before these devices were used, their operational accuracy was confirmed. A test setup was established, and a known current (2A) was introduced using a power source. The clamp-on ammeter (referenced as Figure 1) and the swain meter (referenced as Figure 2) were fitted around the test cables. Observations revealed that both meters displayed a current matching the introduced 2A, confirming the accurate functioning of both the clamp-on ammeter and the swain meter.

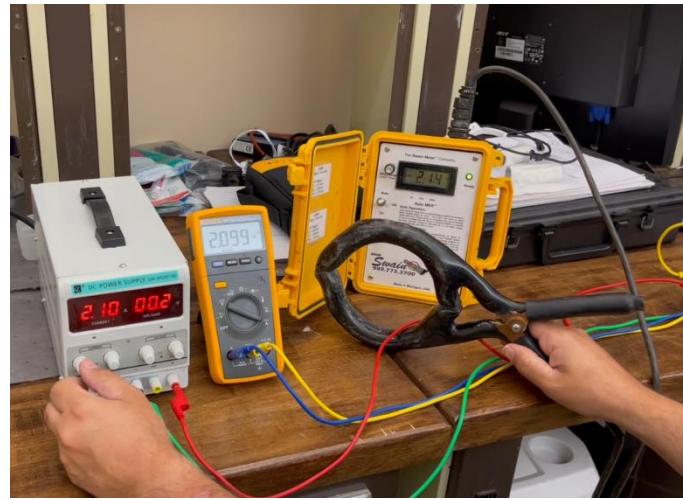
Figure 2: Photograph taken during the verification of swain meter.

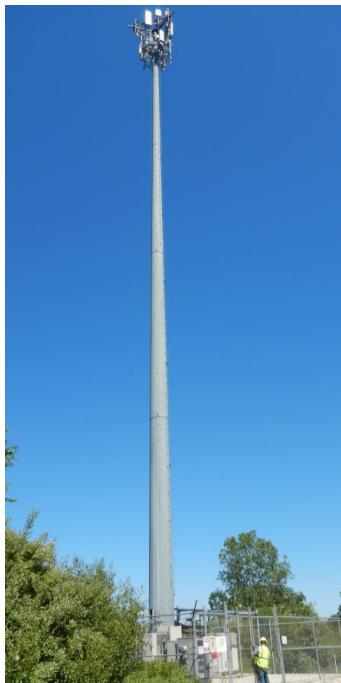
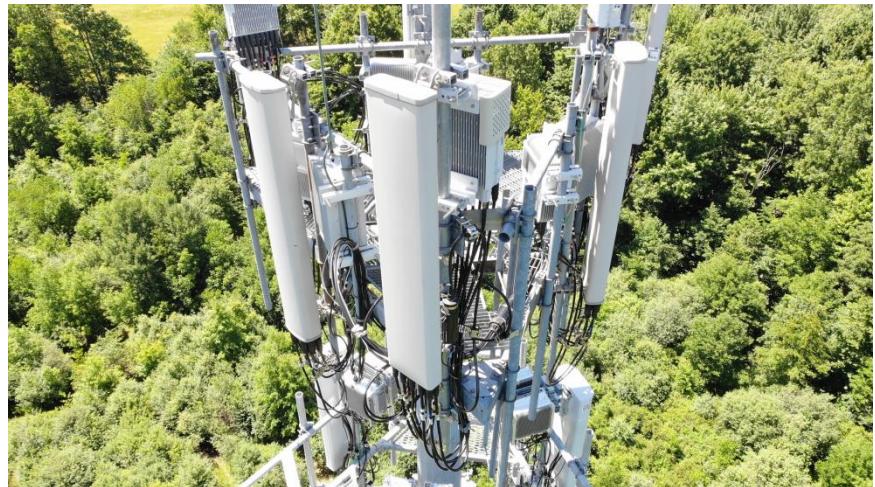
Figure 3: Photograph showing a monopole and the 5G unit connected to it.

Images of the monopole and the self-standing tower equipped with 5G units can be viewed in Figures 3 and 4. As observed from Table 1, monopole 1 has only one ground conductor, while monopole 2 possesses two, falling short of the recommended minimum of at least one ground conductor for each leg of the tower or four ground conductors for monopole as outlined in TIA⁽¹⁾-607-B.¹ It seems that the missing ground conductors may have been severed and potentially stolen. On monopole 1, which is equipped with 5G unit 1, a total delta current value of 92.8A was detected across its two hybrid cables. Meanwhile, a current of 88.0A was registered across the lone ground conductor connected to

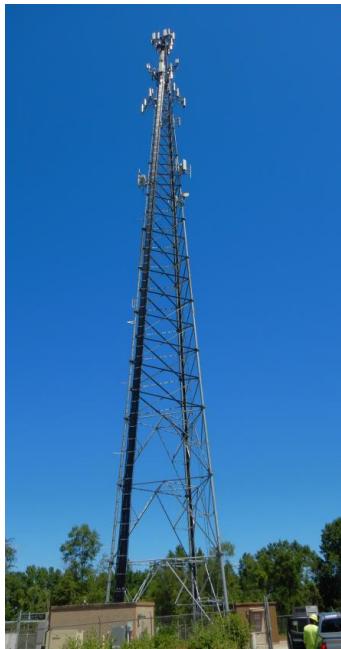
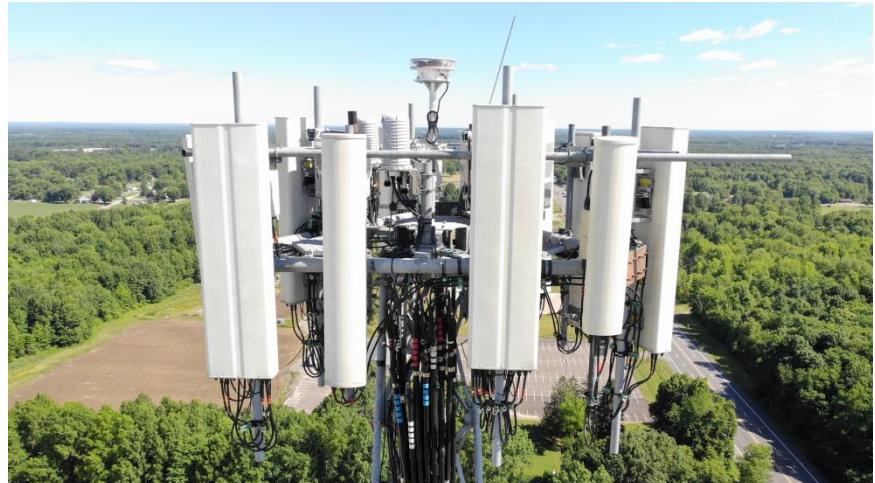
Figure 4: Photograph showing a self-standing tower and the 5G unit connected to it.

The data from the tests indicate that the 5G unit 2, mounted on monopole 2, isn't transmitting any currents onto the structure. Self-standing tower had three 5G units and it can be clearly seen that unit 1 is pumping more current onto the self-standing tower. Though unit 2 on the tower is pumping current on to the tower the current value is very low when compared to current pumped by unit 1 on to the tower.

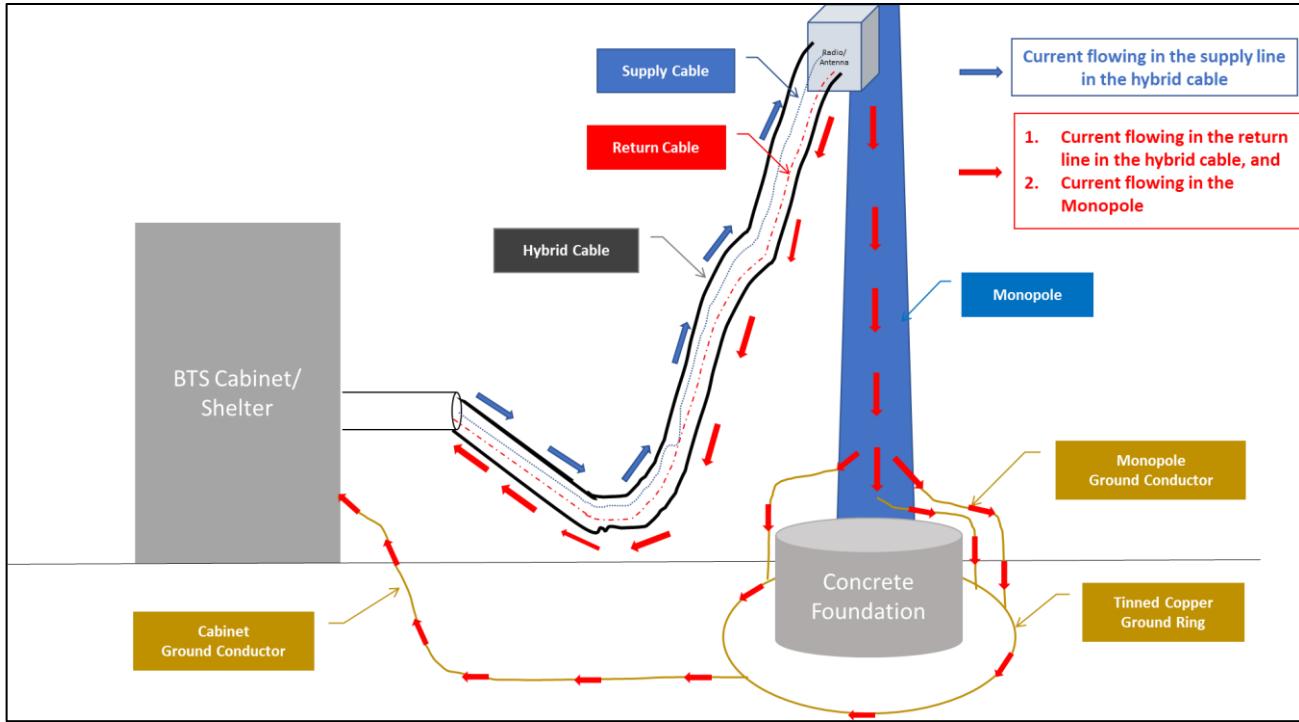
monopole 1's base plate. This suggests that the majority of the delta current identified in the hybrid cable flows through the structure, proceeding to the ground ring via the monopole's ground conductor, and ultimately reaches the cabinet via the cabinet grounding conductor (Figure 5).

Figure 5: The photograph above provides a general depiction of the current flow.

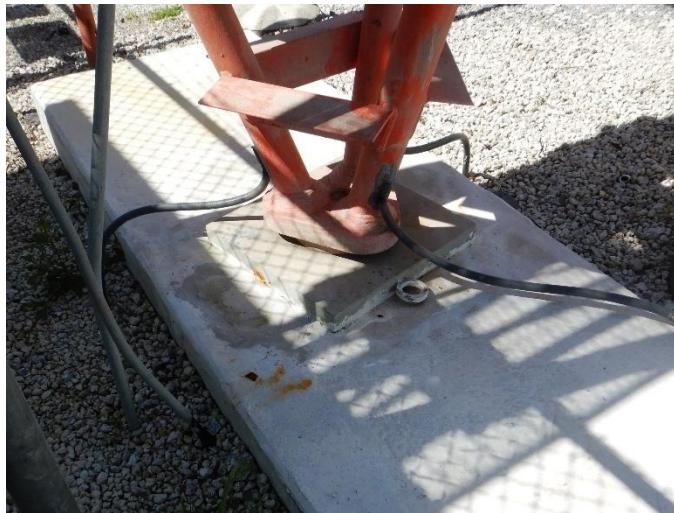
Figure 6: Photograph of the tower where the concrete foundation is open to atmosphere.

- Ensure structures are anchored with concrete foundations and avoid direct burial.
- Utilize separate grounding cables running from the 5G equipment to the ground ring.

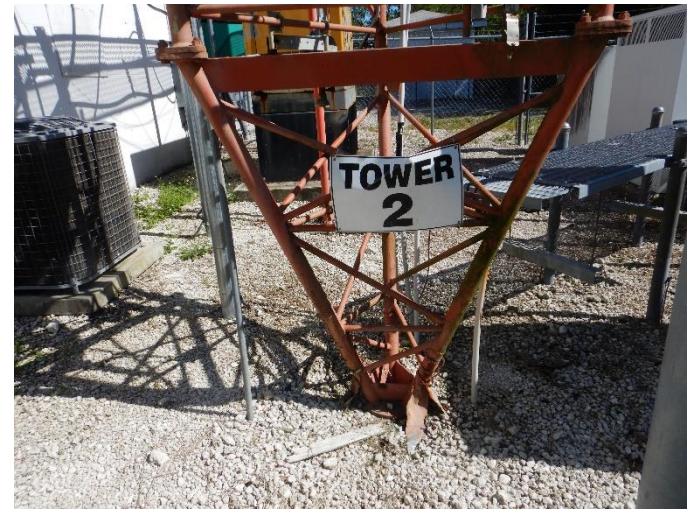
Figure 7: Photograph of the tower where concrete foundation is submerged within the soil

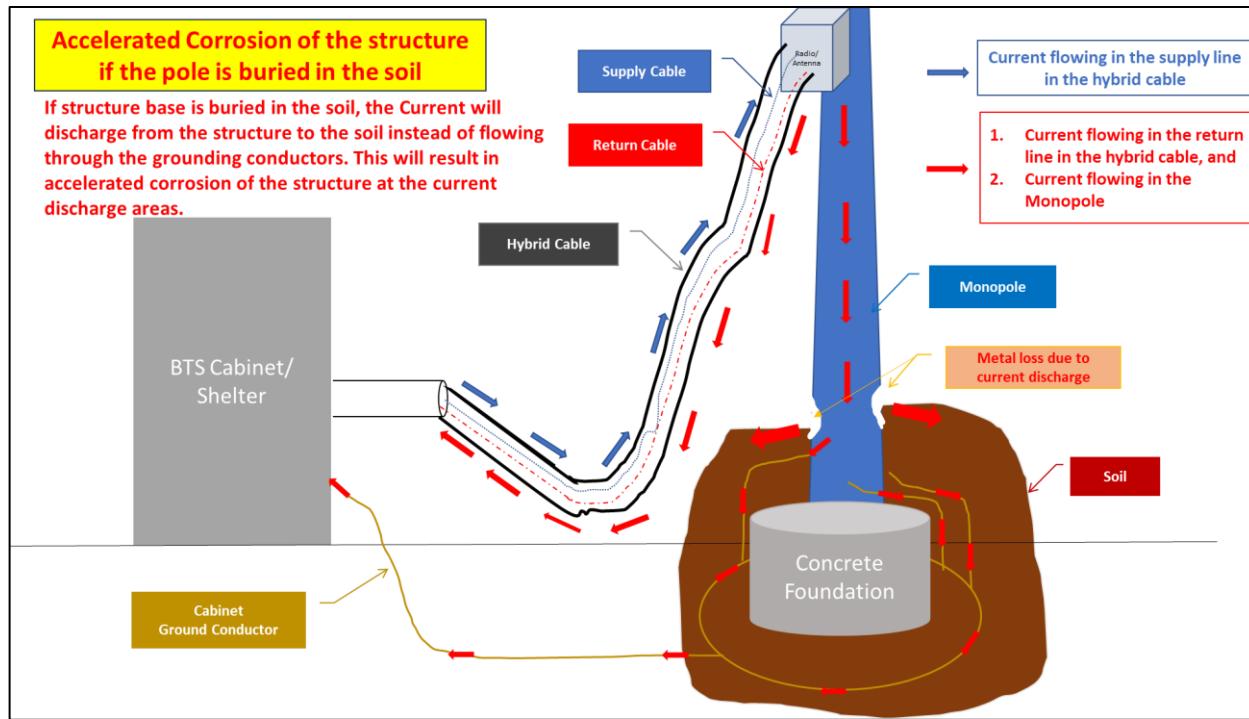
Based on the results from the current measurements, it's clear that the 5G unit 1 on the monopole 1, 5G unit 1 on the monopole 3, and 5G unit 1 on the self-standing tower are transferring currents in excess of 1 A to the examined monopoles, as well as the self-standing tower. Ideally, the concrete foundation of the poles or towers must not be covered with soil (Figure 6). For poles or towers that are directly embedded in the soil, or in situations where the concrete foundation is submerged within the soil (Figure 7), there's a deviation in the current's pathway. Instead of the current traveling through the ground conductors to the ground ring and subsequently to the cabinet, it takes a more direct route, discharging straight from the structure into the soil. This altered flow results in specific areas on the structures from which the current discharges to the soil. These points of discharge are at a heightened risk of rapid corrosion, as depicted in Figure 8.

Figure 8: The photograph above provides a general depiction of accelerated corrosion of the structure if the pole is buried in the soil.

- Apply an isolating coating at the top of the structures to separate the 5G equipment from the metallic structures.
- When equipping monopoles and towers with 5G units, it's crucial to consider the installation of a cathodic protection system to counteract potential accelerated corrosion challenges. Cathodic protection controls metal surface corrosion by converting that surface into the cathode of an electrochemical cell, either by using sacrificial anodes, commonly made of zinc or magnesium, or applying an external electrical direct current. Sacrificial anodes, strategically placed near corrosion-prone areas, corrode preferentially, redirecting the potentially harmful current from the 5G unit away from the primary structure. On the other hand, when employing external electrical currents, the structure is polarized cathodically, staving off the oxidation process leading to corrosion. This is particularly advantageous for larger structures or those in aggressive soil conditions. Regardless of the method, the overarching objective remains the same: to combat the adverse effects of stray currents and ensure the durability and structural integrity of 5G installations.
