# Condition Assessment of Aging Concrete Structures—Part 1

**MEHROOZ ZAMANZADEH, CLINTON CHAR, GEORGE T. BAYER, PEYMAN TAHERI, AND ANIL KUMAR CHIKKAM,**  
Matergenics Inc., Pittsburgh, Pennsylvania, USA.

This two-part article is a review of the corrosion risk assessment, structural considerations, and engineering solutions for the steel reinforced structural elements within an aging concrete building that exhibited accelerated corrosion in corrosive environments, along with factors that could potentially result in the progressive failure and eventual collapse of an aging building. Part 1 addresses the fundamentals of structural analysis, rebar corrosion, carbonation, and the role of chlorides. Part 2 will address inspection and condition assessment procedures and recommendations; engineering solutions by coatings and cathodic protection; case histories; and cathodic protection design of concrete rebar with finite element simulations.

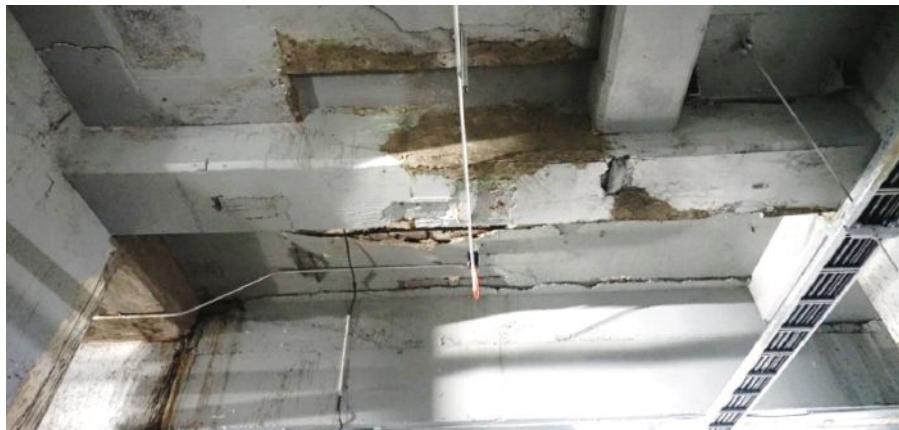
**FIGURE 3** Concrete beam exhibiting cracking due to corrosion of rebar and overload.

If cracks occur in a highly corrosive environment, chlorides and other corrosive ions could enter the crack and attack the steel reinforcing. In this instance, corrosion of the steel reinforcing will expand the volume of the steel. This will result in further cracking, with the cracks increasing in width. In the most severe instances, spalling of the concrete covering the reinforcing bars will occur, exposing the rebars to the corrosive environment. Figure 3 shows a beam that is cracked and deformed due to accelerated corrosion of the rebar and being in an overloaded condition. Severe spalling is also evident on the

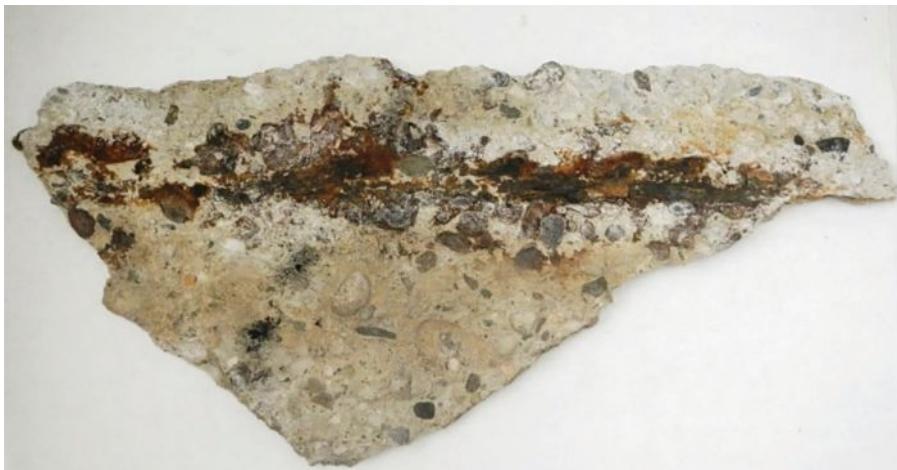
**FIGURE 5** Close-up photograph of the rebar inside core sample with thickness loss shown at the top. The corrosion risk was captured early on. Corrosion mitigation and cathodic protection prevented catastrophic failure in a 100-year-old building.

Figure 5 is a close-up photograph of the rebar inside core sample with thickness loss shown at the top. The corrosion risk was captured early on. Corrosion mitigation and cathodic protection prevented catastrophic failure in a 100-year-old building.
