**Safeguarding Pump Stations:
Ensuring Adequate Cathodic Protection with Advanced Monitoring Tools**

Zachary Mulder, Steve Wagner, and Jared Fleming
Ottawa County Sanitary Engineering Department
Port Clinton, Ohio 43452
USA

Farzan Zolfaghari, Mehrooz Zamanzadeh, Aaron Ulmer, and Anil Kumar Chikkam
Matergenics Inc
100 Business Center Dr
Pittsburgh, PA, 15205
USA

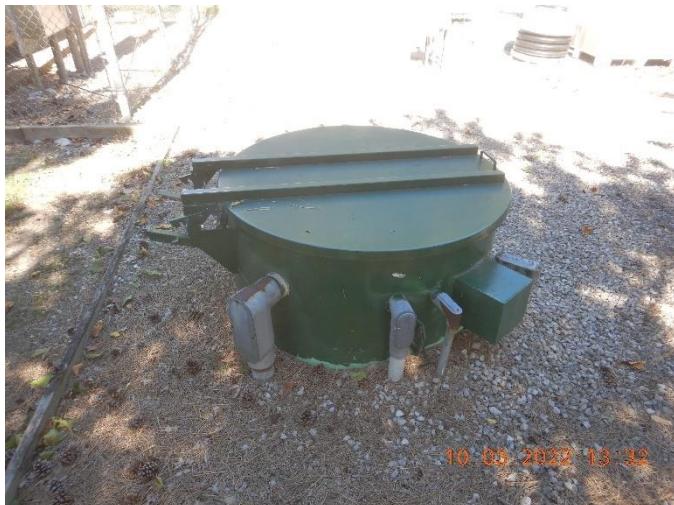
Figure 1: Photograph showing the exterior of the pump station (i.e., entrance tube) at grade level.

The interior polyamide epoxy coatings were found to be in good condition, indicating minimal wear and no visible signs of degradation (Figure 11 – 12). Similarly, the external epoxy coatings on the dry wells appeared intact, suggesting that they continue to offer effective protection against corrosion. However, some coating removal was observed at the external surface of the entrance tubes at grade level, likely due to mechanical abrasion or damage during installation. This localized coating loss exposes sections of the steel tubes to environmental elements, increasing the risk of future corrosion. If left unaddressed or if the magnesium anodes become depleted, the CP system may no longer provide adequate defense, further accelerating the potential for corrosion.

The visual inspection confirmed that both the internal and external coatings are generally in good condition. However, the exposed sections of the entrance tubes at grade level present a potential risk for future corrosion. To address this proactively, Ottawa County initiated a review of the existing galvanic CP system to ensure it is still providing adequate protection. The County engaged the contractor to conduct condition assessment of the pump stations and CP survey. If the results do not meet the -850mV minimum criterion,¹ plans are in place to upgrade the current galvanic CP system to an ICCP system. This upgrade would offer more consistent, reliable, and long-term corrosion protection, particularly given the advanced age of these pump stations.

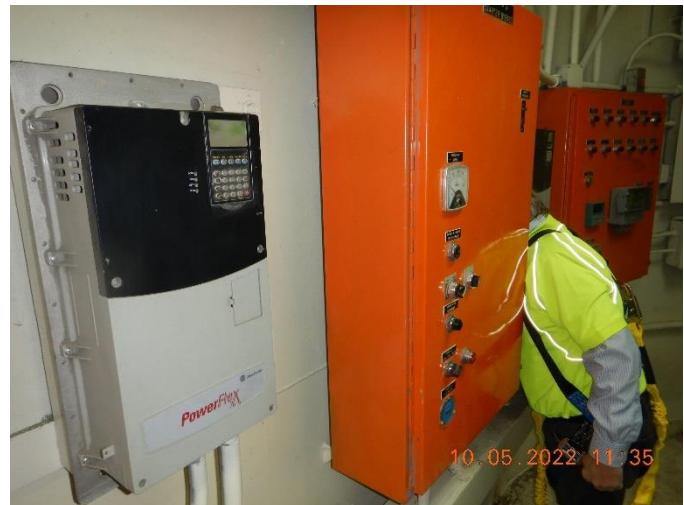
Figure 2: Photograph showing the electronic control systems essential for the automated operation of the pump station, reducing the need for direct human involvement.

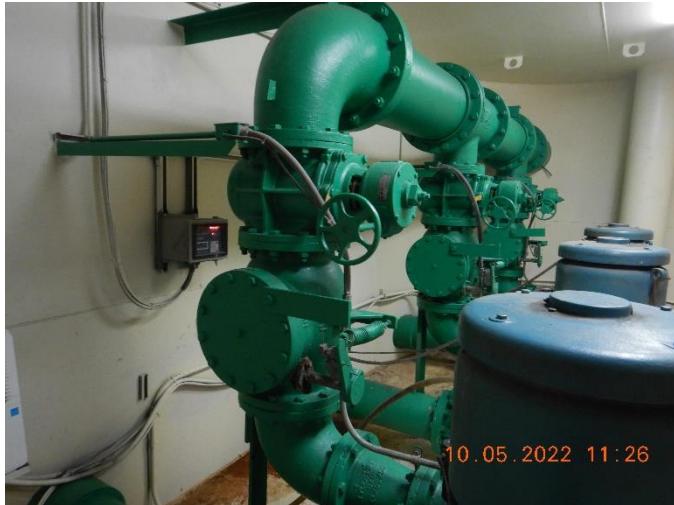
Figure 3: Photograph showing pumps and its associated piping in the pump station chamber.

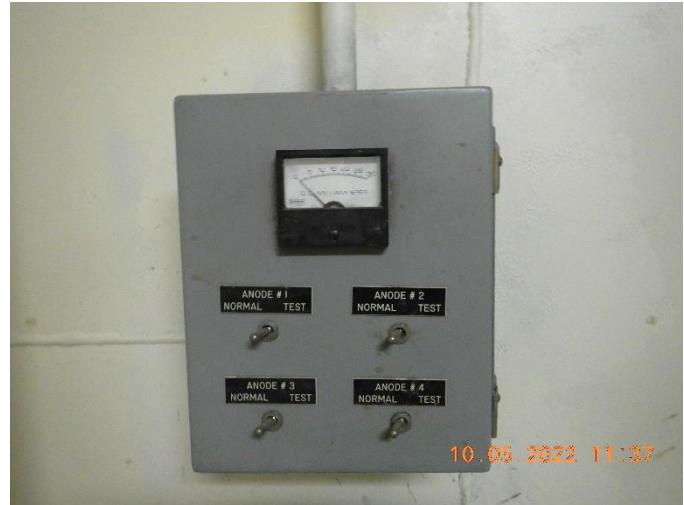
Figure 4: Photograph showing test panel for sacrificial CP system.

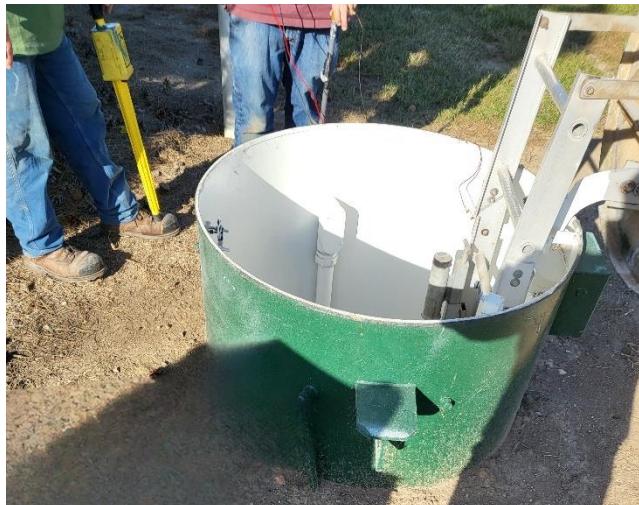
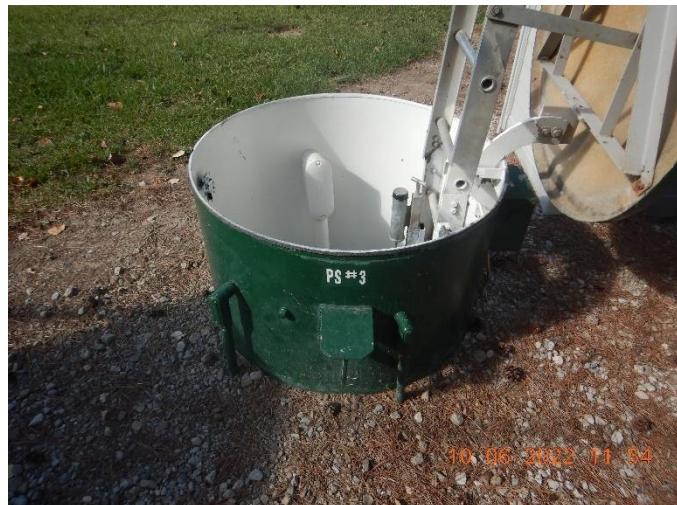
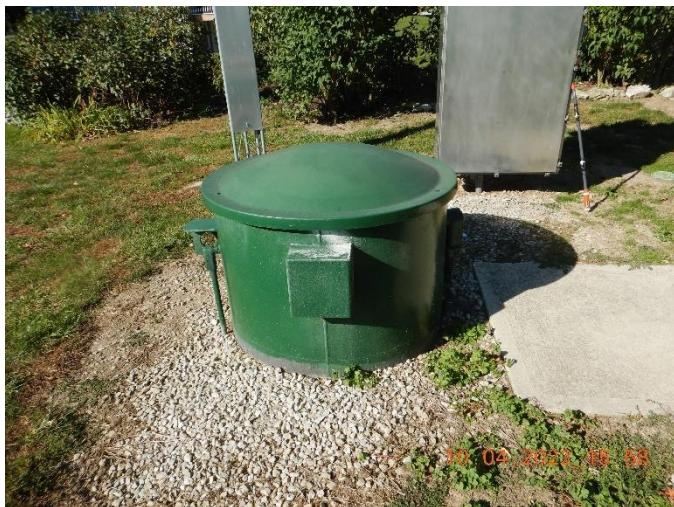
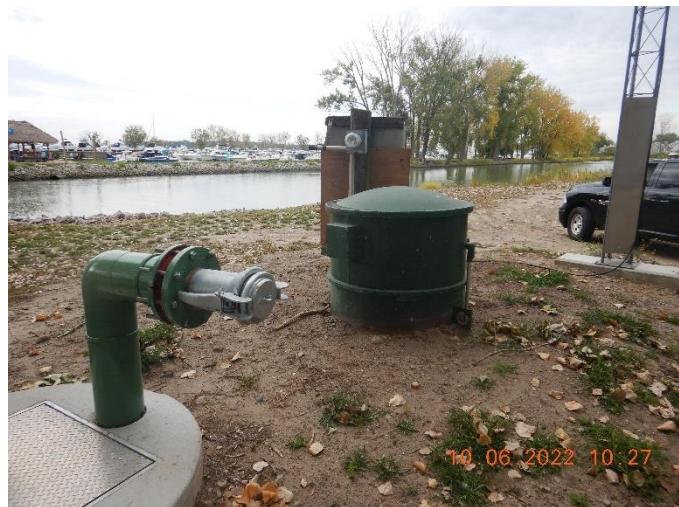
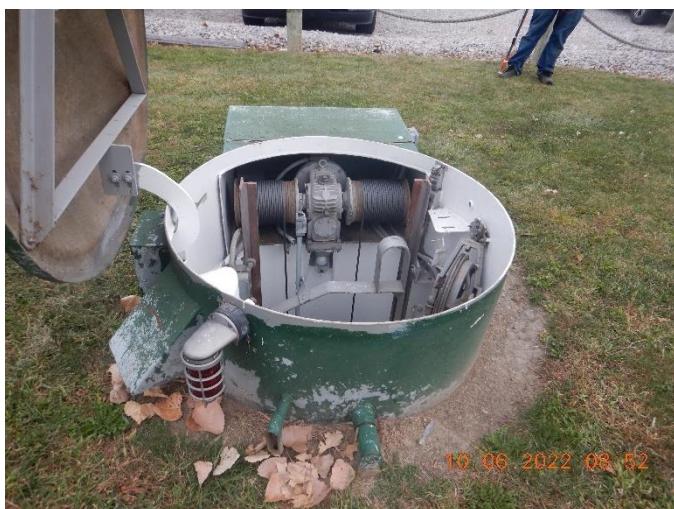
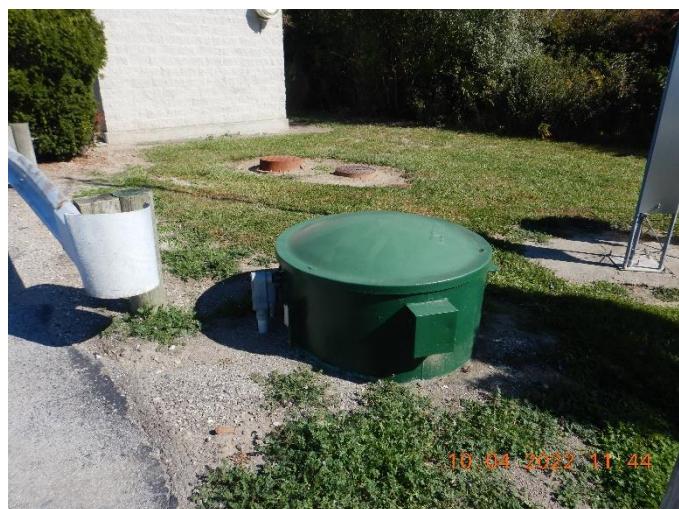
A detailed visual inspection was conducted on the six pump stations under evaluation (Figures 5 - 10). Each station features an external epoxy coating designed to protect the steel structures from corrosion caused by contact with the surrounding soil environment. The interior surfaces of the stations are coated with a polyamide epoxy, which serves as an additional layer of protection against internal corrosion. During the original construction of each lift station, two 17-pound magnesium anodes were installed and directly connected to the exterior shell of the steel dry well to provide cathodic protection.

Figure 5: Photograph showing pump station 2.

Figure 6: Photograph showing pump station 3.

Figure 7: Photograph showing pump station 4.

Figure 8: Photograph showing pump station 5.

Figure 9: Photograph showing pump station 7.

Figure 10: Photograph showing pump station 9.

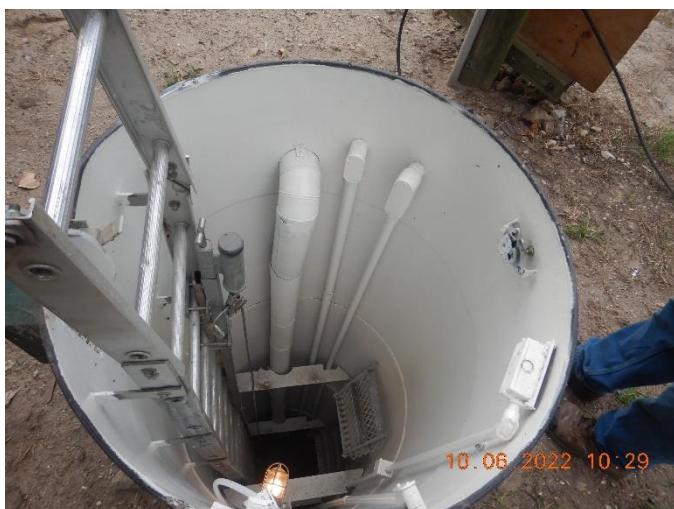
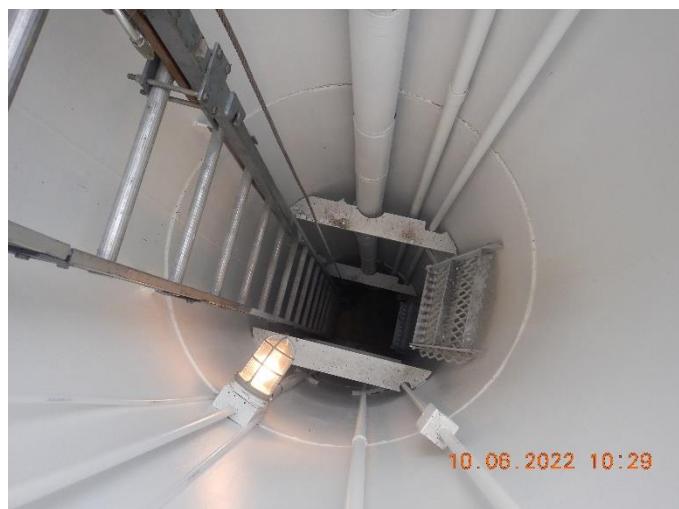
Figure 11: Photograph showing internal view of the pump station 5.

Figure 12: Photograph showing internal view of the pump station 5.

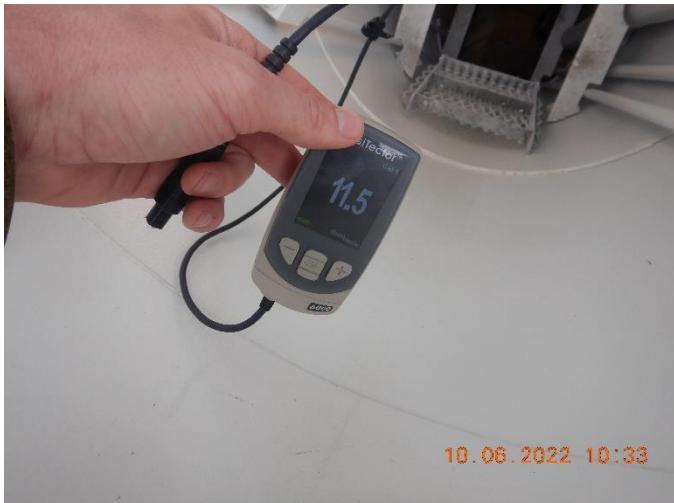
Ultrasonic wall thickness measurements were conducted on the entrance tubes of the pump stations using an ultrasonic wall thickness gauge. Additionally, the coating thickness was assessed with a Positector gauge[†]. Both measurements were taken at a depth of 1 to 3 feet from the top surface of the entrance tubes to provide consistent data for evaluation. The results, detailed in Table 1, serve as a baseline for future inspections, allowing for comparisons over time to monitor any potential degradation in wall or coating thickness. Figures 13 and 14 provide representative images displaying the coating thickness and wall thickness measurements for Pump Station 5.

Figure 13: Photograph showing the coating thickness (in mils) of entrance tube of the pump station 5.

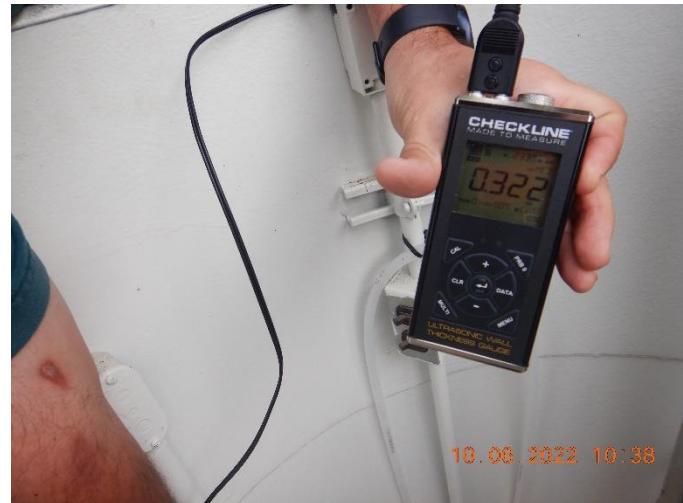
Figure 14: Photograph showing the wall thickness (inches) of entrance tube of the pump station 5.

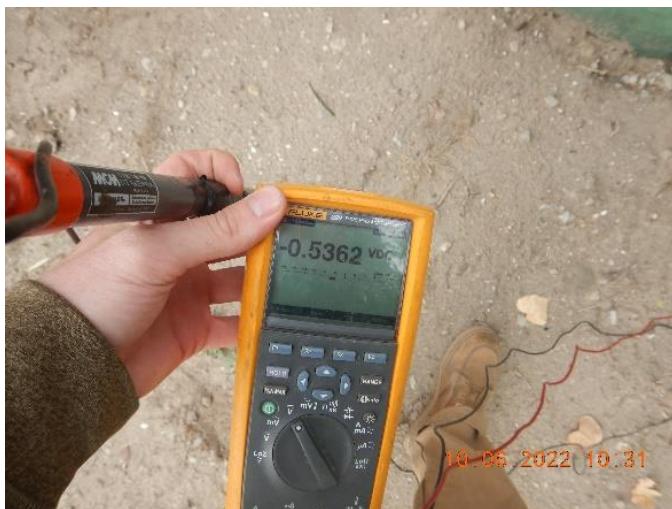
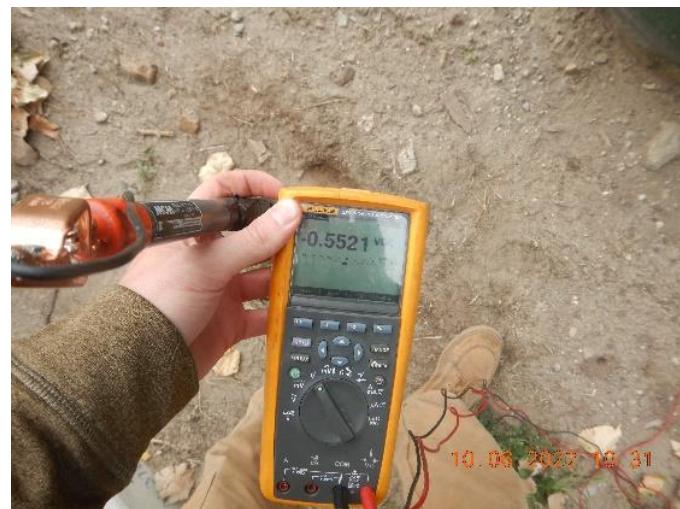
Structure-to-soil potential measurements for the pump stations equipped with the existing galvanic CP system are summarized in Table 2. The results indicate that none of the evaluated pump stations—specifically stations 2, 3, 4, 5, 7, and 9—met the minimum protection criterion of -850 mV with CP applied. These readings suggest that the magnesium anodes originally installed on the exterior of the dry wells during construction have been depleted over time, reducing the effectiveness of the CP system.

Figures 15 and 16 present representative images of the structure-to-soil ON potential measurements for Pump Station 5, illustrating the process used to assess the effectiveness of the existing CP system. These images, along with the data in Table 2, provide a comprehensive view of the current state of the pump stations' corrosion protection systems.

Figure 15: Photograph showing the structure-to-soil ON potential of the pump station 5.

Figure 16: Photograph showing the structure-to-soil ON potential of the pump station 5.

The structure-to-soil potential data, collected and analyzed by the contractor, played a crucial role in guiding Ottawa County's decision-making process. Based on the inadequate readings, the County determined that the existing galvanic CP system was no longer sufficient to provide long-term corrosion

protection. As a result, the decision was made to replace the depleted galvanic system with an ICCP system.

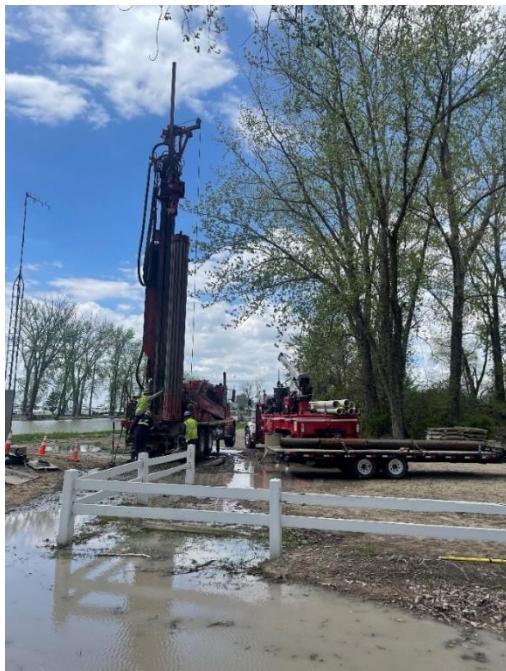
Figure 18: Photograph taken during the drilling process for anodes installation at pump station 5.

The new rectifiers and the junction boxes were installed by Ottawa County at all six pump stations. The modified shallow well anodes system was installed in a 50 feet deep hole, featuring a 20 feet PVC casing at the top, and steel casings where required. Within this setup, MMO anodes were strategically placed at varying depths from the ground level. The anode holes were efficiently backfilled with coke breeze, which is known for its effectiveness in enhancing CP processes. Figures 18 and 19 show representative pictures taken during the drilling and anode installation process.

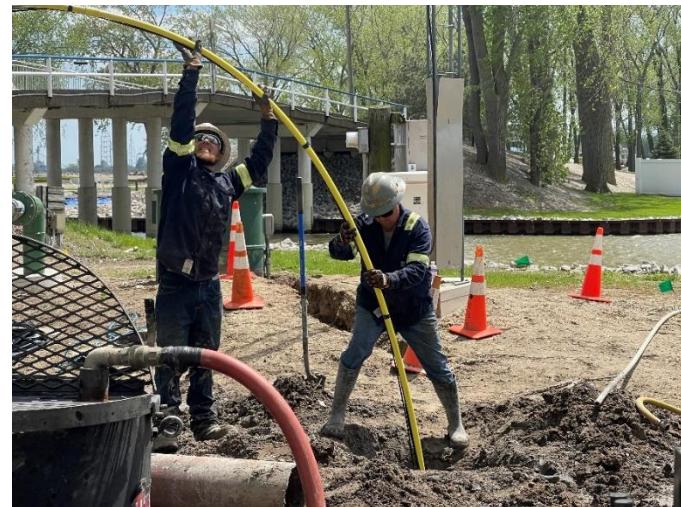
Figure 19: Photograph taken during the placement of the anodes and vent pipe in the drilled hole.

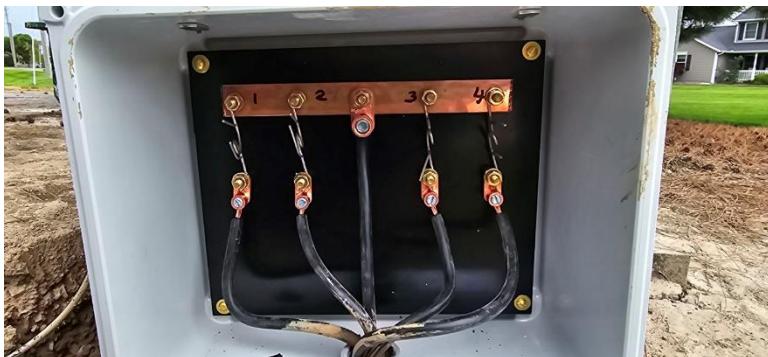
Figure 20 a): Photograph showing the junction box.

The anode leads were meticulously routed to a junction box (Figure 20 a)). From this central point, a header cable was neatly run to the rectifier (Figure 20 b)), facilitating the effective flow of current throughout the system. One end of the header cable was bolted to the structure (Figure 21) and the other end is run to the negative terminal of the rectifier.

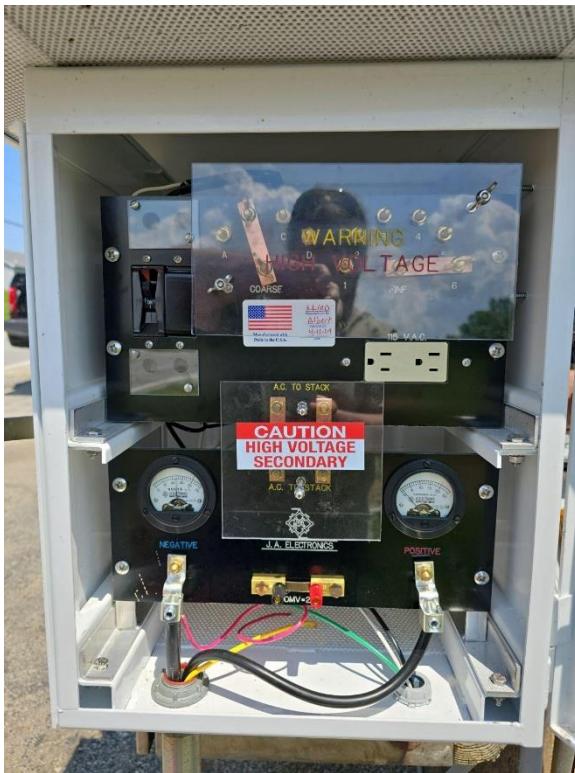
Figure 20 b): Photograph showing the rectifier.

After CP installation, the tap settings in the rectifiers were set to ensure that the structures are receiving adequate CP i.e., more negative than -850 mV in the OFF condition.

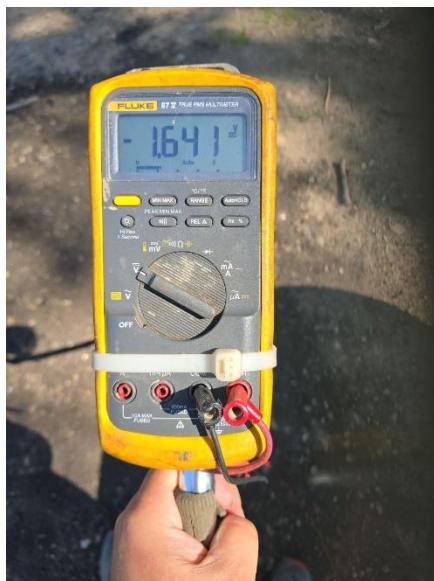
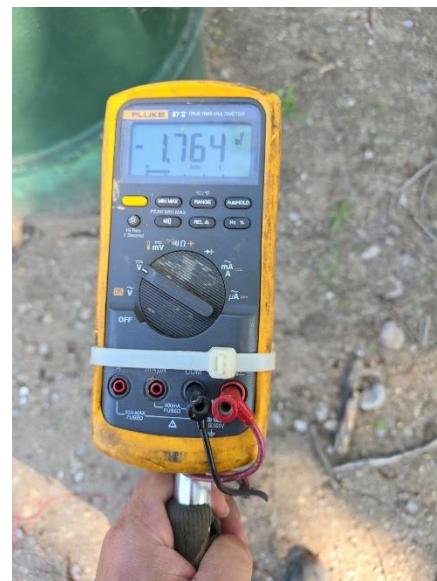
Initially, ON potentials were recorded. Then, the rectifier was interrupted to obtain the OFF readings. Both the ON and OFF potentials were found to be more negative than -850 mV. Table 3 presents the ON potential data after upgrading to the new ICCP system. The data clearly shows that the ON potentials are more electronegative than -850 mV compared to the previous survey data listed in Table 2. This significant finding indicates that the new ICCP system is highly effective, providing adequate CP to the pump stations. Figures 22 and 23 present representative images of the structure-to-soil ON potential measurements for Pump Station 5, illustrating the process used to assess the effectiveness of the upgraded CP system.

Figure 22: Photograph showing the structure-to-soil ON potential of the pump station 5.

Figure 23: Photograph showing the structure-to-soil ON potential of the pump station 5.

Structure-to-Soil potential measurements confirm that the newly installed ICCP system is functioning as intended, offering enhanced protection to the carbon steel structures at the pump stations. This ensures that the structures are safeguarded against external corrosion, maintaining their integrity and prolonging their operational life.

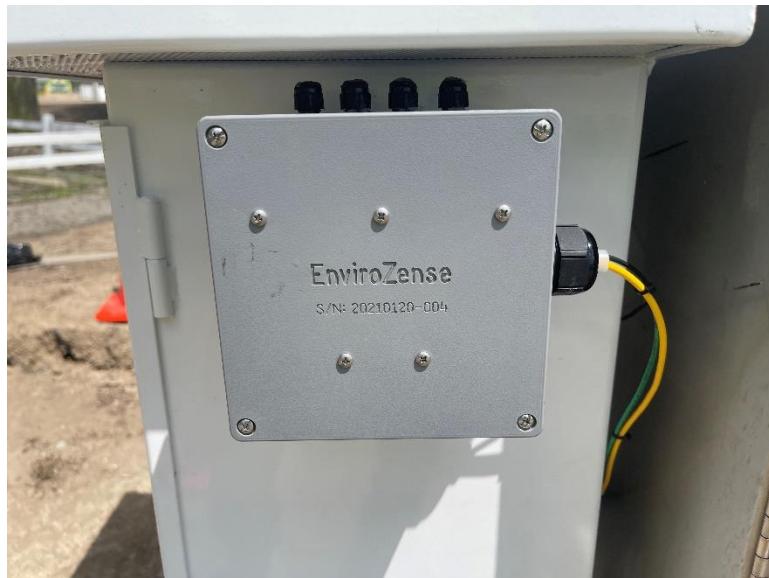
Figure 24: Photograph showing the real time structure-to-soil potentials monitoring sensor attached to the rectifier.

The sensor continuously monitors the structure-to-soil potentials and sends immediate notifications if the structure is not receiving adequate protection. This system offers Ottawa County a proactive solution for managing corrosion risks. Through the sensor WebView platform, Ottawa County can monitor potential data from each structure in real time. Critical corrosion potentials are highlighted for quick identification, allowing the team to prioritize structures that require immediate attention.

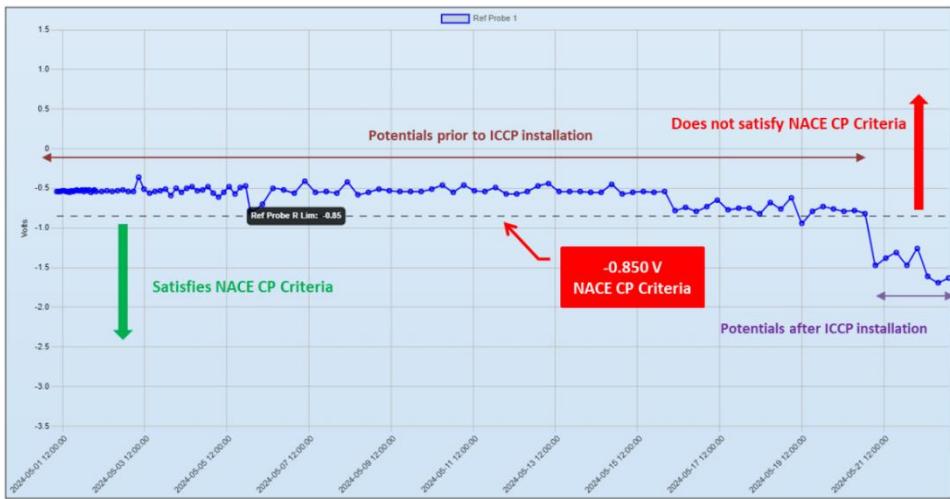
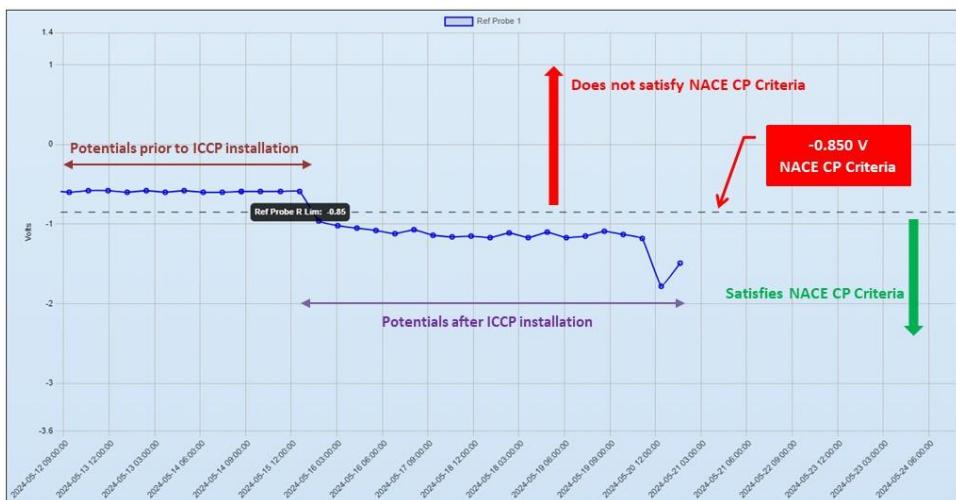
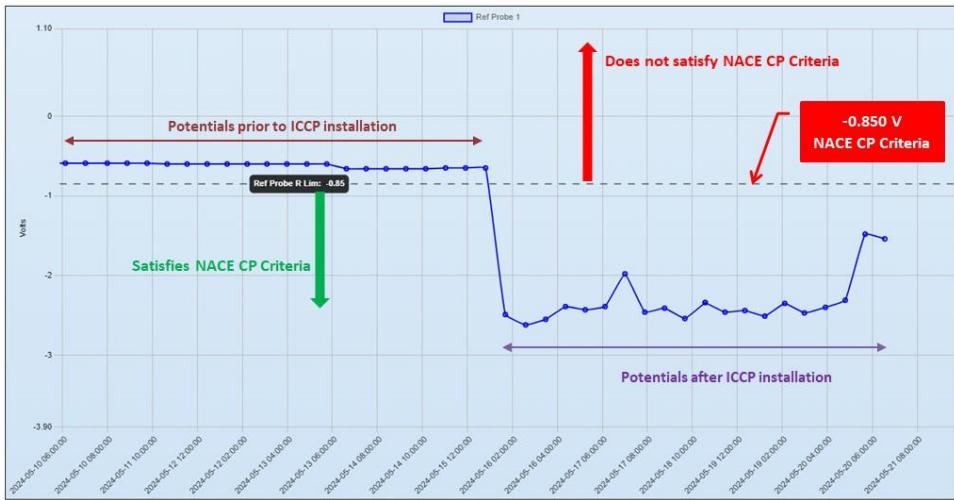
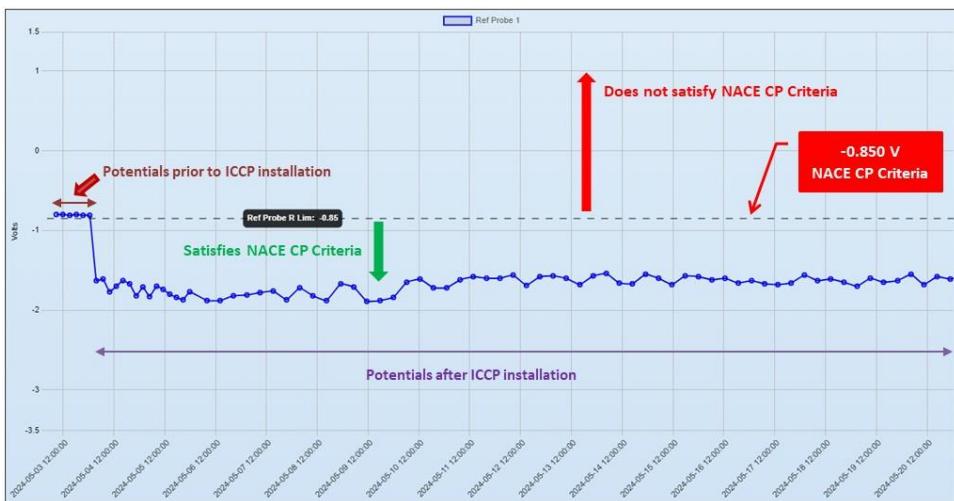
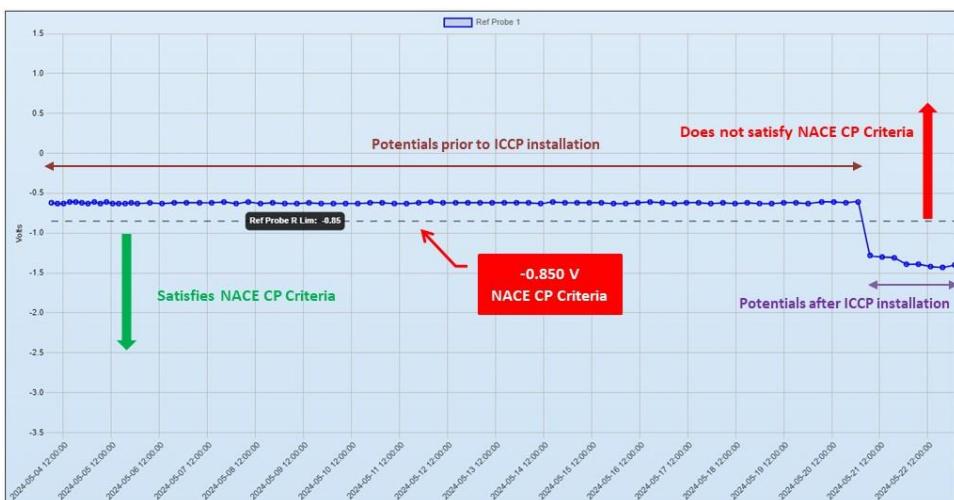
In addition to real-time alerts, the system also graphs data (Figure 25 – 30), providing an easy-to-read analysis of how long each structure has been exposed to corrosive environments. This feature simplifies the tracking of long-term trends and ensures that Ottawa County can take timely actions to preserve the integrity of their infrastructure.

Figure 25: Plot showing the real time structure-to-soil potential data of pump station 2.

Figure 26: Plot showing the real time structure-to-soil potential data of pump station 3.

Figure 27: Plot showing the real time structure-to-soil potential data of pump station 4.

Figure 28: Plot showing the real time structure-to-soil potential data of pump station 5.

Figure 29: Plot showing the real time structure-to-soil potential data of pump station 7.

Figure 30: Plot showing the real time structure-to-soil potential data of pump station 9.
