Watermain Breaks - Materials Does Matter

Edward Larkin
Matergenics Inc
100 Business Center Dr
Pittsburgh, PA 15205
USA

CASE HISTORY 1: GRAPHITIZATION² OF DUCTILE IRON WATERMAIN

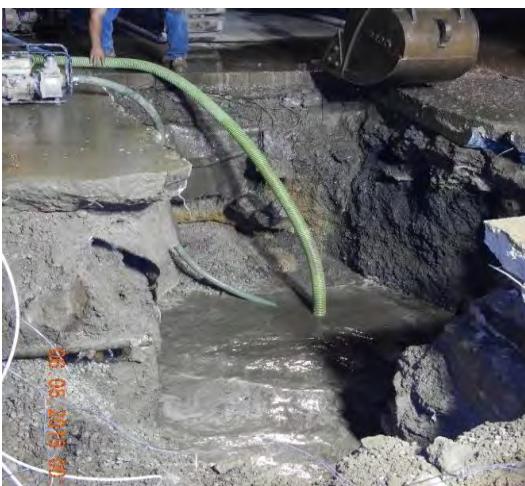
Visual examination of the failed 16-inch diameter water pipe indicated that the failure of the pipe occurred as a result of a hole in the bottom side of the pipe. Water was still leaking from the pipe and collecting at the bottom of the trench (Figures 9 - 11). After visual examination of the new pipe sections and the old pipe remnant, soil samples were collected near the pipe for laboratory analysis. Testing was also performed to look for the presence of stray currents.

Figure 9: Photograph showing pumping out of the water to expose the 16-inch diameter pipe in the trench.
