Effects of Corrosion and Wildfires on Galvanized Steel Towers: A Case Study with Wildfire and Corrosion Sensors

Mehrooz Zamanzadeh, Anil Kumar Chikkam, George T. Bayer, Clinton Char, Carolyn Tome, Farzan Zolfaghari, and Nathan Pace

Matergenics Inc.
100 Business Center Drive
Pittsburgh, PA 15210

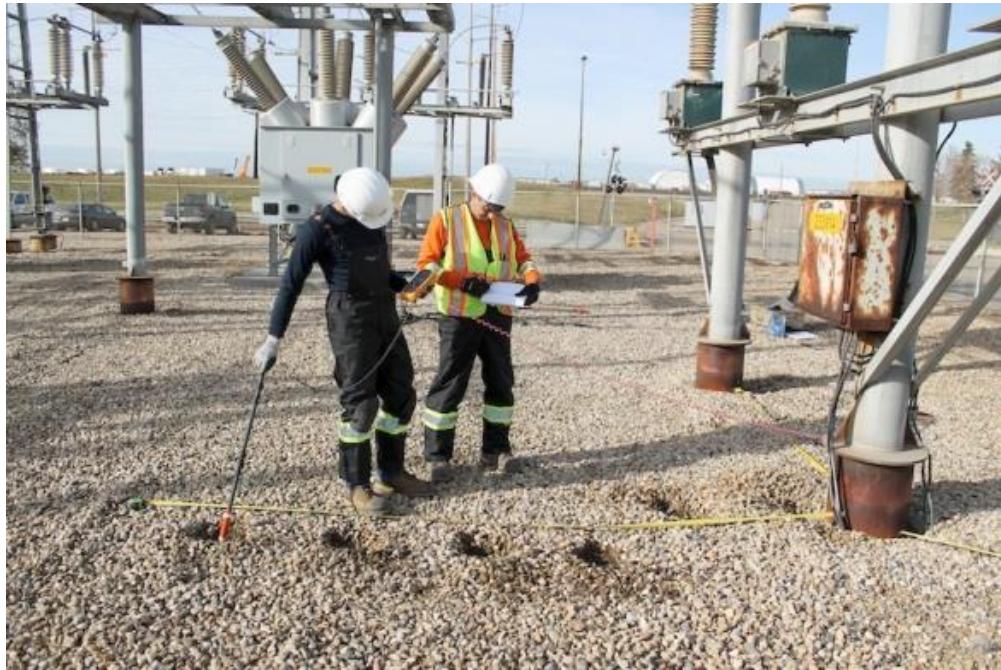
Figure 4 shows a corrosion crew performing corrosion risk assessment in a substation. Figures 5(a) and 5(b) show transmission tower legs exhibiting signs of microbiological corrosion. Figure 6 is a galvanized anchor bolt under a base plate for a communication tower exhibiting accelerated corrosion and extensive thickness loss. Figure 7 shows internal corrosion of a substation aging galvanized pole on concrete foundation. The measurement of corrosion potential will indicate the corrosion activity on galvanized members, as seen in Figure 8.

Figure 4: Corrosion crew performing corrosion risk assessment in a substation.

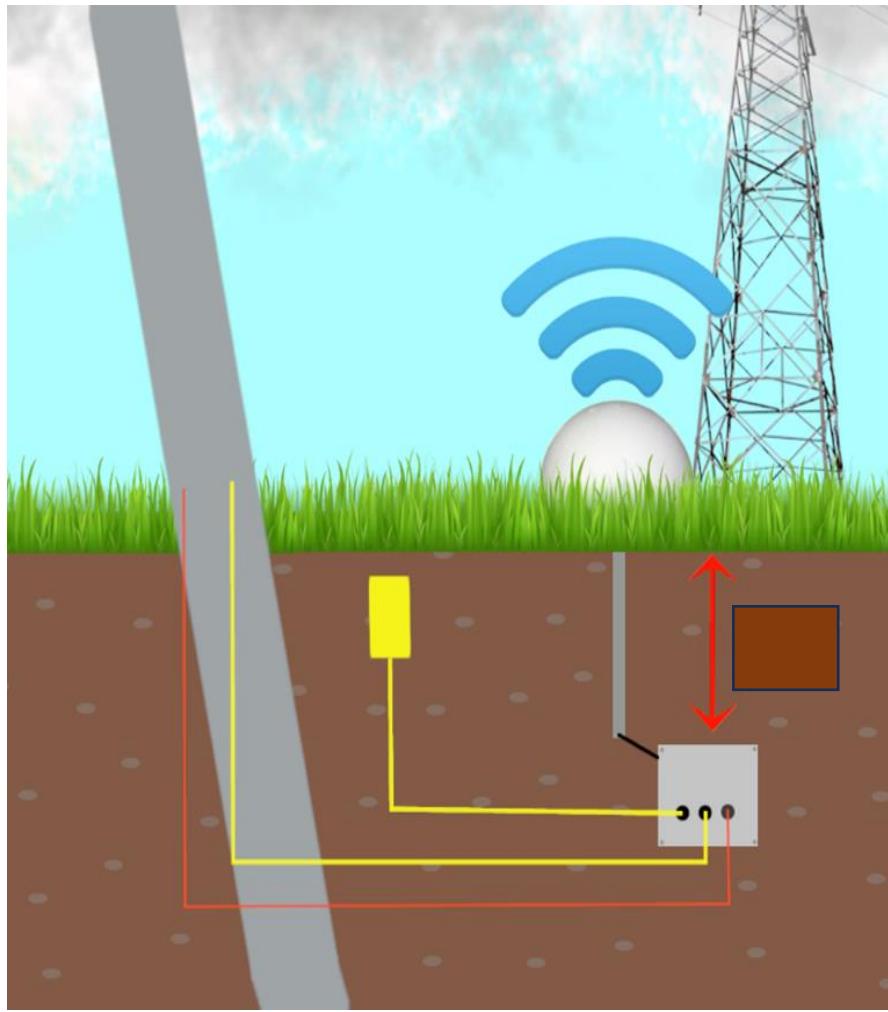
Two years ago, the authors installed temperature/corrosion sensors at two client site locations in Hawaii. The initiative aimed to demonstrate the critical role these sensors play in real-time monitoring, thereby allowing the client to take immediate corrective actions. Figure 9 shows a schematic of the sensor system. Data from these sensors are transmitted via satellite for timely assessment.

Figure 9: A corrosion wildfire sensor transmitting corrosion and temperature data to WebView on time to provide warnings.
