**Metal, Moisture, And Mystery:**

**The Curious Case of The Corroding phone Charger Pin**

Anil Kumar Chikkam  
Matergenics Inc  
100 Business Center Dr  
Pittsburgh, PA, 15205  
USA

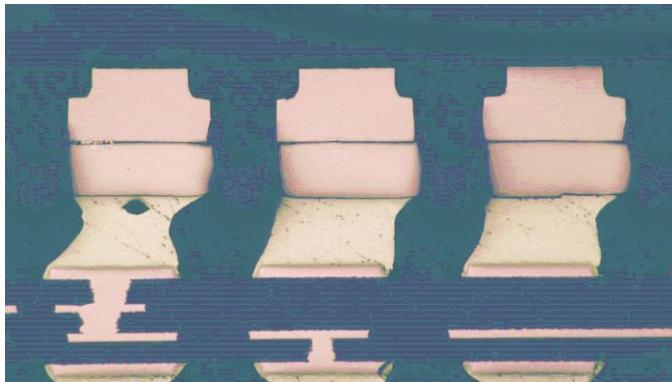
Figures 11 and 12 offer a photomicrographic exploration of the fourth, fifth, and sixth pins from the brand-new charger cable from the original manufacturer. Captured at 50X and 1000X magnifications respectively, these figures display the intact and undamaged structure and coating layers, offering a contrast to the corroded charger and presenting a benchmark for comparison.

**Figure 11: Photomicrograph of the fourth, fifth, and sixth pins from the brand-new charger cable from the original manufacturer. Magnification: 50X**

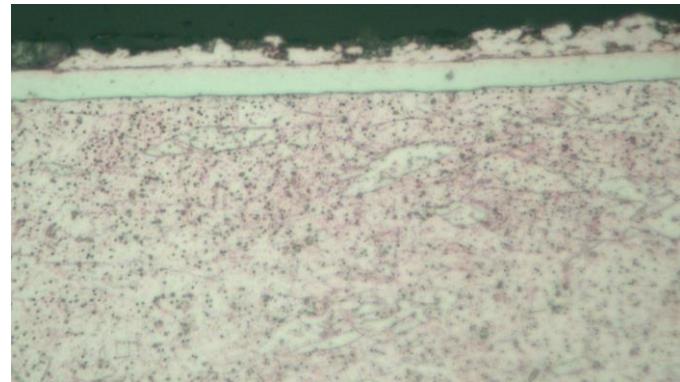
**Figure 12: Photomicrograph showing three layers of coating on the copper substrate. Magnification: 1000X**

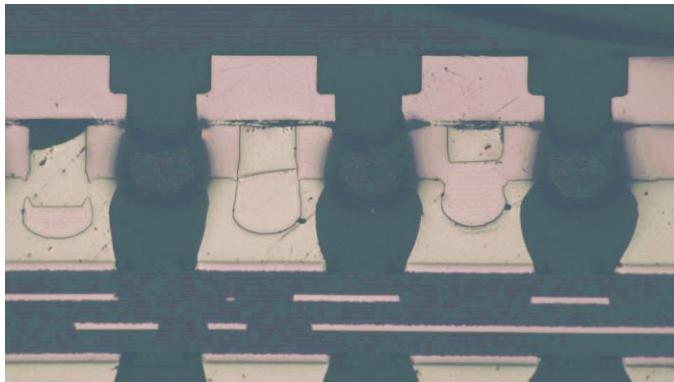
In a parallel examination, Figures 13 and 14 present photomicrographs of the fourth and fifth pins from the brand-new charger cable obtained from the original manufacturer approved third-party vendor. These images, captured at magnifications of 50X and 1000X respectively, echo the findings from the original

**Figure 13: Photomicrograph of the fourth, and fifth pins from the brand-new charger cable from the original manufacturer approved third-party vendor. Magnification: 50X**

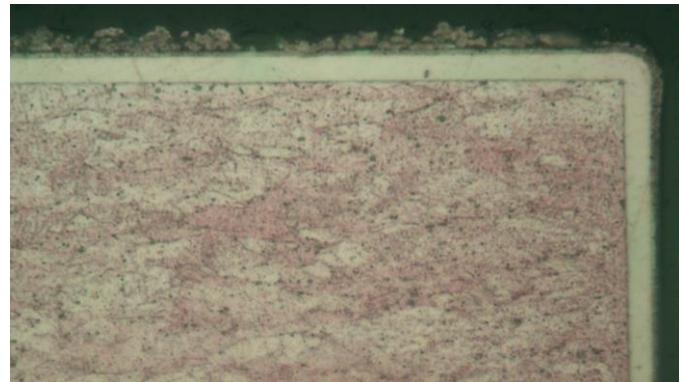
**Figure 14: Photomicrograph showing three layers of coating on the copper substrate. Magnification: 1000X**

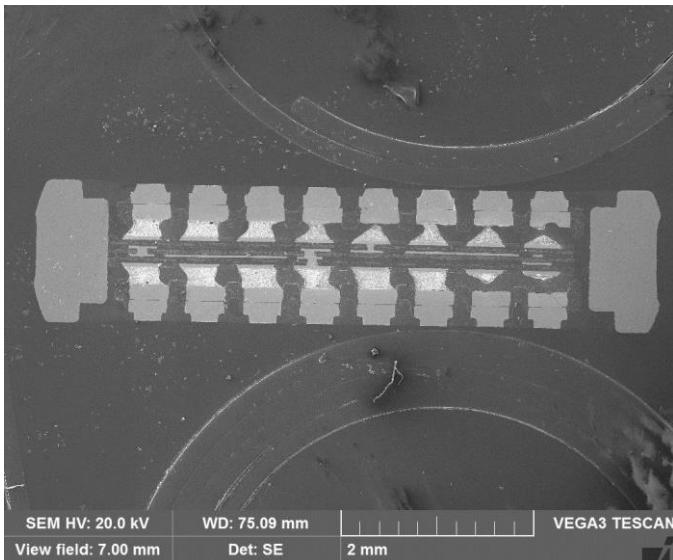
Figure 19 captures the entirety of the pins from the new charger, sourced directly from the original manufacturer. Delving deeper, Figure 20 zooms in on one specific pin, magnifying its features and structure for a closer and more detailed examination. The high-resolution SEM imaging reveals the nuances, layers, and craftsmanship of this individual pin, serving as a representative sample for understanding the construction and design of all the pins.

**Figure 19: SEM image showing comprehensive visualization of all the pins from the new charger from the original manufacturer.**

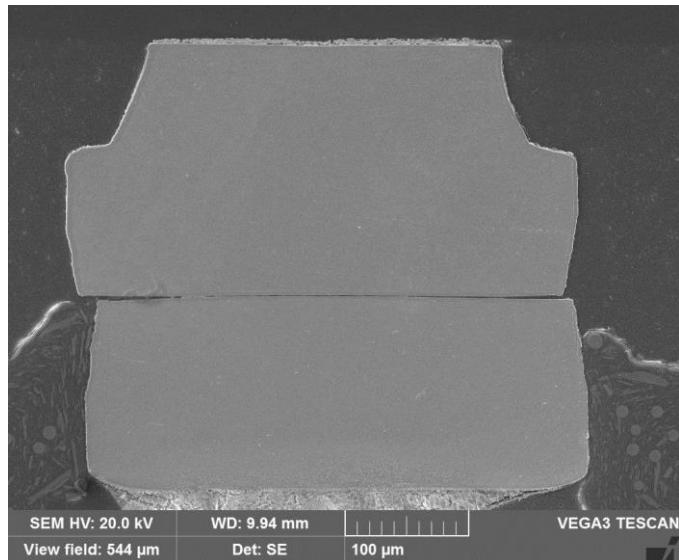
**Figure 20: SEM image taken at one of the pins.**

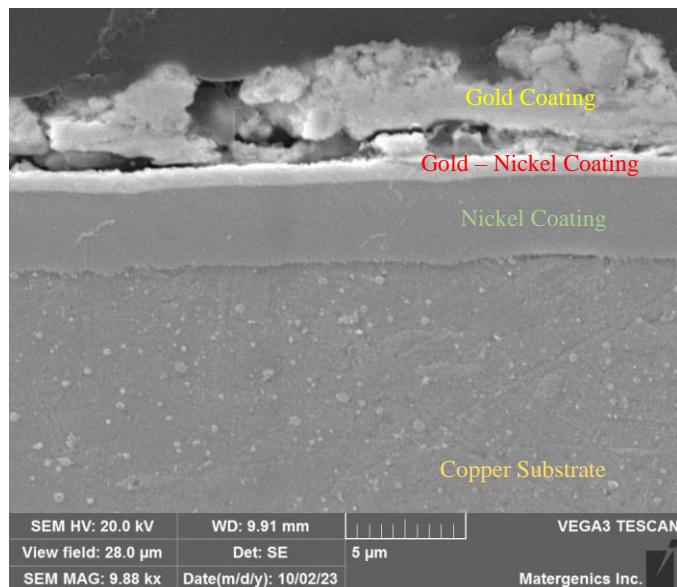
Upon meticulous scrutiny of the pin visualized in Figure 21, it becomes evident that the foundational copper substrate, which forms the core of the pin, is not left exposed. Rather, it's intricately enveloped by a trio of protective coating layers. These layered coatings are designed with the primary intent of safeguarding the copper substrate against the rigors of corrosion, which could compromise its electrical conductivity, as well as the inevitable wear and tear resulting from regular use.

**Figure 21: SEM image showing that the foundational copper substrate is intricately enveloped by a trio of protective coating layers.**

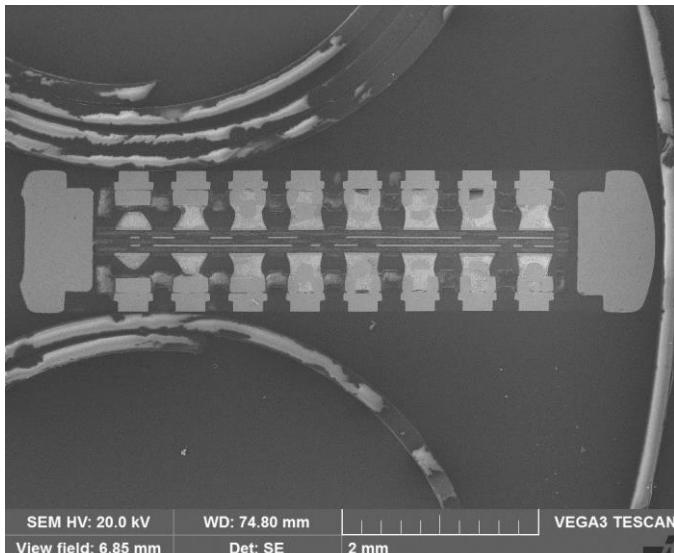
Analogous SEM observations (Figures 22 – 24) were recorded for the charger sourced from an original manufacturer-approved third-party vendor, which was acquired from a nearby local store. This detailed SEM analysis showcased similarities, indicating that even though the charger was not directly from the original manufacturer, it adhered closely to the same rigorous standards and specifications.

**Figure 22: SEM image showing comprehensive visualization of all the pins from the new charger sourced from an original manufacturer approved third-party vendor, which was acquired from a nearby local store.**

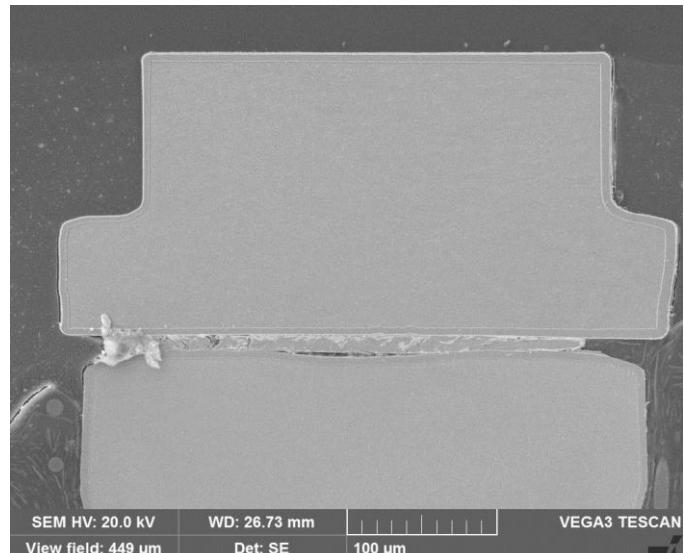
**Figure 23: SEM image taken at one of the pins.**

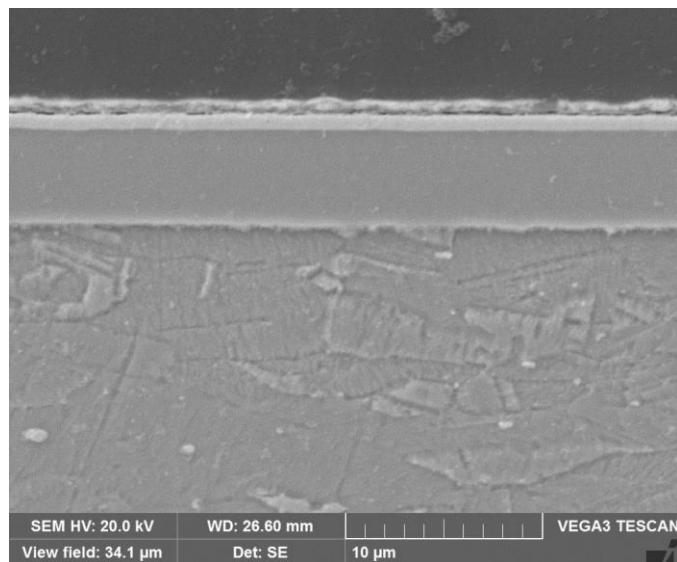
**Figure 24: SEM image showing that the foundational copper substrate is intricately enveloped by a trio of protective coating layers.**
